Audi C4 Avant Tailgate / Hatch repair

The trim piece on my hatch had the usual squeaks, the sunshade was barely hanging on and the pull down handle had completely broken free. This write up should help with trim disassembly and repair. Some of my write up is copied from other posts. All cardinal directions are as if the hatch is in the closed position.

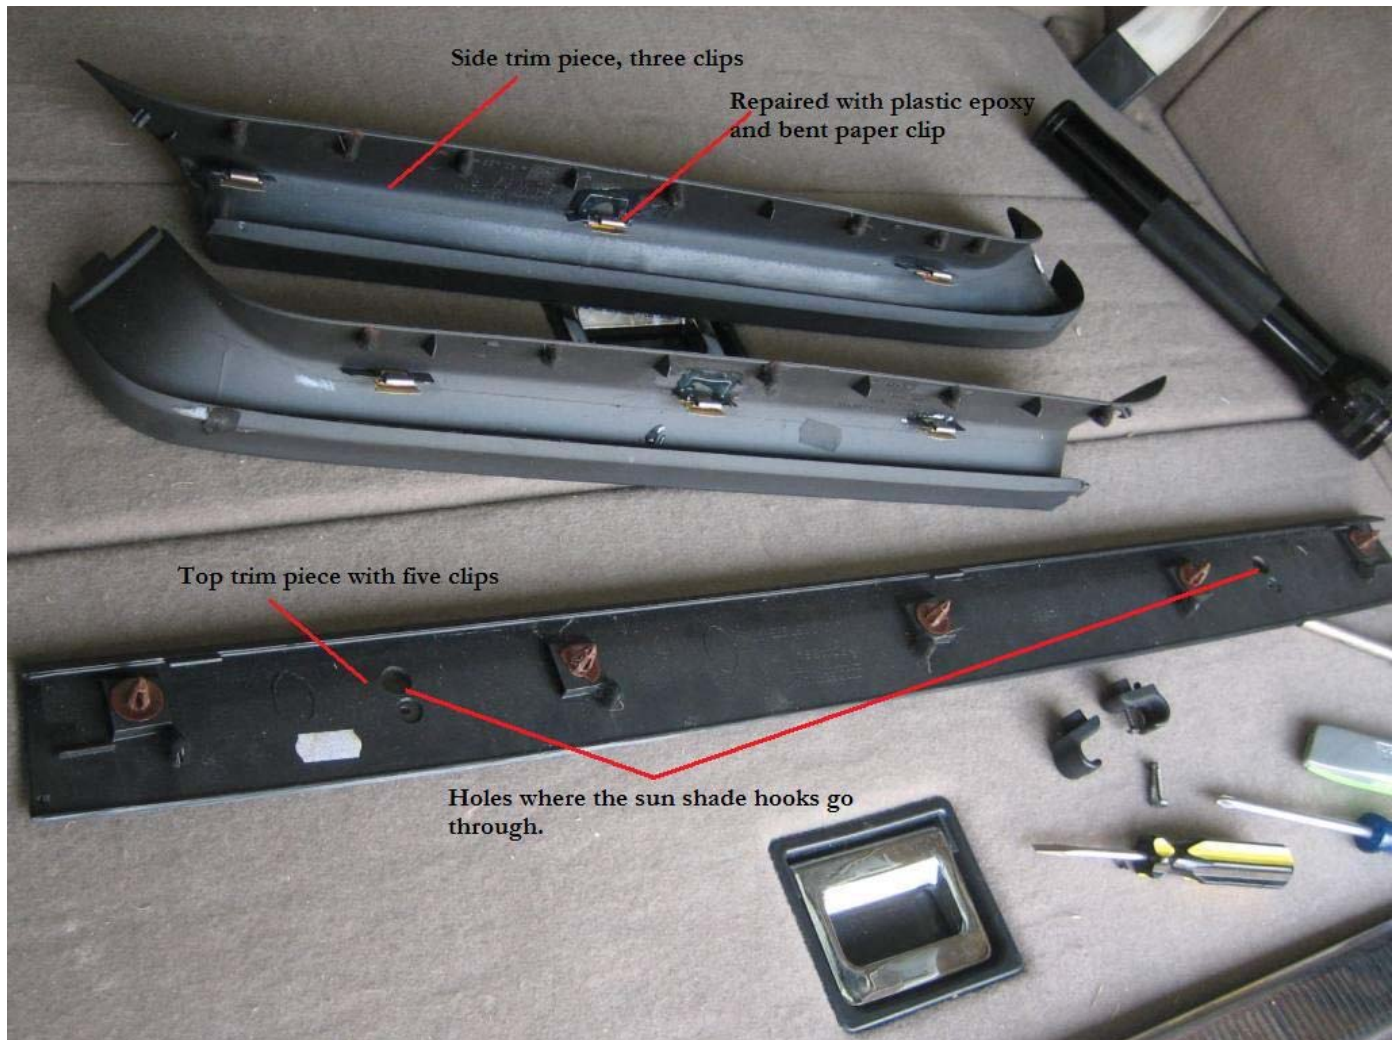
First, remove the two screws holding the two hooks for the sun screen. Then, unsnap the top piece in five locations. Unsnap L and R side plastic pieces by pulling the trim pieces towards center.

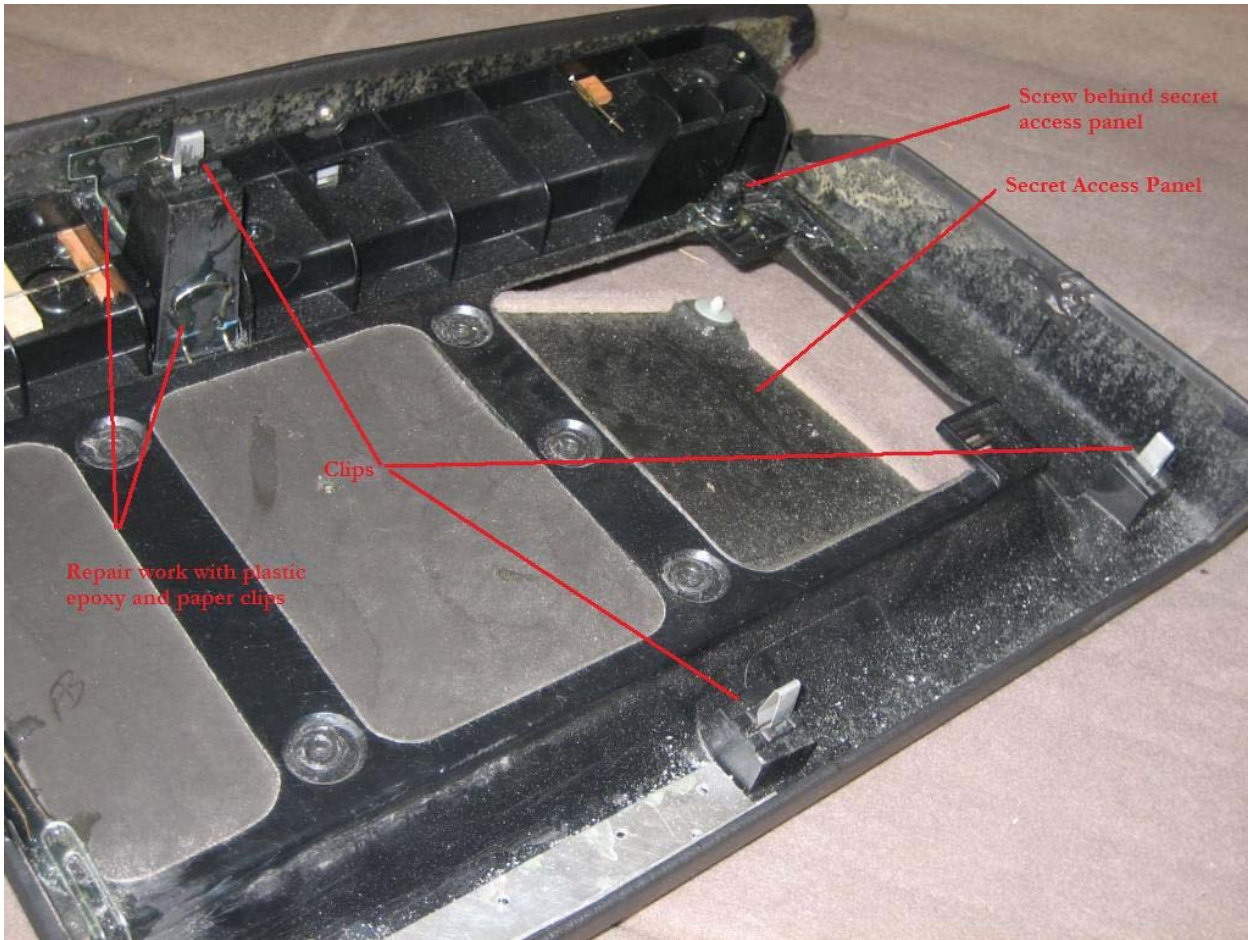
The top piece needs to be removed before the side pieces can be removed, and the side pieces need to be removed before the bottom (main) piece can be removed. Remove the 2 black screws underneath the latch and one screw on each side of the bottom panel. Pop out the secret flap type compartments of the lateral parts of the carpeted section with a flat screwdriver. These hidden compartments correspond to an area behind each taillight. Unscrew one hidden screw behind each secret panel (outside upper corner).

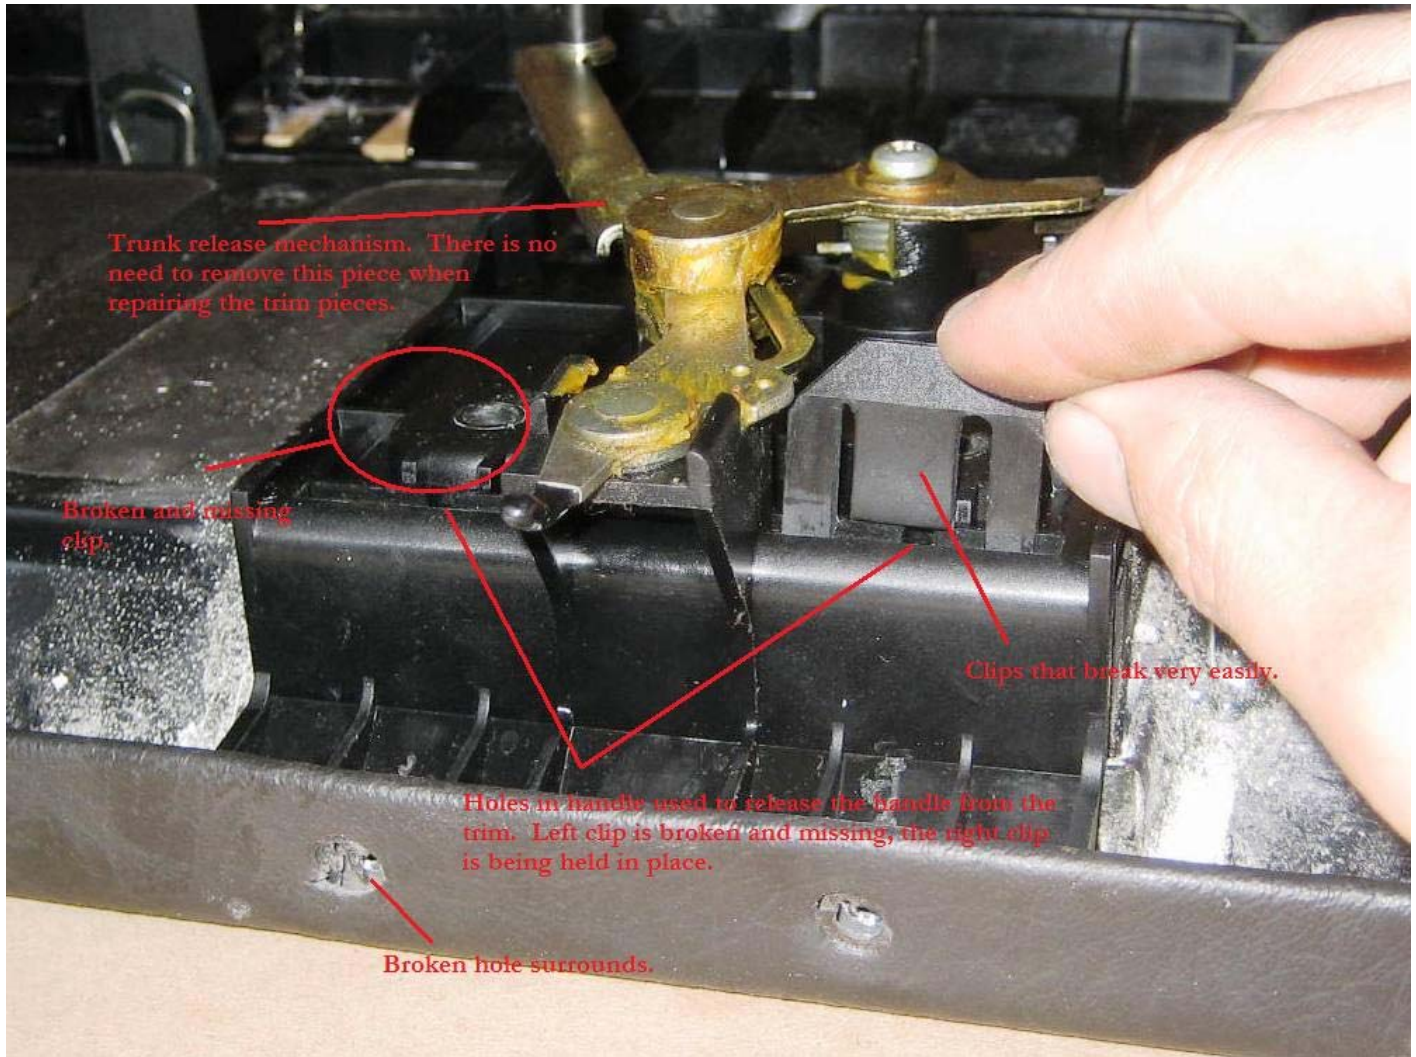
Now, at the bottom of the handle trim below the torx screws are two very small holes. Find a thin long object like a nail and push in to the two holes. In the below picture you can just see the holes where the nail will come thru. Use the nail to lever the tab to release the handle trim. YOU DO NOT NEED TO TAKE OUT THE TORX SCREWS IN THE DOOR HANDLE.

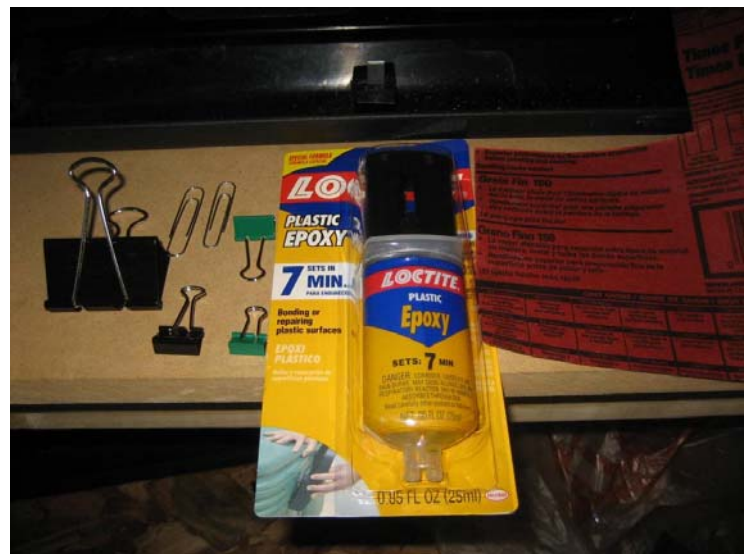
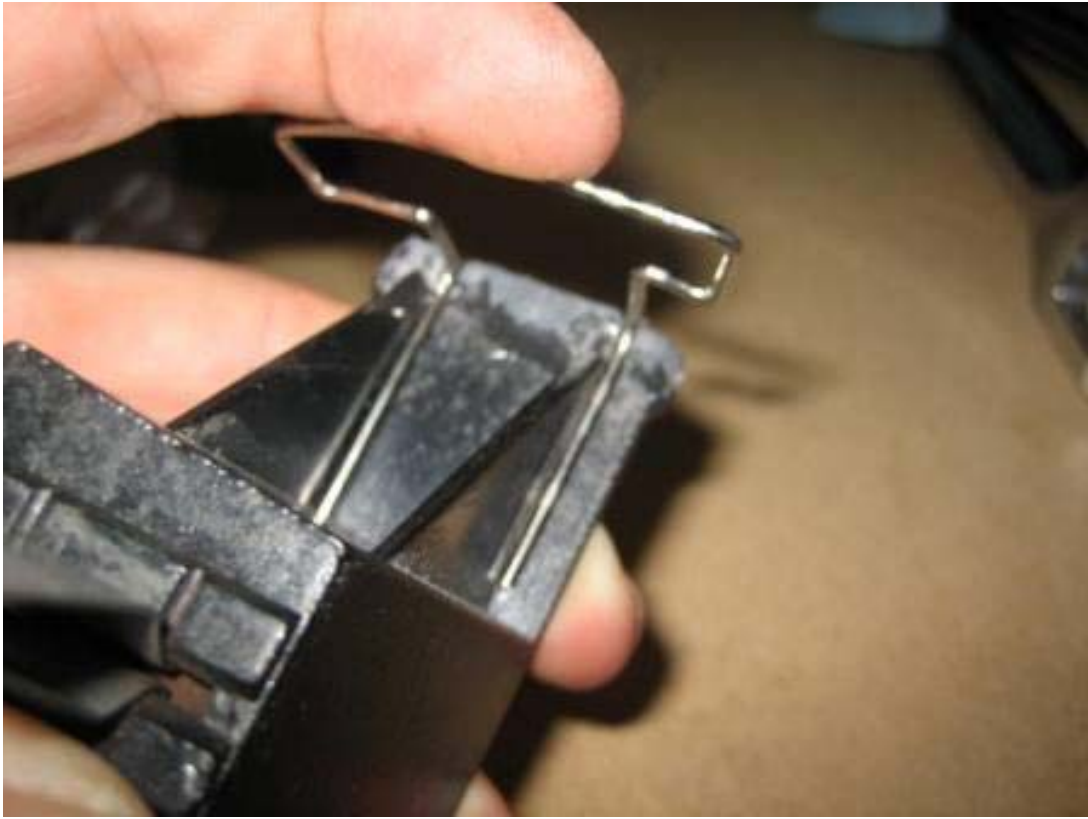
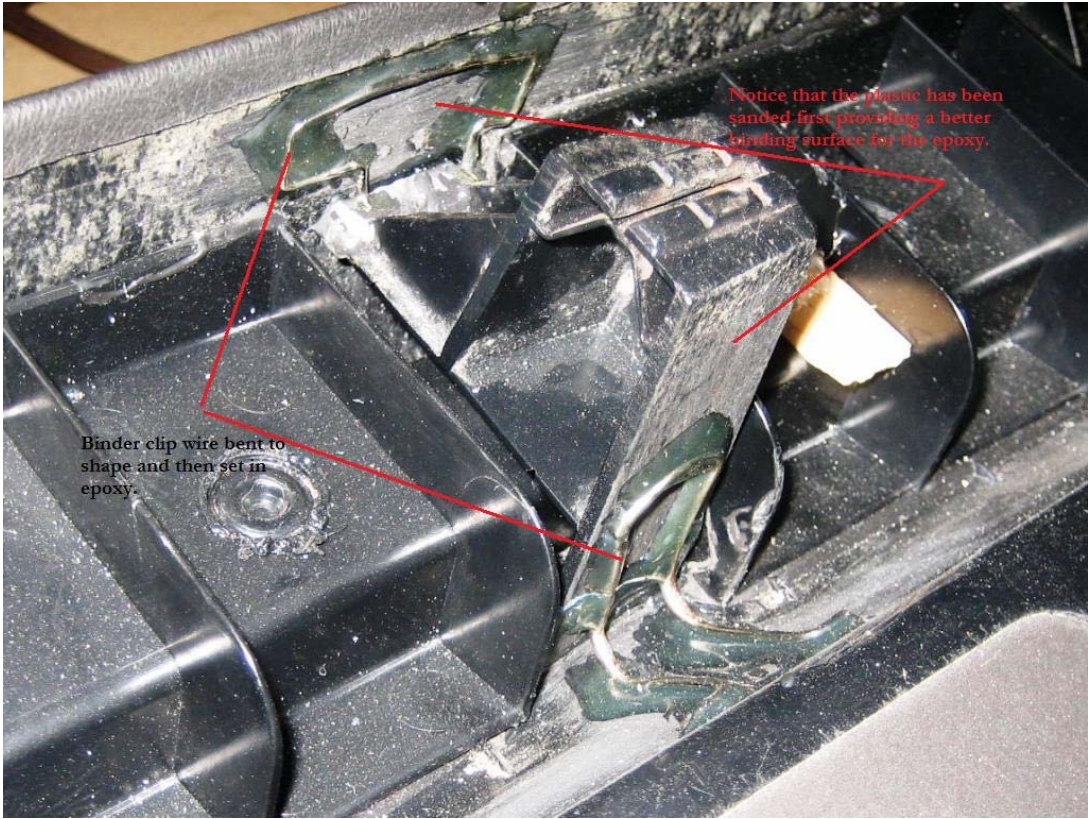
After careful inspection I found quite a few cracks in the plastic as well as the above mention broken clips and tabs. Instead of just gluing the pieces back together, I decided to reinforce the broken pieces as best I could. I chose the metal wire from paper clips and various sized binder clips to act like rebar in concrete. I also found some plastic epoxy, as opposed to all purpose epoxy. I used fine grit sandpaper to prep the plastic.

Since the epoxy runs, I would glue one area, let it dry, and then flip the piece and glue the other plane.

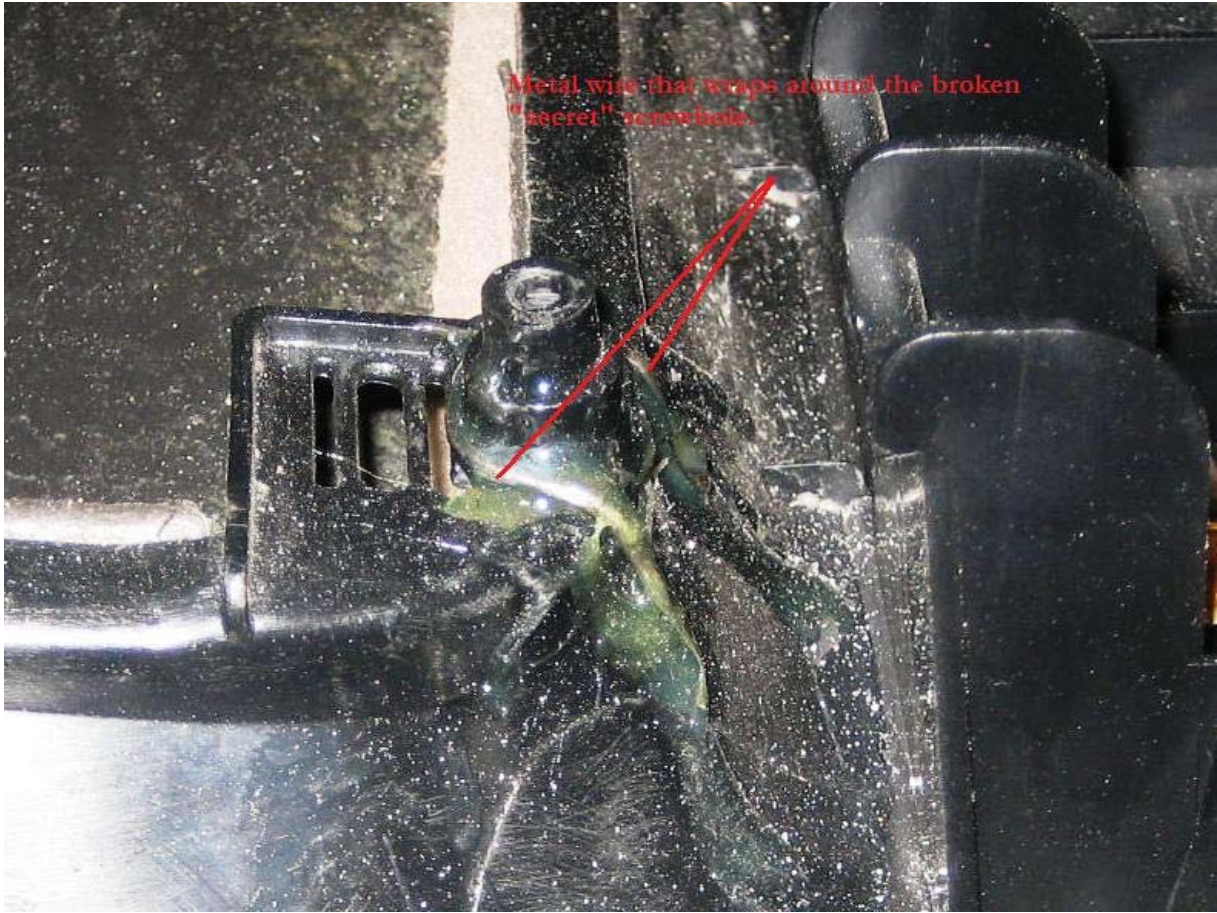
Metal wire that wraps around the broken "screw" to contain.

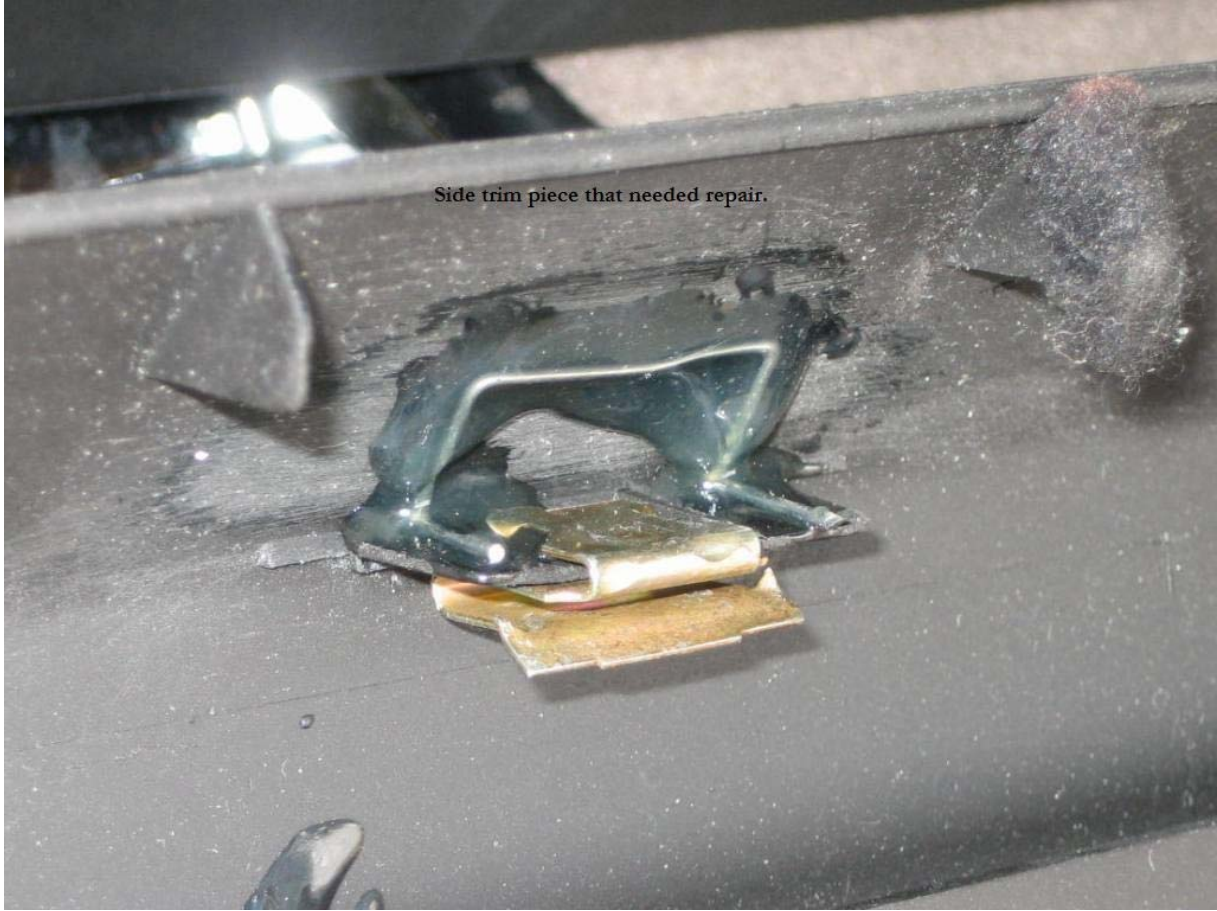
Side trim piece that needed repair.

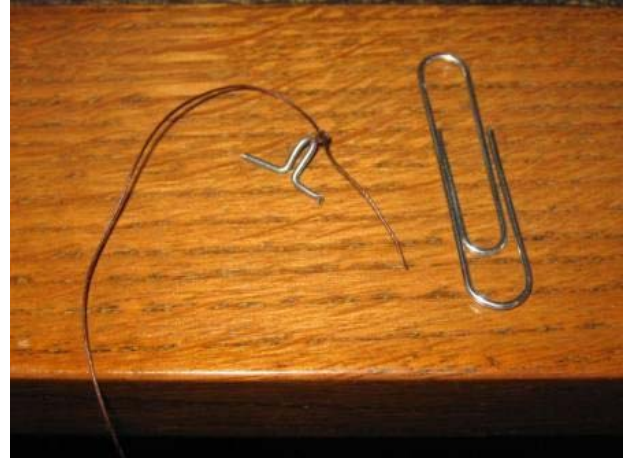
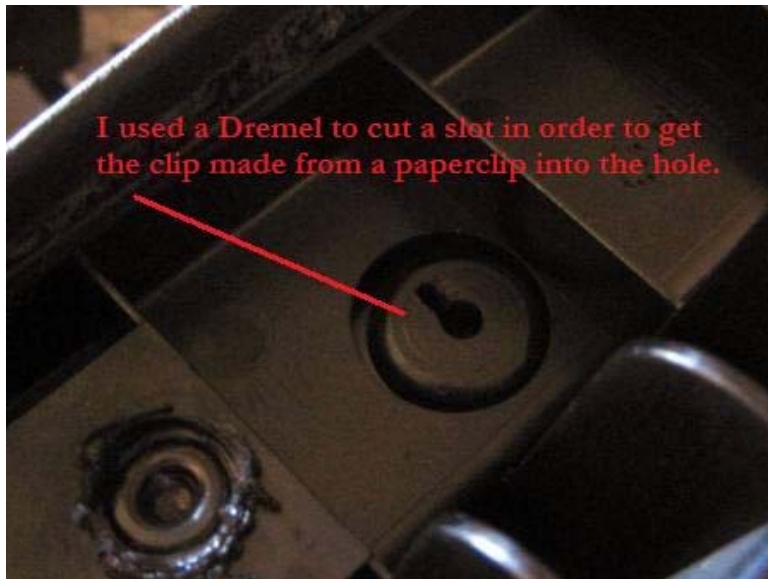
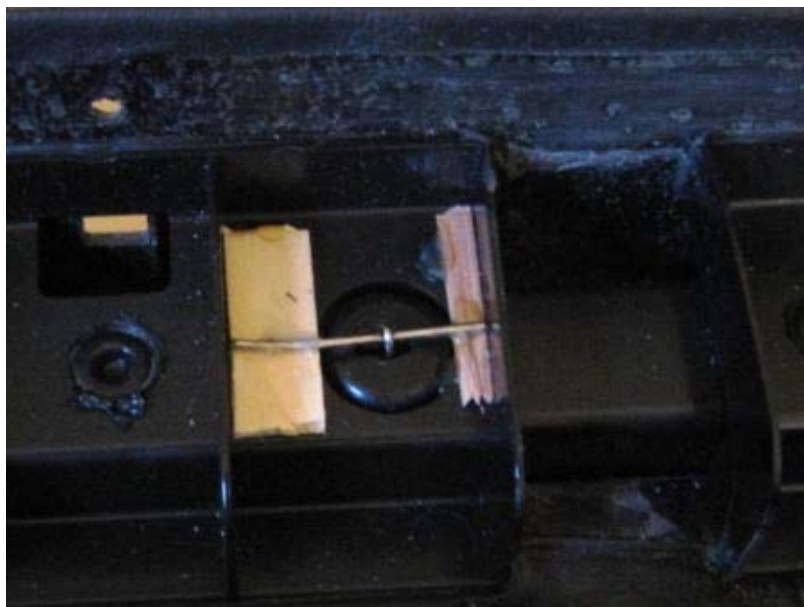
After repairing the various broken plastic clips, it was time to tackle the rattling sun shade and the pull down handle. The sunshade is held in place by a screw on each end and several plastic welds (looks like cigar burns). The plastic near the screws was beyond broke and most of the plastic welds had failed. My fix might be a bit overkill and a little on the ugly side, but it has held strong for the last 6 months.

I think the following three pictures illustrate what I did, but a few words will help. After bending and shaping the metal from a paperclip, I tied some heavy sewing thread onto the piece to make it easier to hold onto. The metal cross bar is from a heavy binder clip (most paper clips are too thin). The pieces of wood are actually wood shims, which allowed me to snug things up. A packet of shims cost around a dollar. A couple of dabs of epoxy holds things in place.

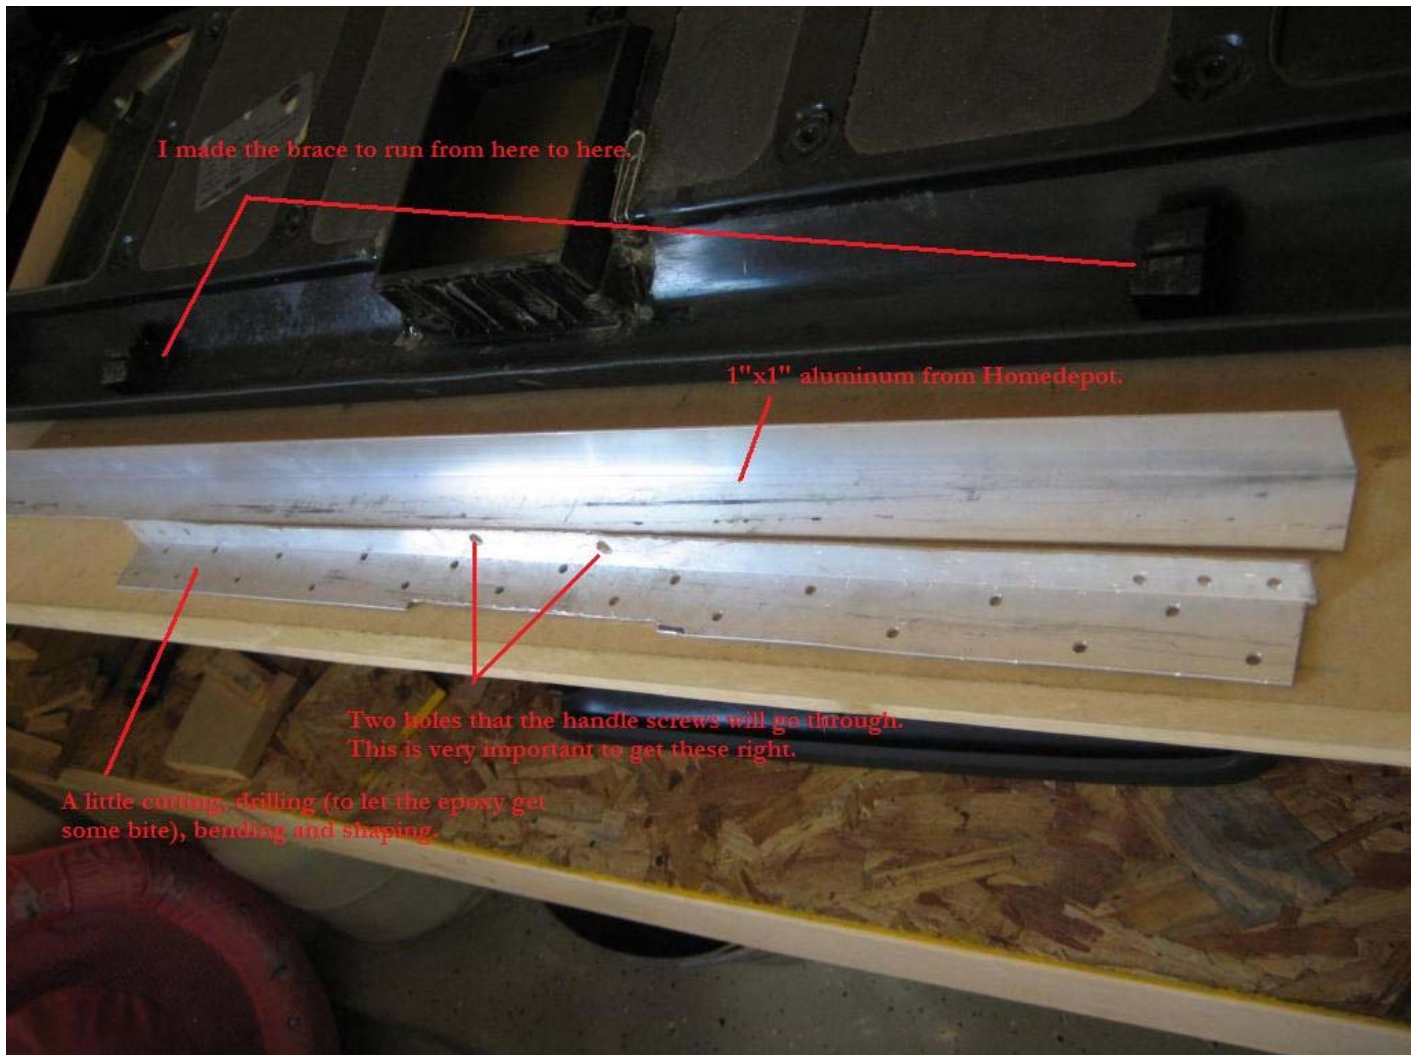
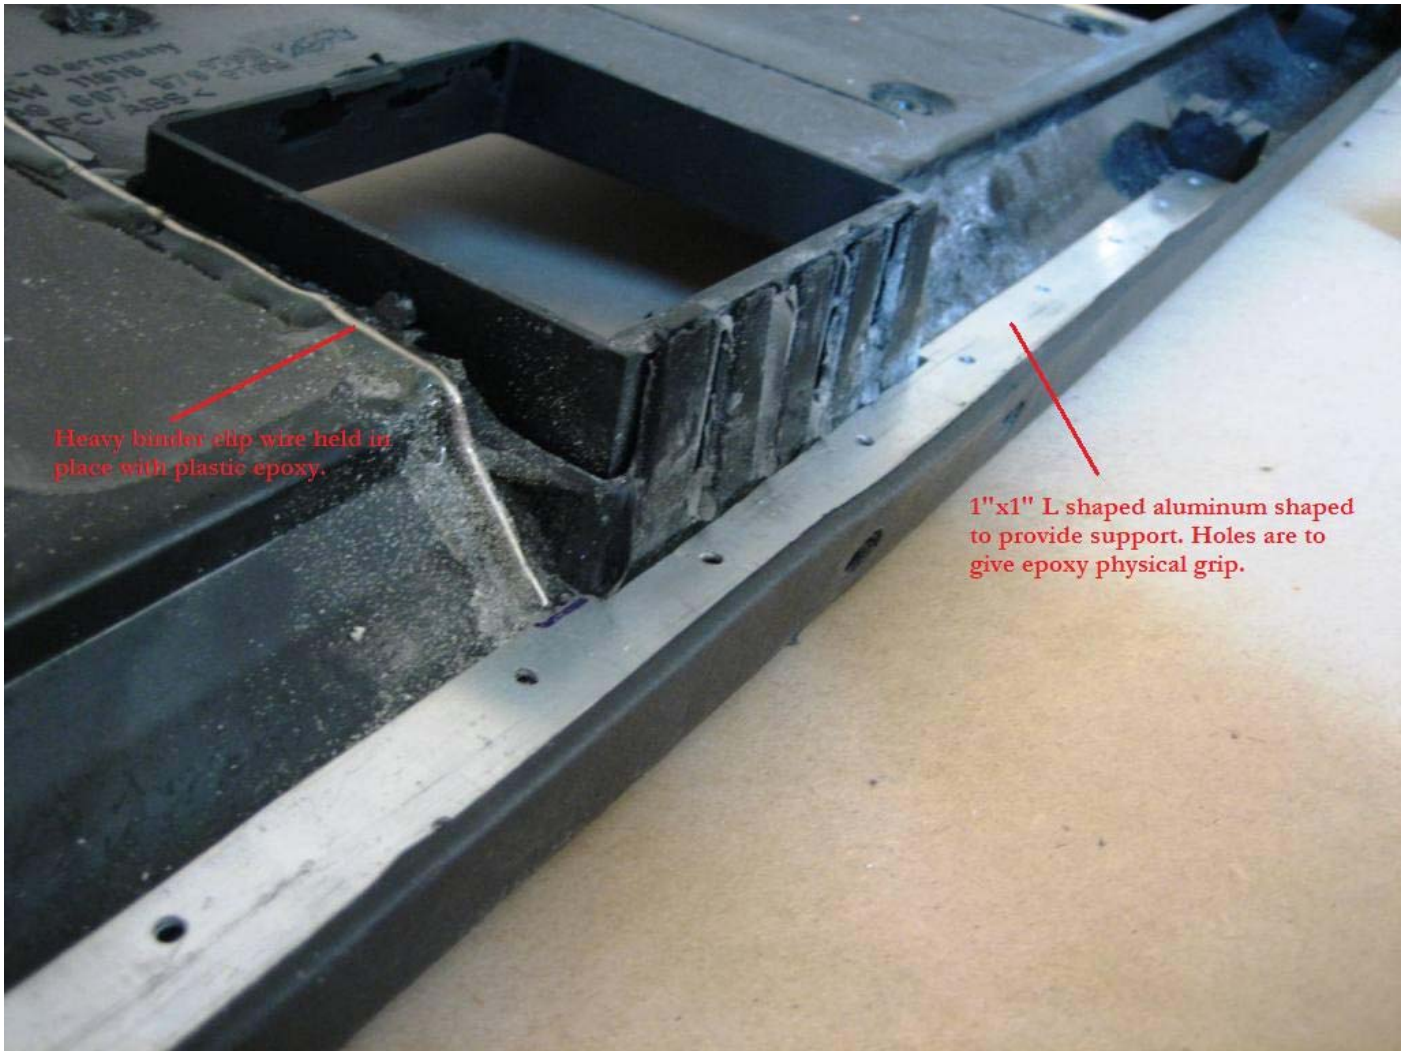
Fixing the pull down handle was the trickiest. Much of the plastic surrounding the handle was in poor shape and both tabs had broken off. Closing the hatch requires pulling down on the handle with a good bit of force. Pulling down on the hatch with a hand on the black exterior paint during a Texas summer is a sure way to burn your hand, so fixing the handle properly was essential. After studying how the handle interacts with the trim and tailgate, I decided that I needed to beef up the area around the handle and spread out the force as much as possible. Some 1 inch by 1 inch L shaped aluminum would do the trick. By having the piece span from the two clips points, and having the two handle screws go through the aluminum, I was able to spread out the force across the entire bottom of the trim. The two screws should bear the majority of the force, but I wasn't taking any chances. I hope to never have to do this job again.

The plastic handle is welded to the main trim at the top of the handle. The bottom has four “fingers” that push on the main trim piece. The main trim piece had several cracks which I epoxy’d and supported with heavy binder clip wire. The four fingers did not quite touch the aluminum bracket, so I placed another shim piece between the L bracket and the fingers. Be careful with the size of this shim, because it could have interference problems when reassembling. Check fitment with the plastic piece that the two screws go into.

I also filled in the holes where the screws go thru the trim and then re drilled them.

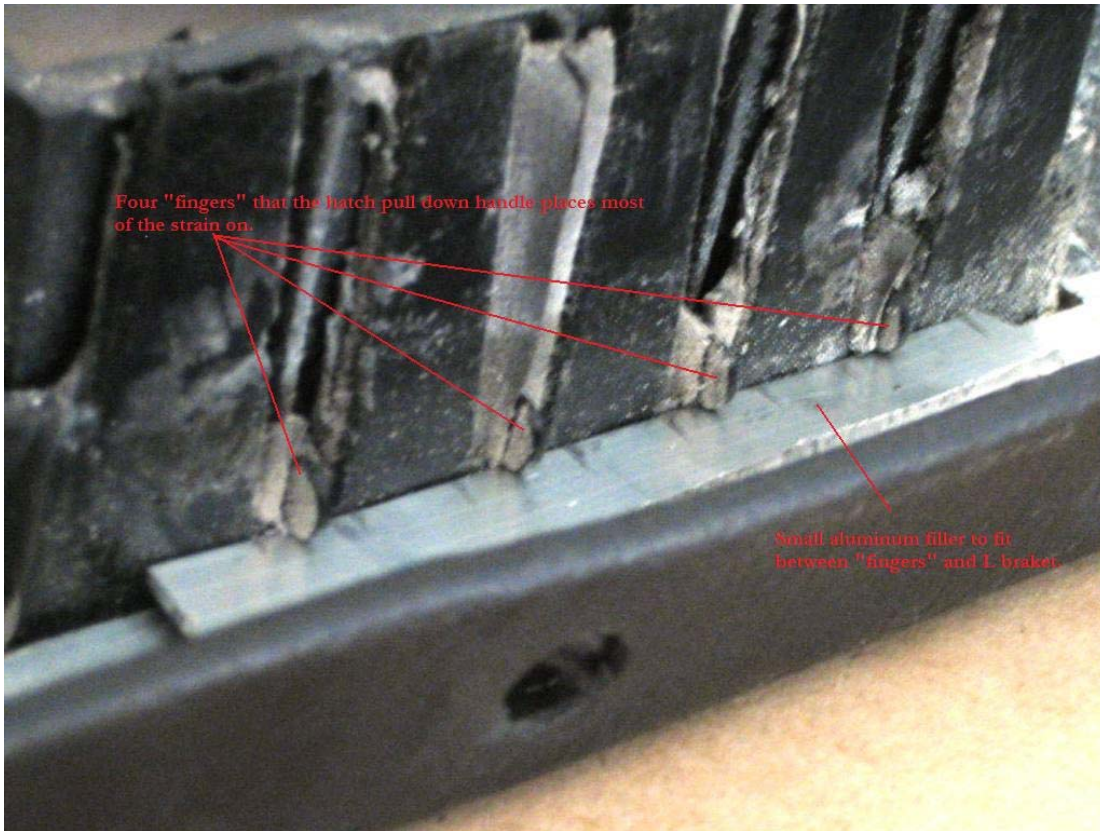
Four "fingers" that the hatch pull down handle places most of the strain on.

Small aluminum filler to fit between "fingers" and L-bracket.

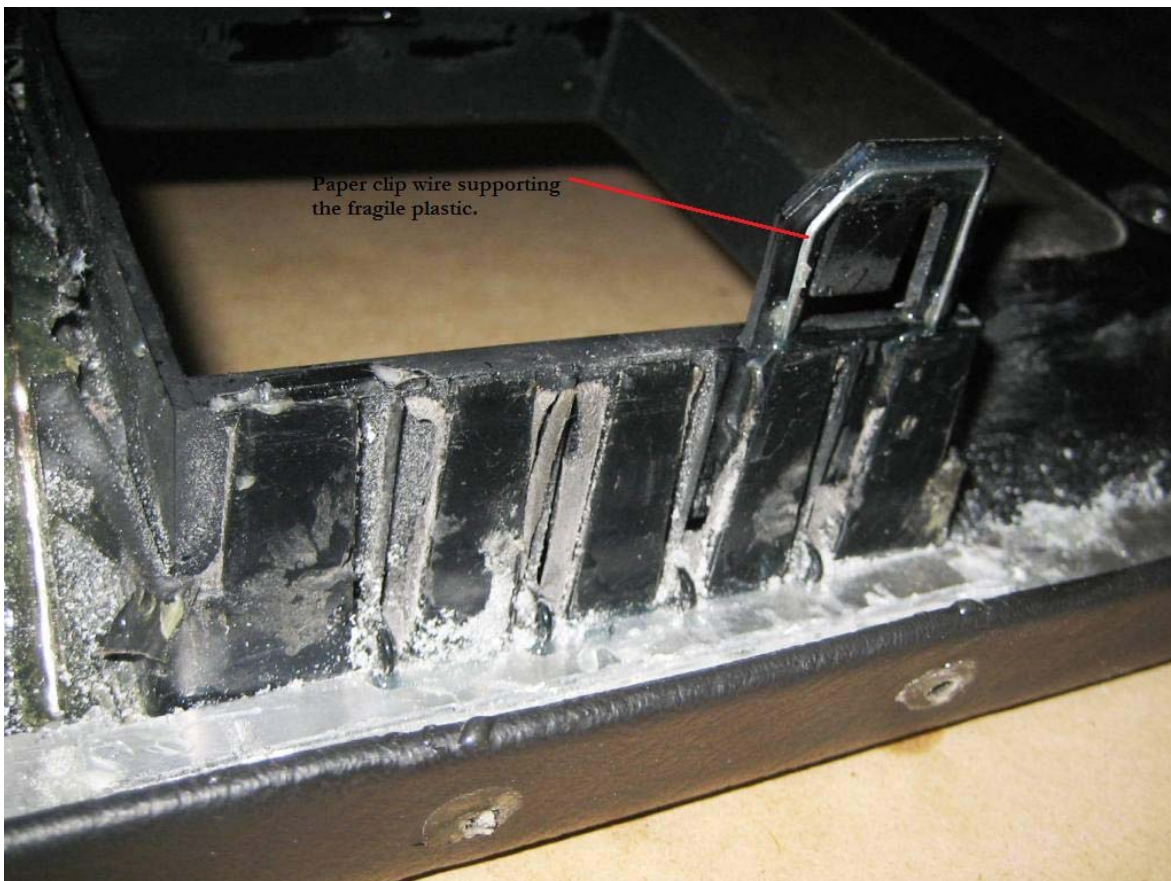
Paper clip wire supporting the fragile plastic.

Lastly, I reattached and supported the infamous plastic tabs. Hope this helps.
