# UrS6 Brake Servo Replacement

This write-up covers the replacement of the brake servo on a 95.5 S6. The master cylinder remained intact and connected, so there was no need to bleed the brakes upon completion. This can be done by one person, but having an assistant at the point of mounting the new servo might save time. There is a technical bulletin available on Scott Mockery's site that discusses this and is viewable at:

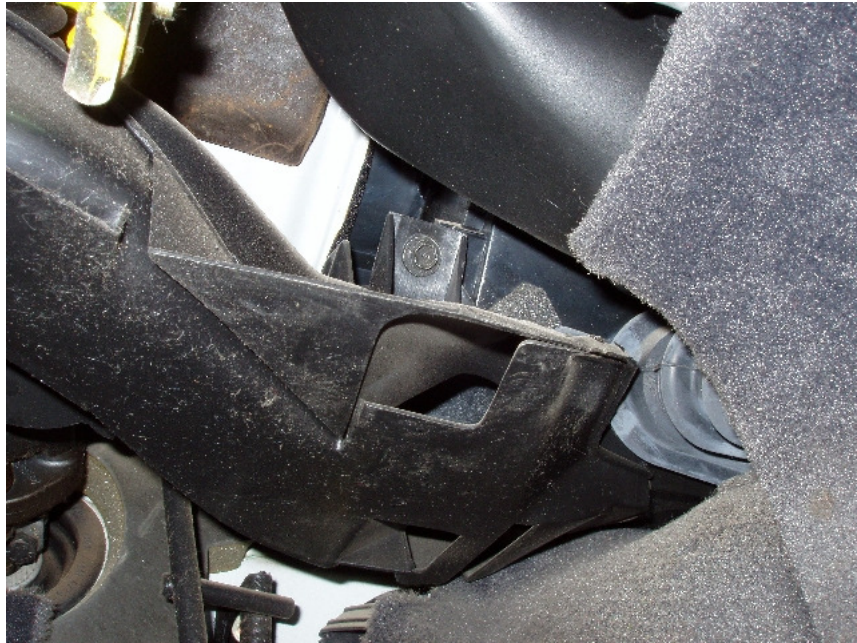
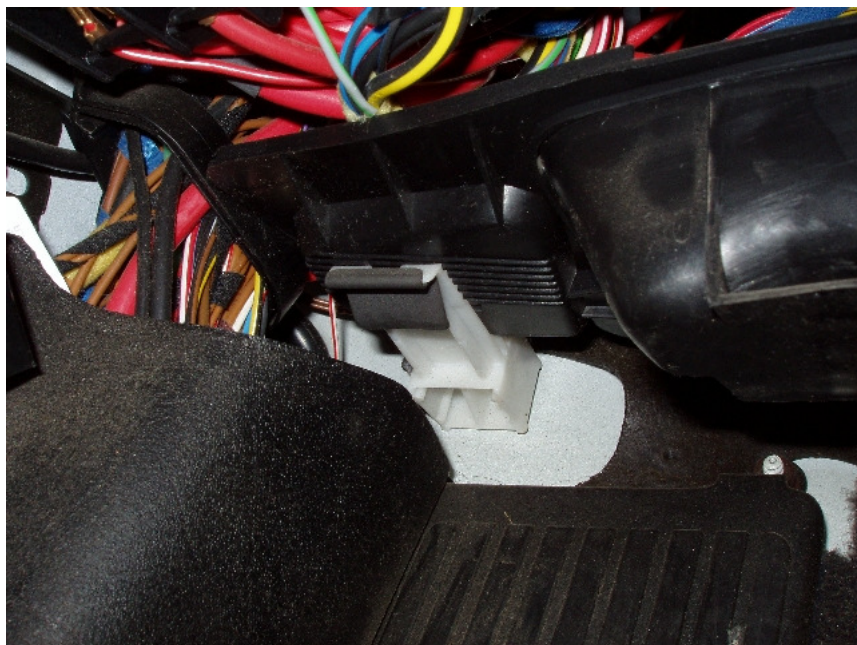
6. Remove air duct closest to pedal cluster. Held by one screw on one end and

snaps into a clip on the other.

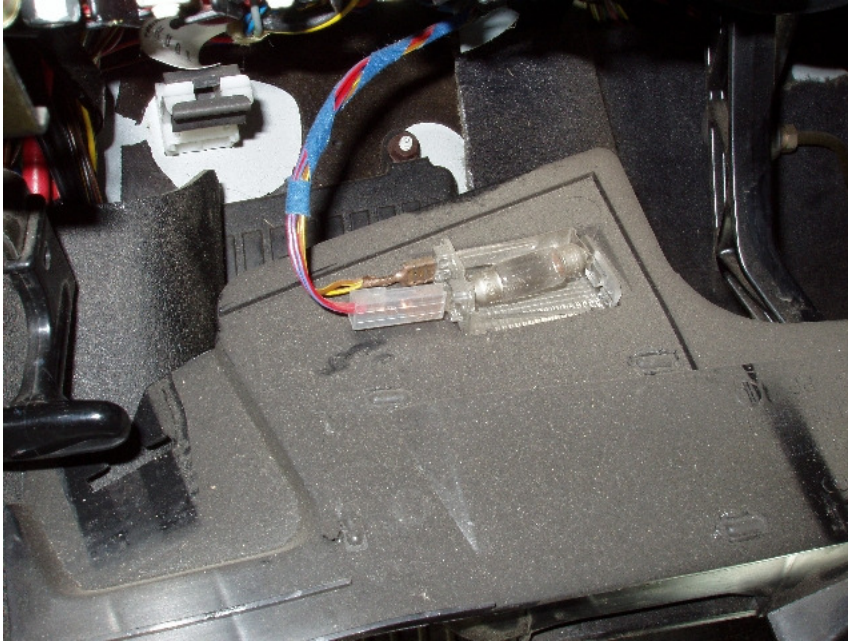
7. Disconnect leads to light mounted in the duct.

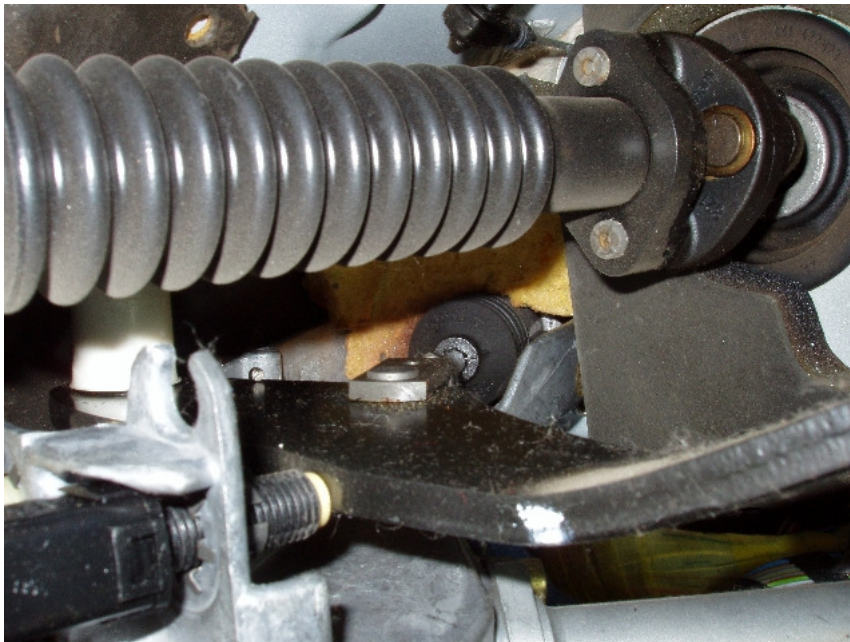
8. Looking up at the brake pedal from underneath, you can see the servo pushrod

- coming through the firewall and the clevis where it attaches to the brake pedal arm.
9. There is some yellow sound insulation surrounding the rubber bellows on the servo pushrod that will have to be moved out of the way to access the locknuts

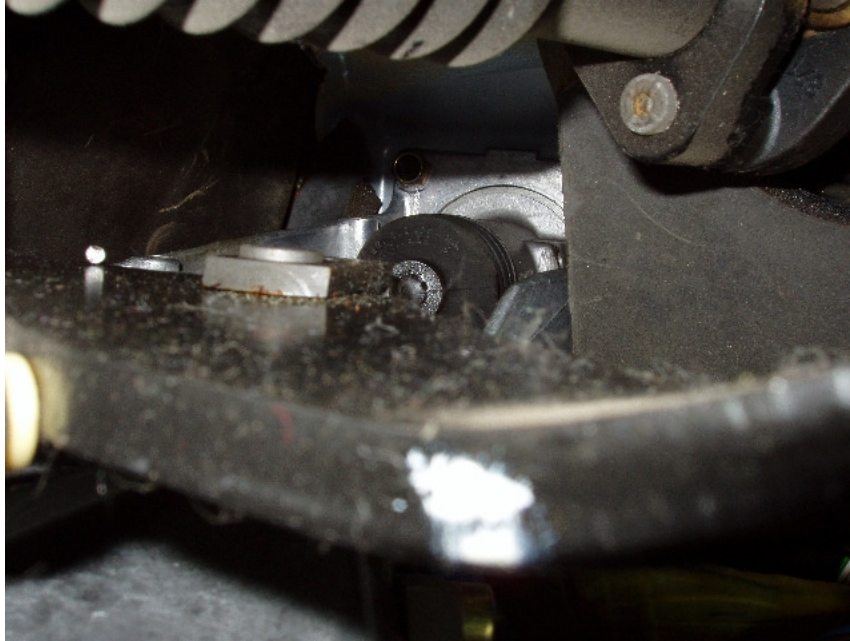
10. Visible in the above picture, you can just see one of the nuts after the sound insulation was removed. Three of the four nuts can be seen and accessed relatively easily. The fourth nut is blind and must be accessed by feel. Give your back a rest and move around to the engine bay.

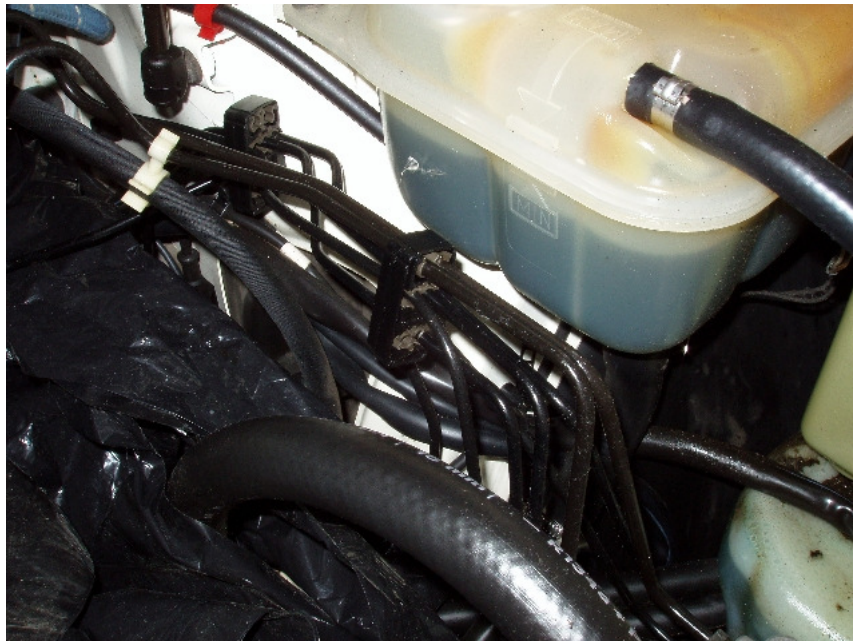
11. Note position of all the hard brake lines in the two multi-line clips that run along

the fender wall. Pictures and sketches helped me get the lines back in place after they had been moved.

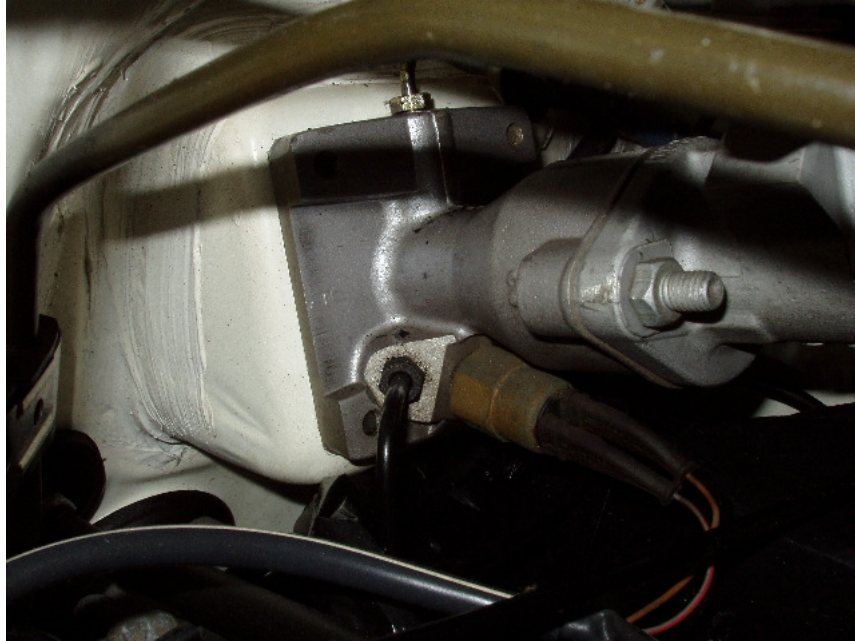
- electrical leads to the brake servo. The two hydraulic lines visible above are the pressure line (lower next to the electrical connection) and the return line (on the top of the servo). These need to be disconnected. They take an 11mm flare wrench. I covered the ends with plastic caps and wrapped them in plastic while they were disconnected. It should be noted that one should not move the brake pedal with the lines removed from the servo.

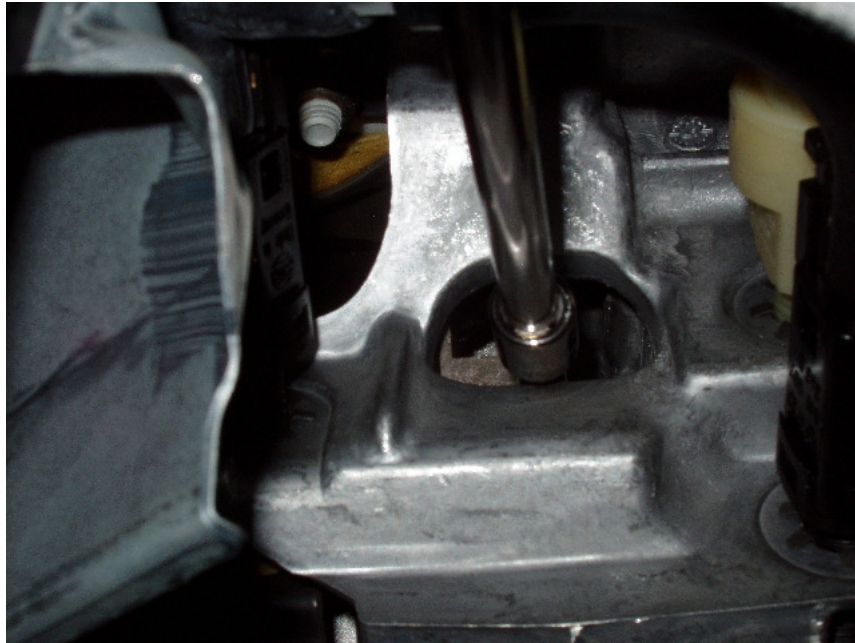
to rattle around the firewall for ever. For the blind nut, assemble the extensions one by one, feeding them through the small, rectangular hole in the brake support bracket as shown here. This is mostly a matter of feel. I could not see the nut no matter how I contorted, but others claim that they could – provided the extensions were  $\frac{1}{4}$ " sized. When you have it, back it out gently. I lost this nut somewhere.

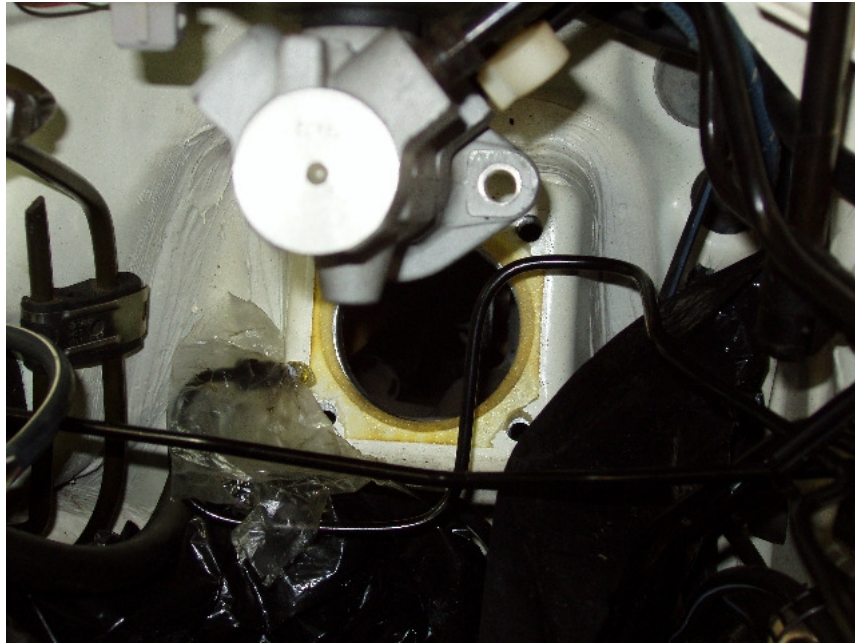
19. Remove the servo. The removal must be done carefully as the pressure line coming into the servo is bent in such a way that it kind of captures the servo. Gentle persuasion will win out however. In this picture, you can see the remains of the foam gasket after the servo has been taken out. I chose to remove the old gasket and install a fresh one.
20. Before installing the new servo, the clevis and locknut must be removed from the

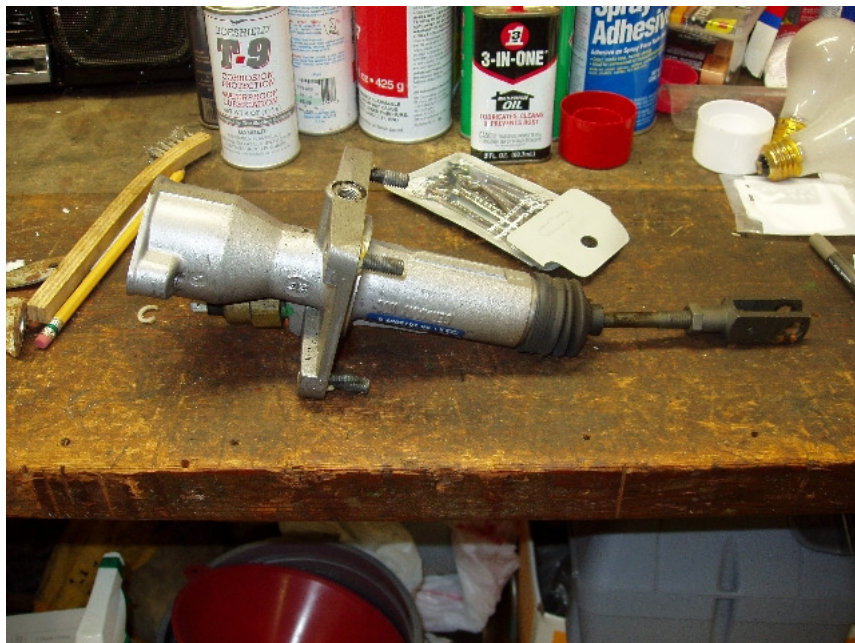
old servo and installed at the correct location on the new servo pushrod. I marked off the distance ( $230\text{mm} \pm 0.5\text{mm}$ ) on a piece of wood and placed it under the new servo with one end of the wood against the mating surface of the servo. After installing the locknut and the clevis on the new servo's pushrod, I

threaded the clevis down the pushrod until the 230mm mark was centered in the clevis hole. Care must be taken that the pushrod be fully extended and perpendicular to the mating surface of the servo flange when taking this reading. Tighten the locknut and prepare to mount the new servo.

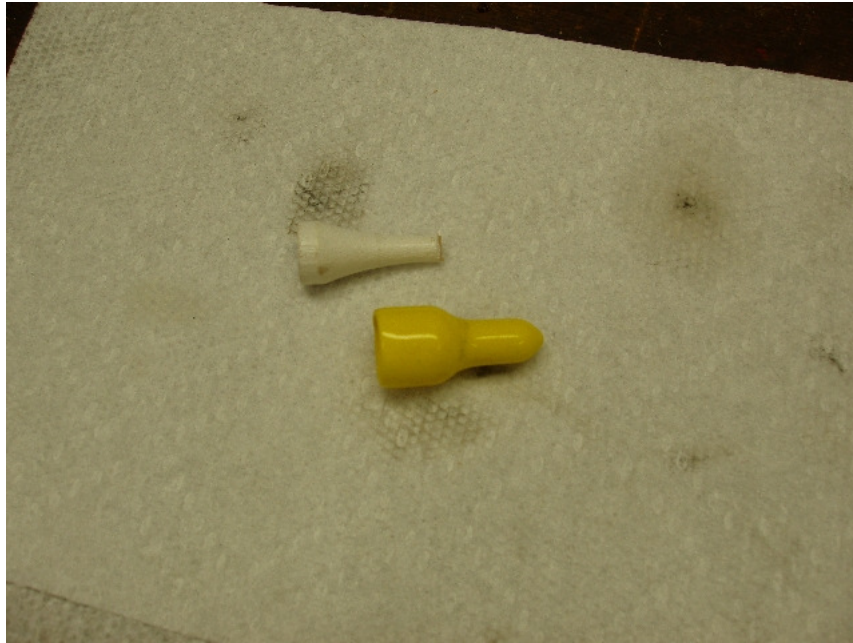
21. Before I positioned the new servo, I put a plug in the blind hole (upper wheel side when viewed from the engine bay). The thought was that if there was something pointy poking through the hole, that maybe the locknut would center itself as I blindly fed it up and into position. I locked the yellow plug in the hole using a golf tee that had half the shaft cut off.
