C4 12V V6 Cam Position Sensor Replacement DIY

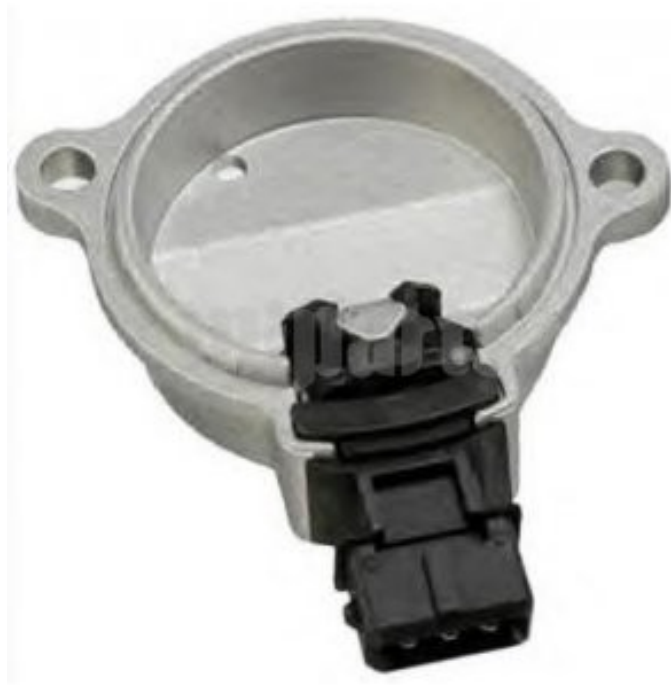
Cam sensor:

PN 078 905 161C. I got an one through a dealer but, if you are feeling lucky, aftermarket ones are cheap (buy two, install one and keep one in the car as a spare)

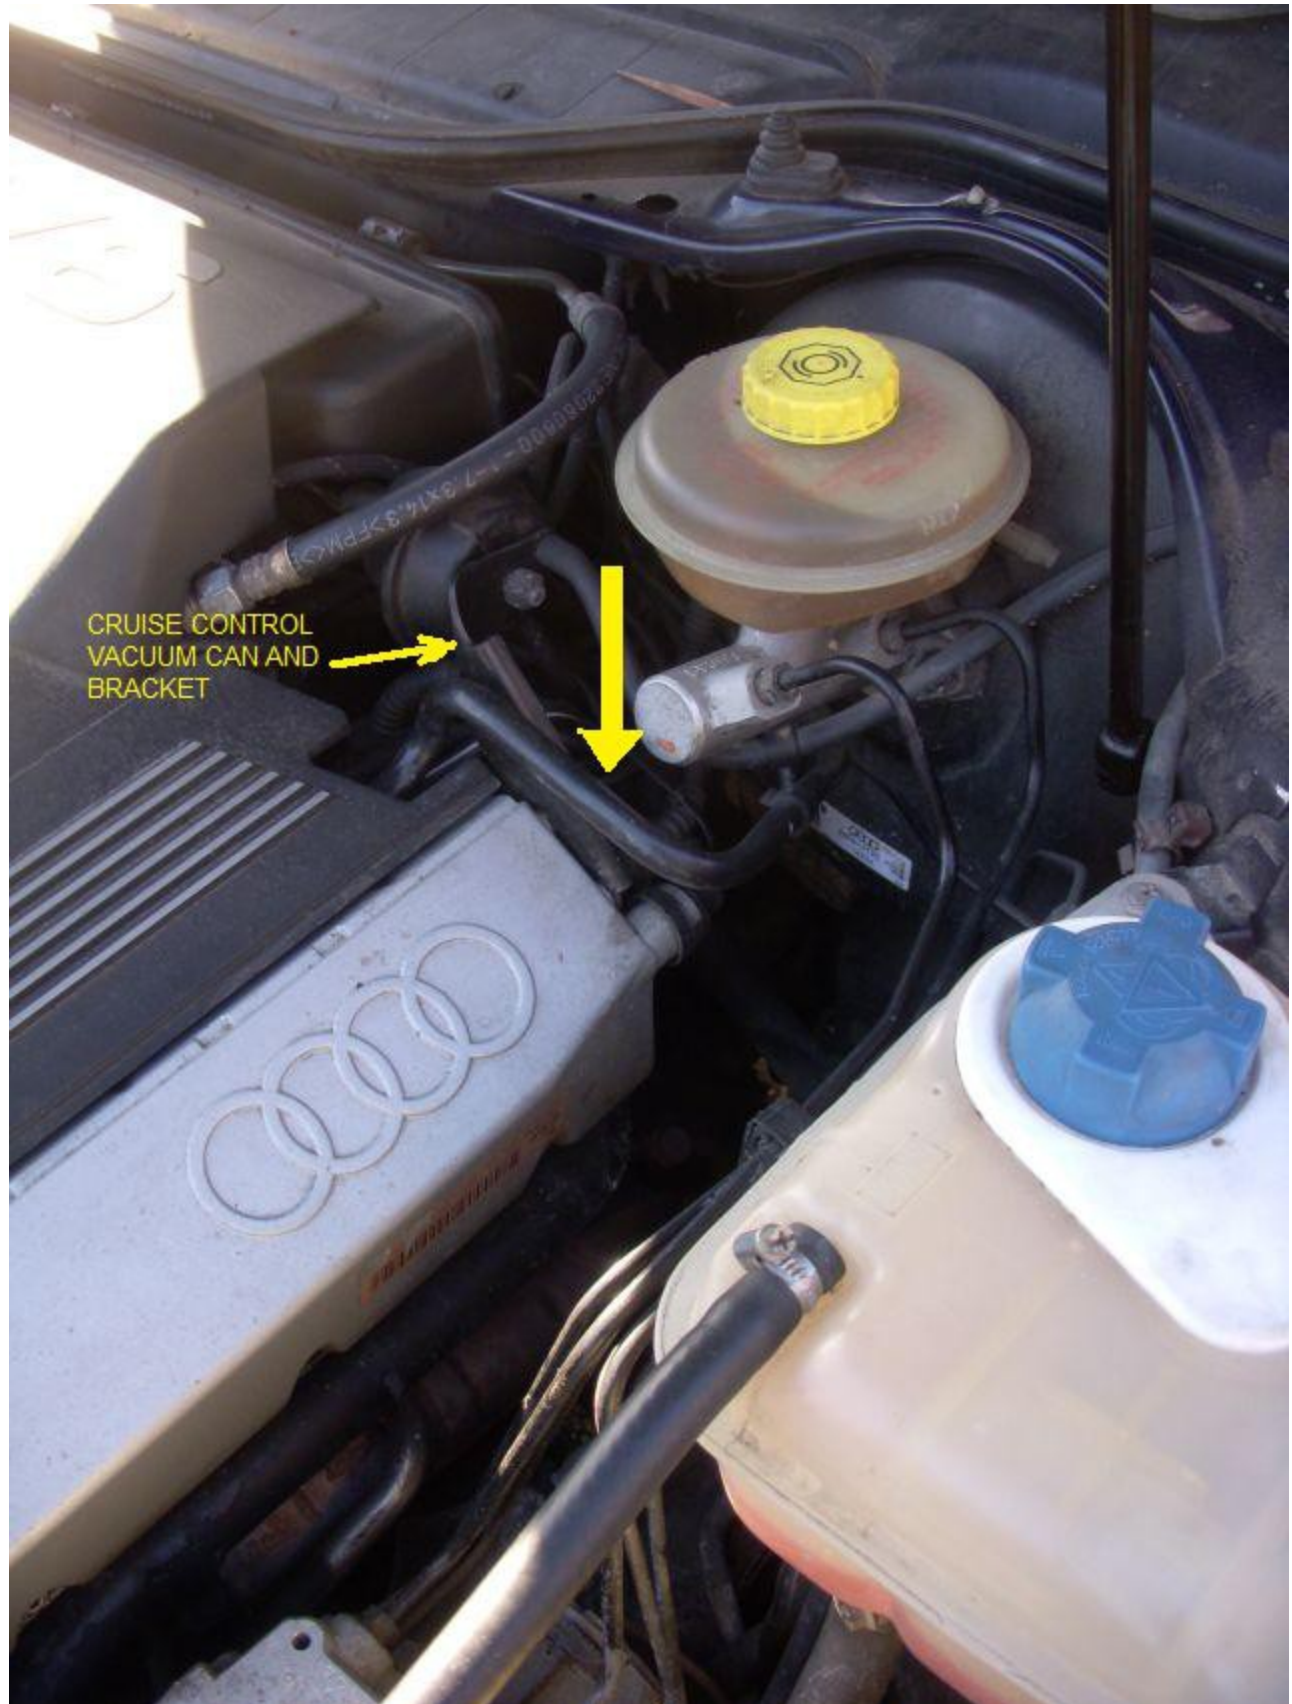
Finding the cam sensor: It's at the back of the left engine bank (follow the yellow arrow). Note the location of the cruise control vacuum can and bracket. The bracket is the one thing that makes this DIY a bit difficult.

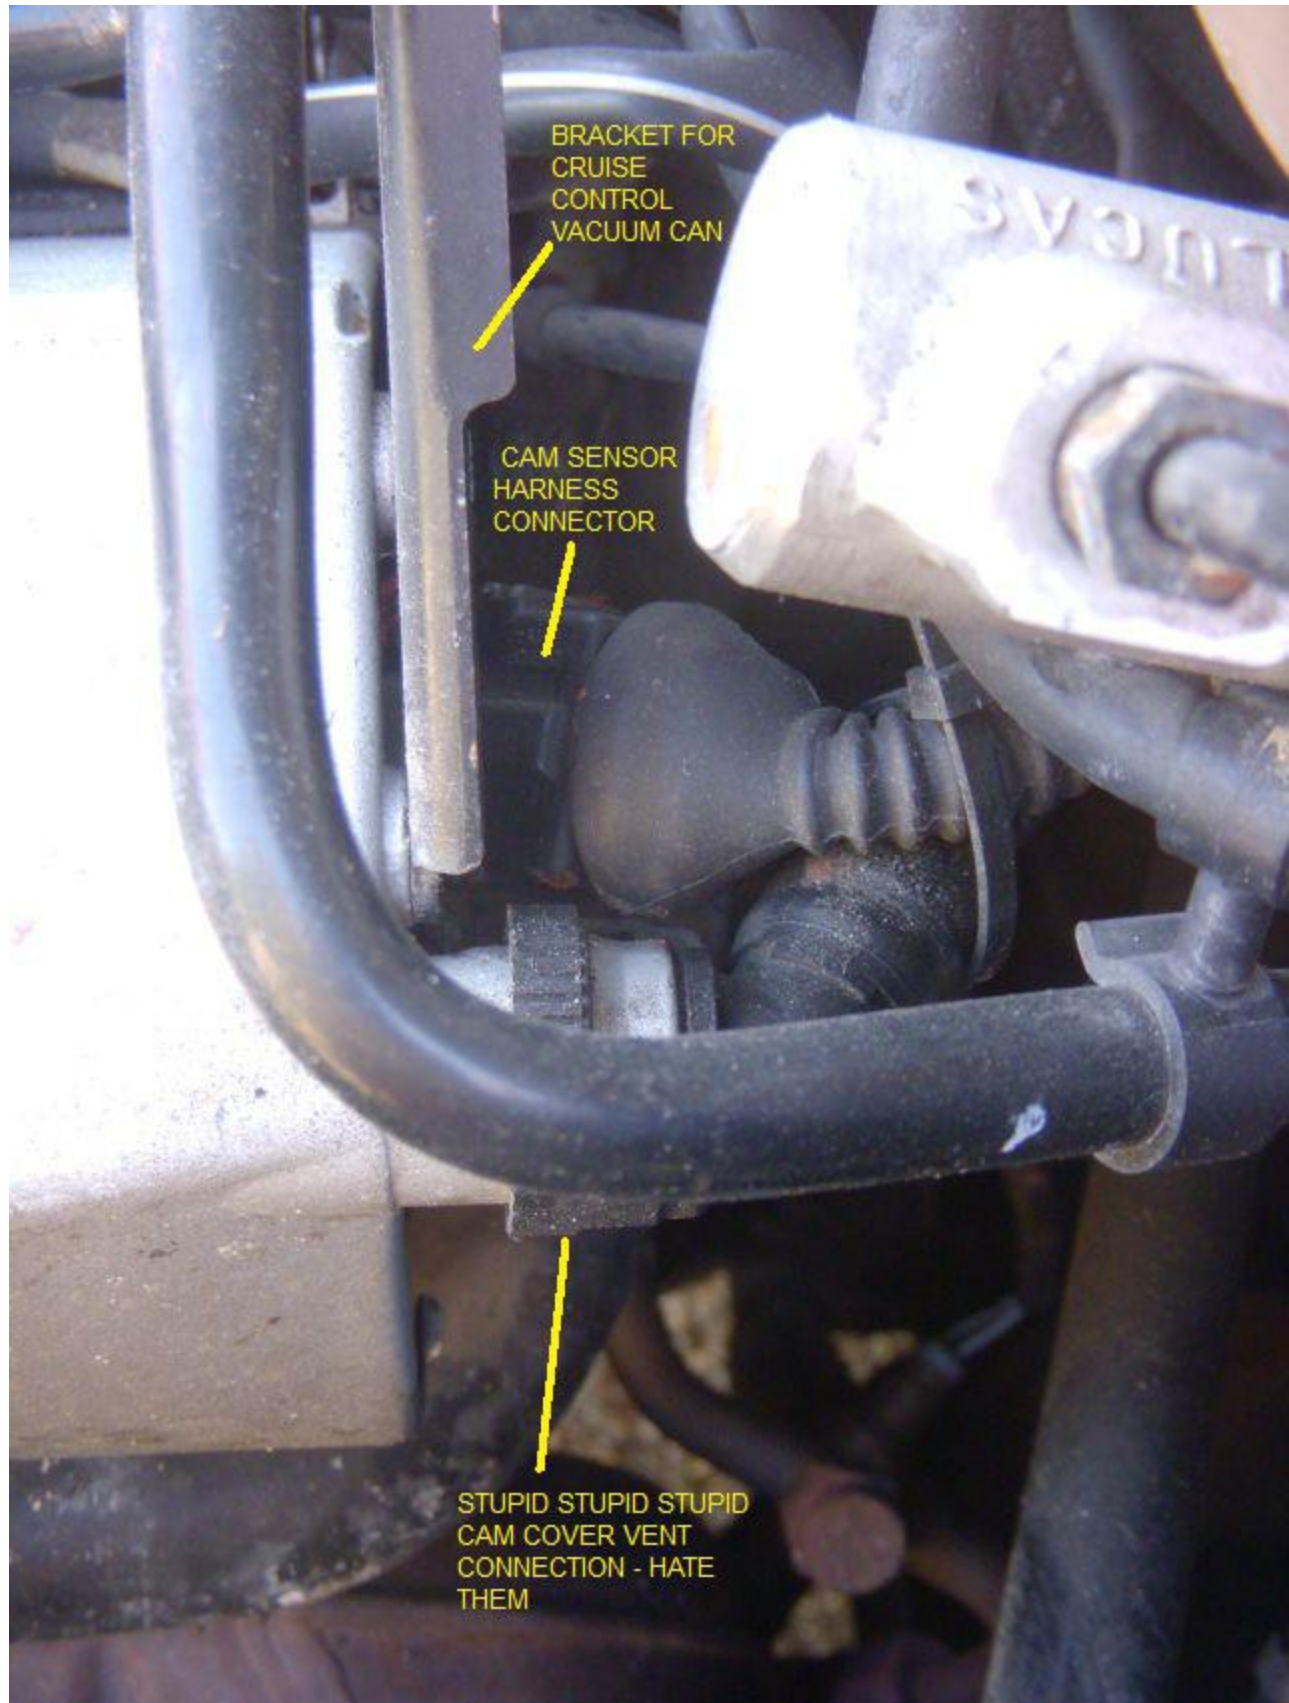
Here is a closer shot of the cam sensor connector and the cruise control vacuum can bracket (destined to cause a little grief) (Note: I HATE those pinch clamps that hold the vapour vent tubes to the cam cover):

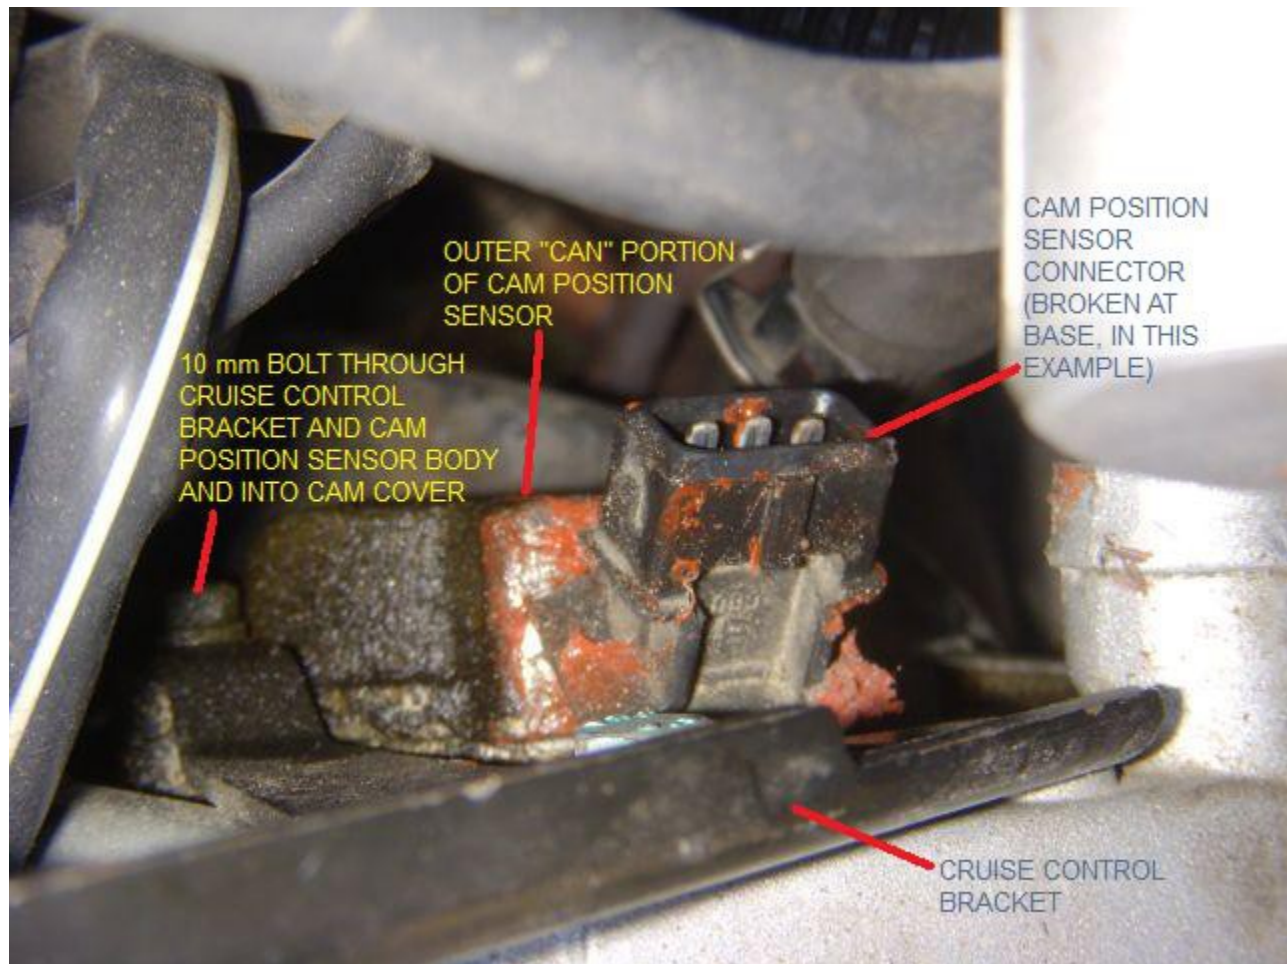
With the cam position sender harness connector and the cam cover vent tube disconnected and moved out of the way, you can see the connector on the cam position sender (broken in my case) and one of the two 10 mm head bolts that hold the sender to the cam cover, as shown here (Note the cruise control bracket actually ends up partially holding the sender to the cam cover):

So, at this point, to remove the cam position sender, you need to remove two, PN N 01021710 M6 x 20, 10 mm head bolts, the one you see on the left in the photo above, and one towards the outer side of the engine and on the bottom edge of the sender body (hidden in the photo above).

I used a stubby 3/8" ratchet and both short and long 10 mm sockets to get these bolts loosened. Then I spun them out by hand, making sure that I didn't drop them. Then I wriggled the cam position sender off the cam cover. There was an issue with the sender body getting hunk up underneath the cruise control bracket (the portion shown to the left in the photo above). I did get the sender out without removing the cruise control bracket but it was a pain.

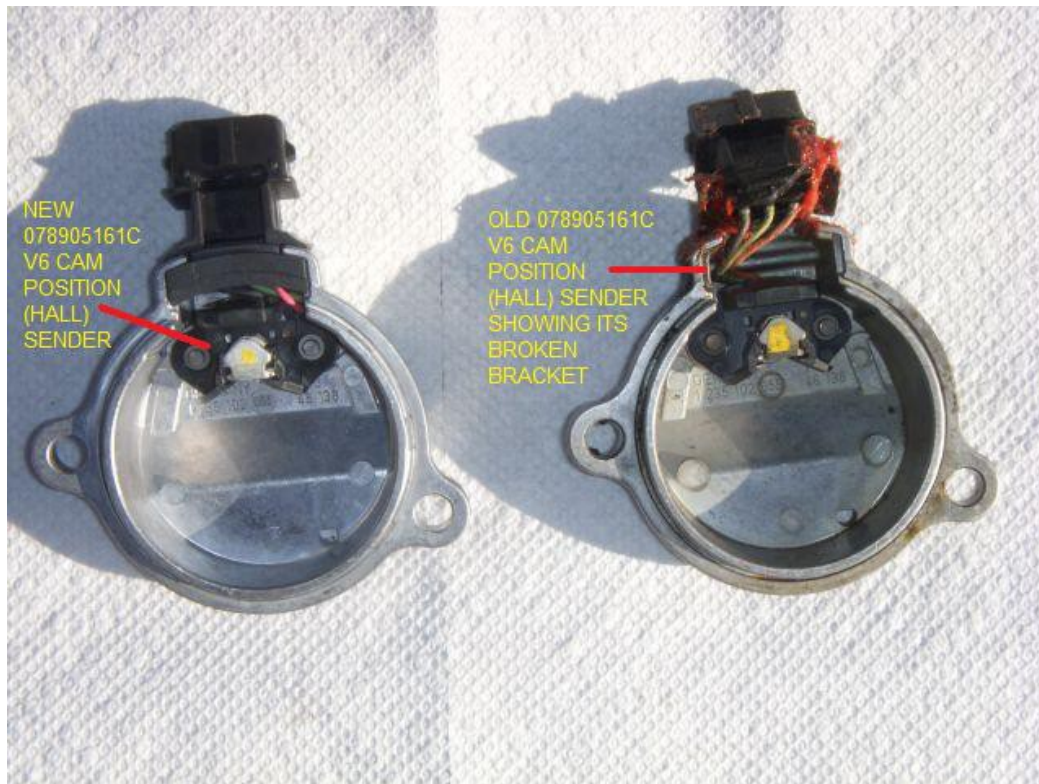
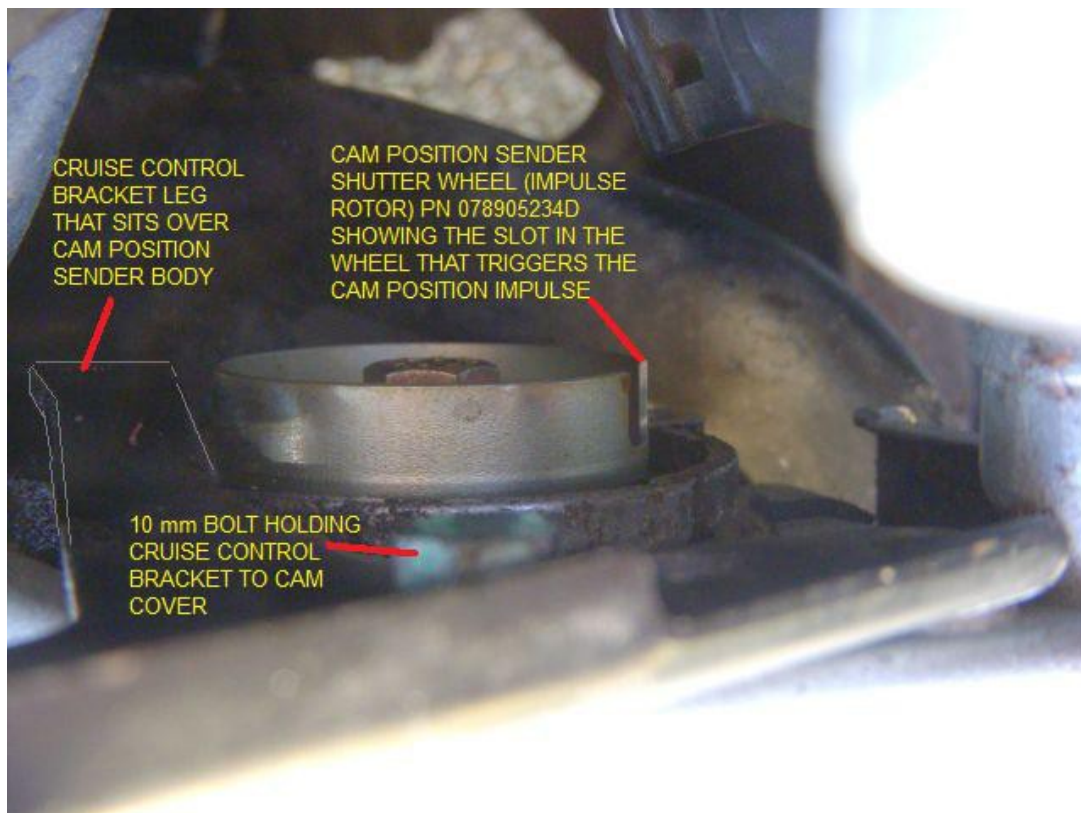
In this photo you can see the new 078905161C Cam Position (Hall effects) sender on the left and the old damaged one (broken bracket on the right). In the second photo, with the sender removed, you can see the shutter wheel (impulse rotor) and the slot in its edge that sends the position impulse to the ECU when it passes through the Hall effects sender.

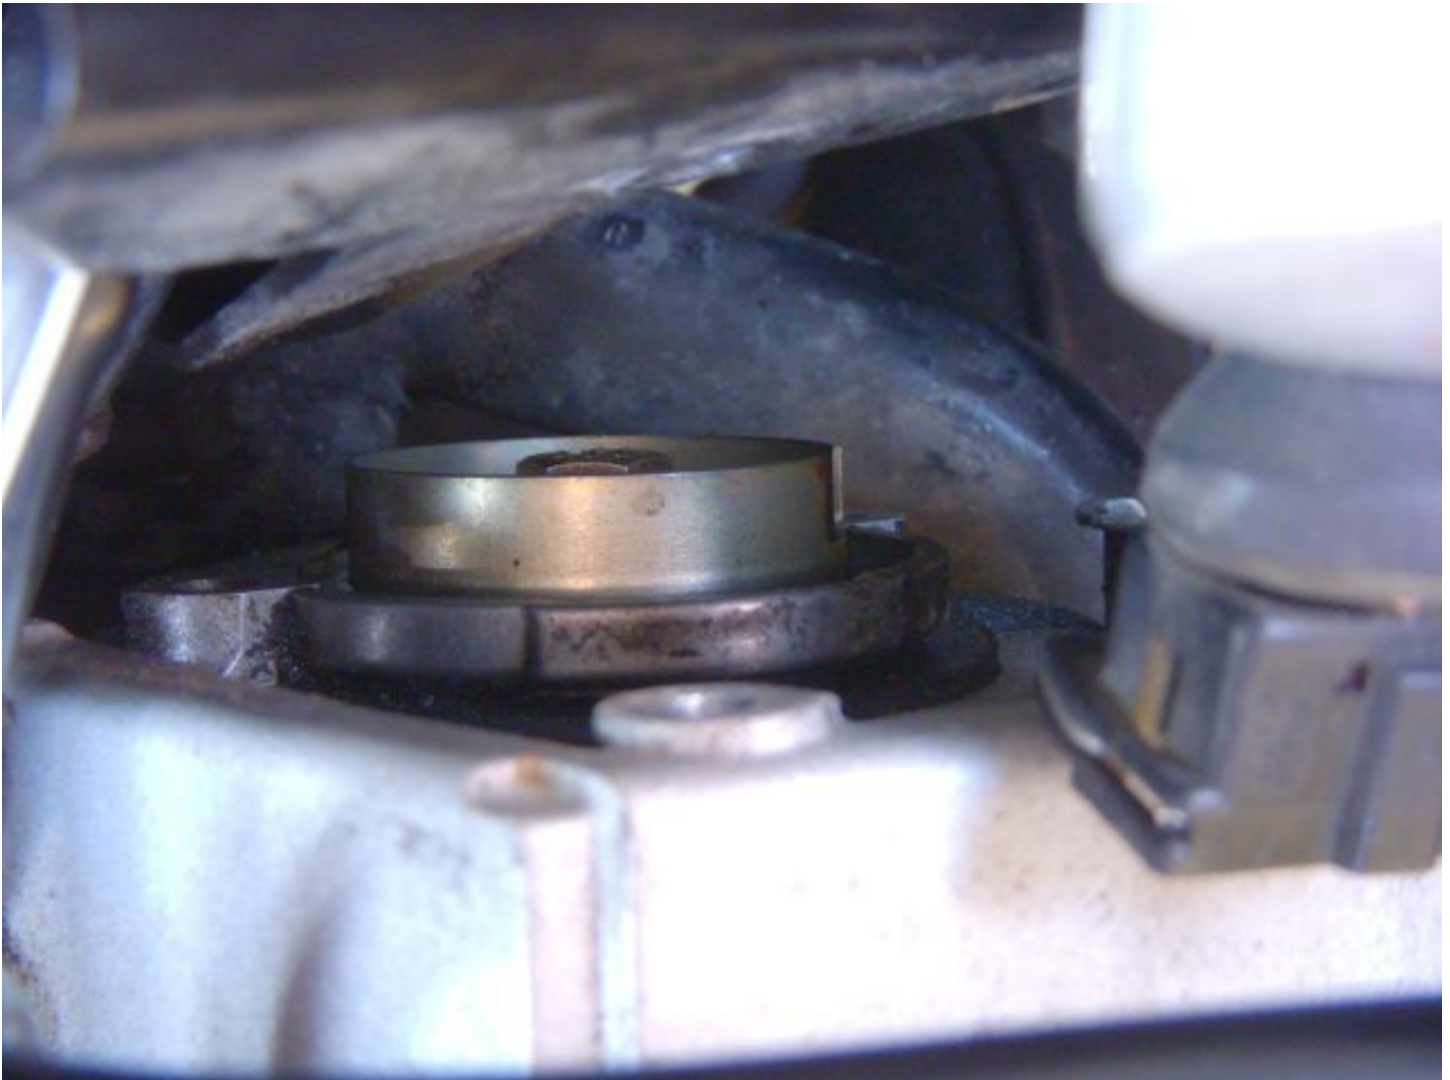
I tried to get the new cam position sender back into place with the cruise control bracket in place but it was too much of a pain and I didn't think that I would be confident that everything was lined up properly. Since there was only one more 10 mm head bolt holding the bracket to the cam cover (the green-headed bolt in the previous photo), I just removed it. This made it easier to see what was going on, as seen in this photo:

Being able to see what was going on, I put the cam position sender over the shutter wheel (impulse rotor) making sure that the lip of the rotor/shutter fit into the gap in the Hall sender. Then I started the bottom sensor bolt by hand. Then I put the cruise control bracket back in place, including the leg of the bracket that covered the edge of the sender. I started these bracket bolts by hand and then used the stubby ratchet and the 10 mm sockets to tighten the three bolts (one at the bottom outside of the sender, one on the upper part of the cruise control bracket and the one that goes through the cruise control bracket and the cam position sender body and then into the cam cover). No room for a torque wrench so the spec is "GoodandTight".

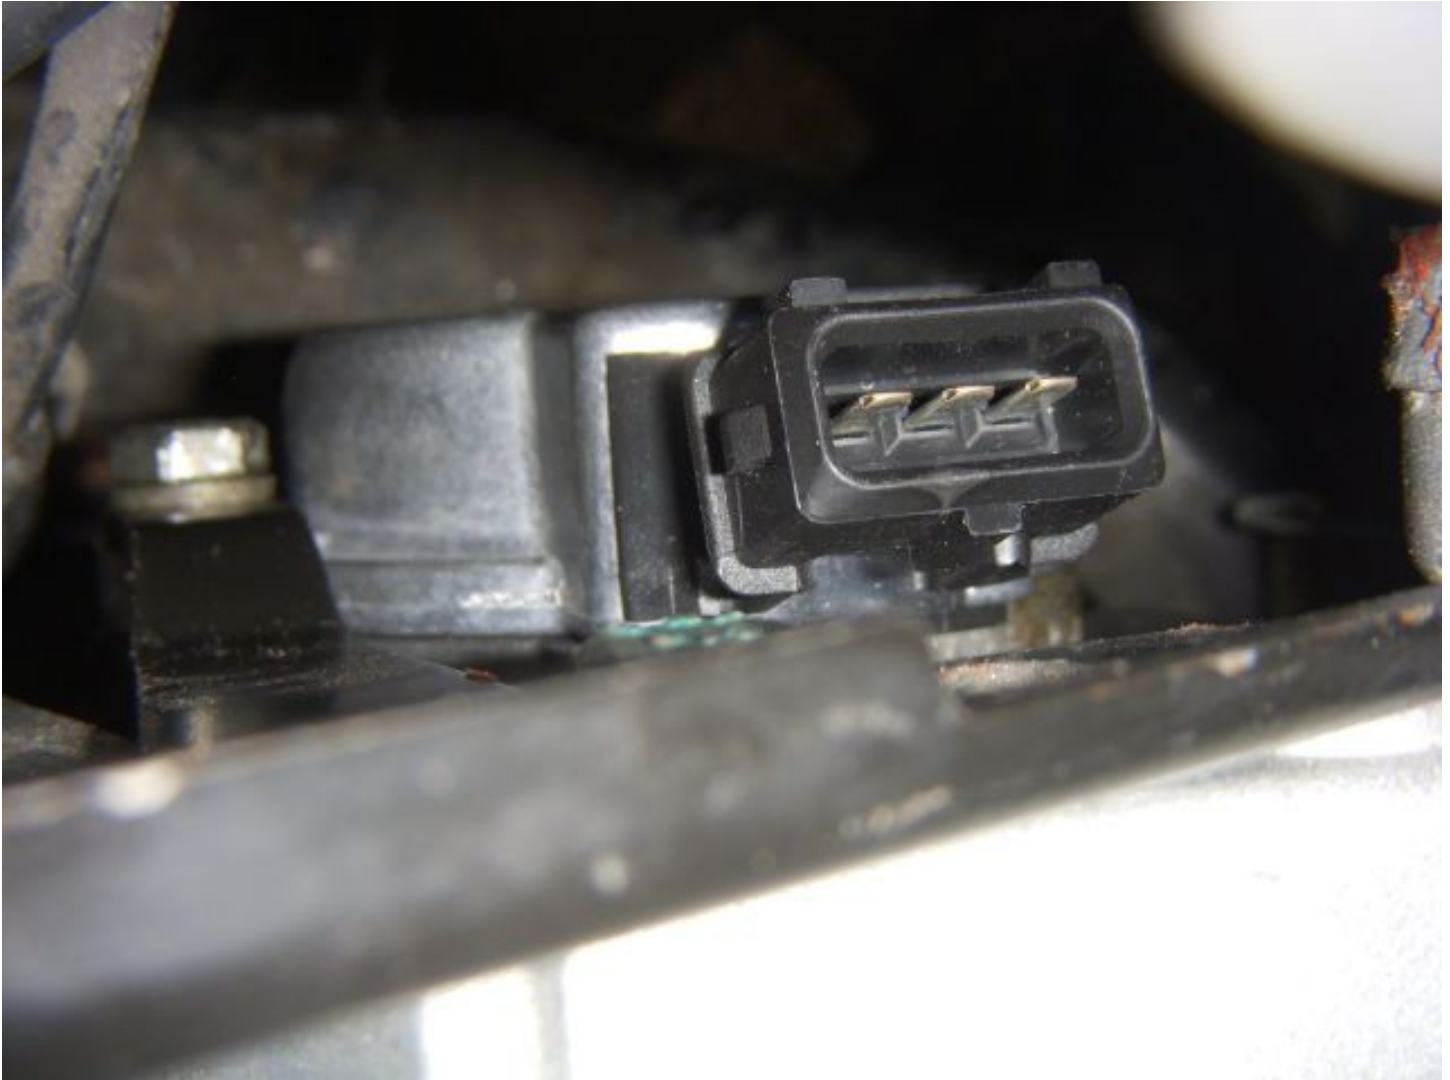
Here is the new sender with the unbroken connector all buttoned down, waiting for the connection to the harness connector:

So the only things left to do was to put the connector on (push in the bail spring and push the connector on – it only goes on one way) and reconnecting anything else that you had disconnected (in my case the stupid cam cover ventilation tube).
