Replacement of the Hall Sender on a 7A, 3B, early AAN and some VW product distributors June 2010

By Dave Forgie (UrS4boy) with contributions from Jorge R (Pulga1952) and Bill Z.

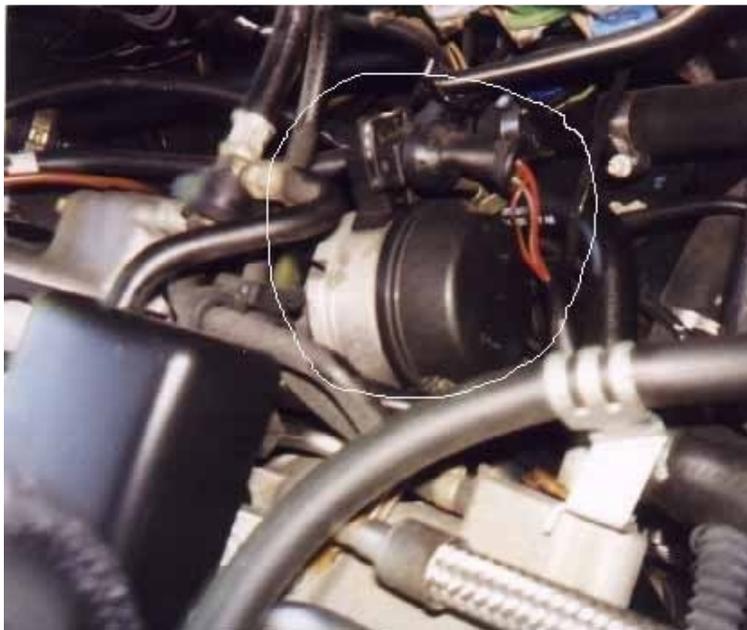
In the case of the five cylinder 20 valve turbo engines, only the early AAN engines, i.e. those engines built before January 31st, 1992 in cars assembled prior to about mid-February, 1992 (to VIN NN100000), had their Hall effects sender in a vestigial distributor (aka "the tuna can") distributor, as discussed here in this G40 Cam Position Sender (Hall Sensor) post: <http://forums.quattroworld.com/s4s6/msgs/22580.phtml> and shown here at the back of the intake side of the AAN head (the "distributor" has a gear that is driven off a gear on the back end of the intake cam):

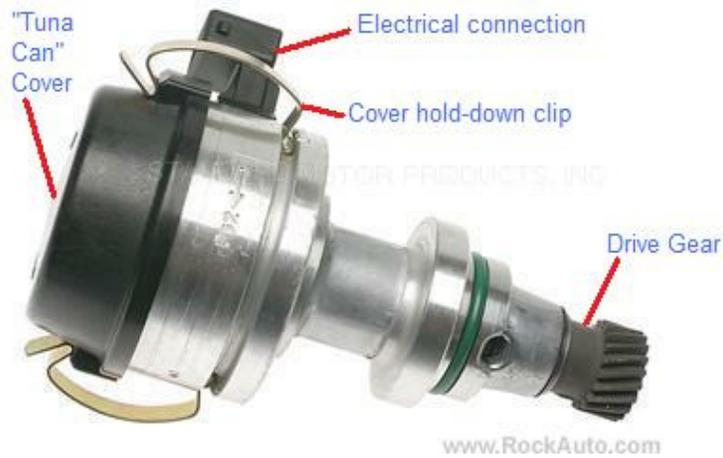
The first thing to do is to remove the “Distributor” (“tuna can”) from the engine by removing the electrical connector(a), removing the cover on the distributor/Hall sender noting the position of the rotor or slotted-wheel inside (mark with felt pen), and then removing the hold-down bolt and sliding the unit out of the head. It should look like this (but maybe without the cover, note the cover hold-down clips):

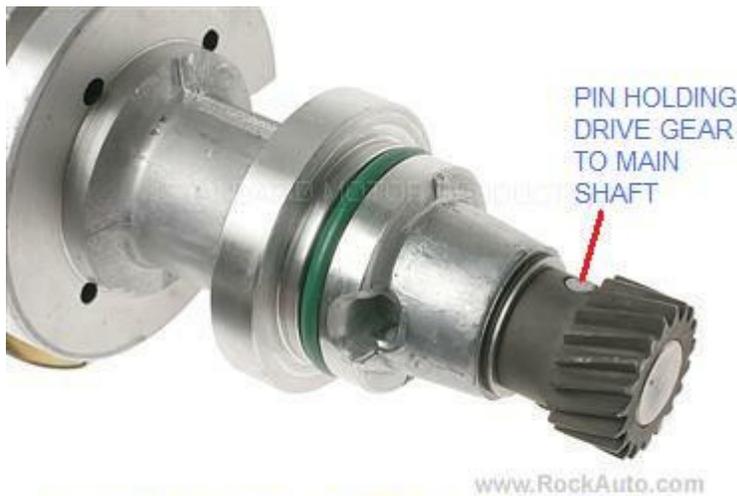
The first task is to remove the drive gear at the end of the distributor unit. It is held to the main shaft by rivet or spring pin, as shown here:

Bill Z said “I had to drill the rivet head off and then tap it through. It had a solid pin in it which I replaced the rivet with the spring pin. I drilled off the pin and used a punch and a small ball peen hammer to tap it out. I measured the OD of the shaft and cut the spring pin to size.”

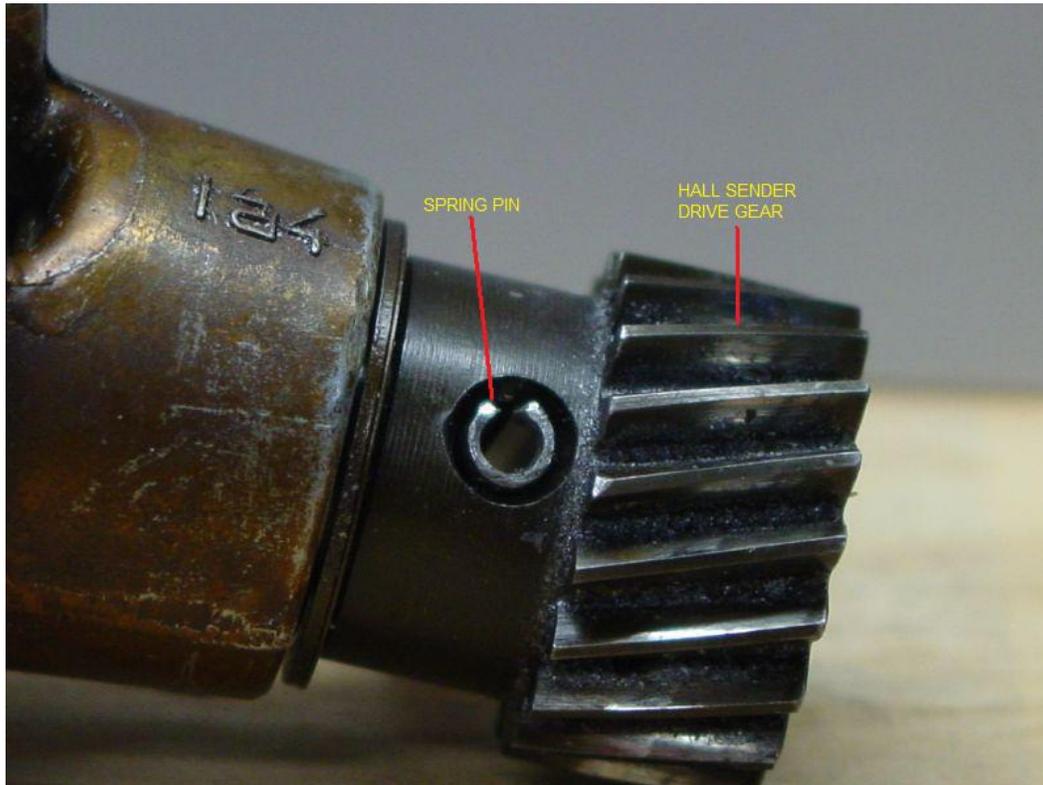
If you have a spring pin holding the drive gear to the shaft, it will look like this one on an AAN Hall sender, photo taken by Bill Z at the end of the reassembly process:

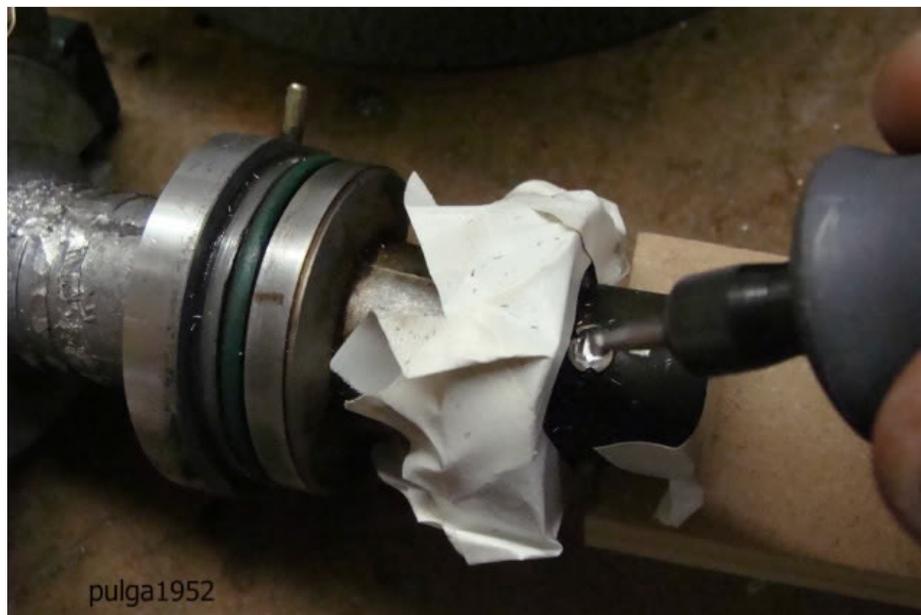
If are looking at a rivet and not the end of a spring pin, you will need to Dremel off the end of the rivet, as shown here in Jorge R's photo of a VW ABA distributor:

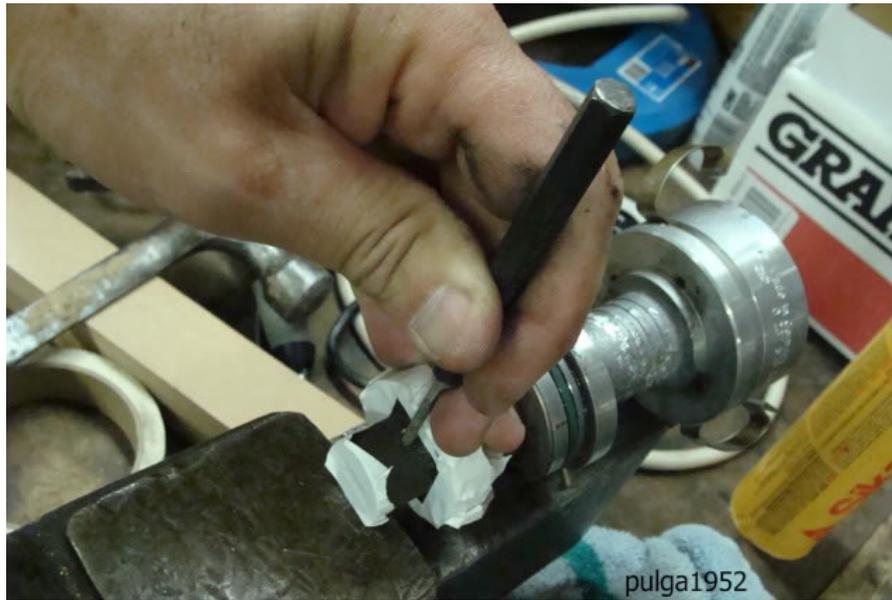
Cradle the distributor/Hall sender unit in vice or firm location and use a pin punch to remove the spring pin, as shown here in Jorge R's ABA distributor photo:

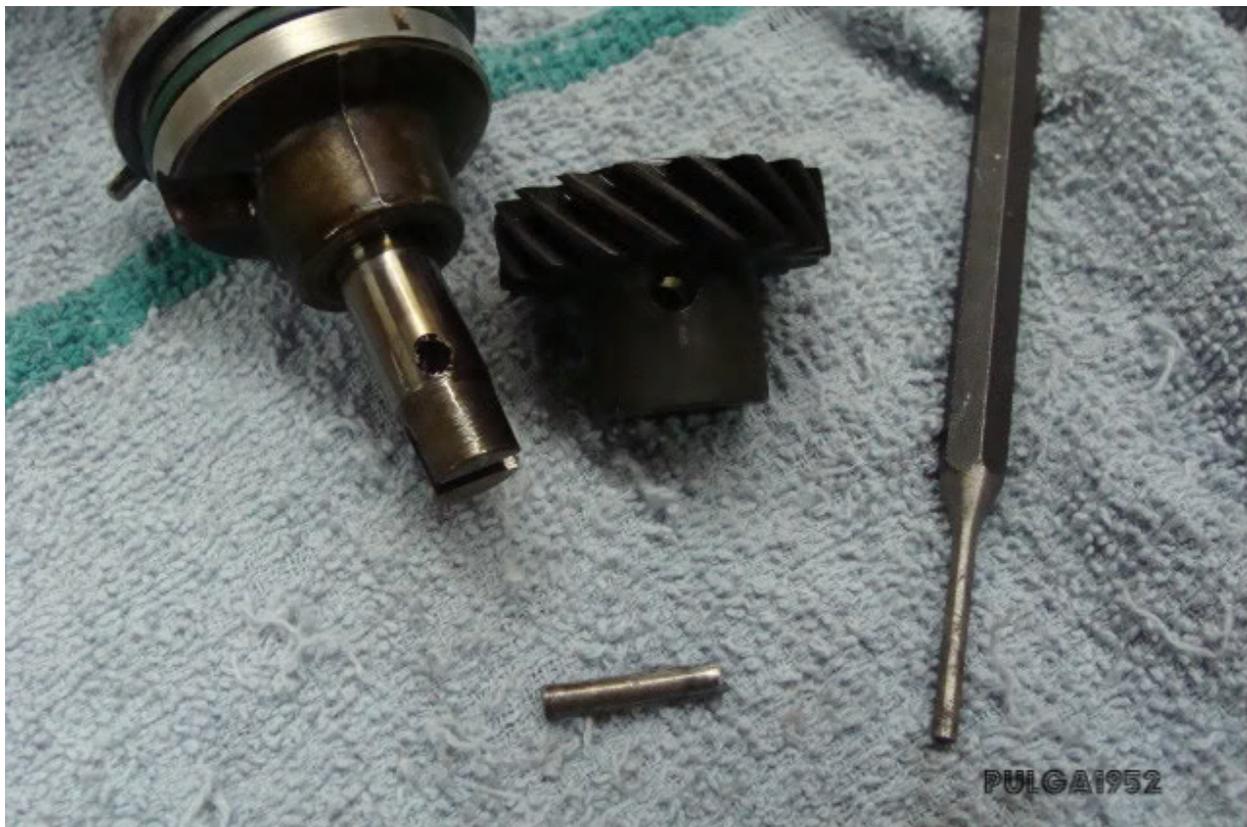
This should leave you with the drive gear off and the ability to pull the drive shaft completely out of the top of the distributor/Hall sender unit, as shown here in Jorge R's photo:

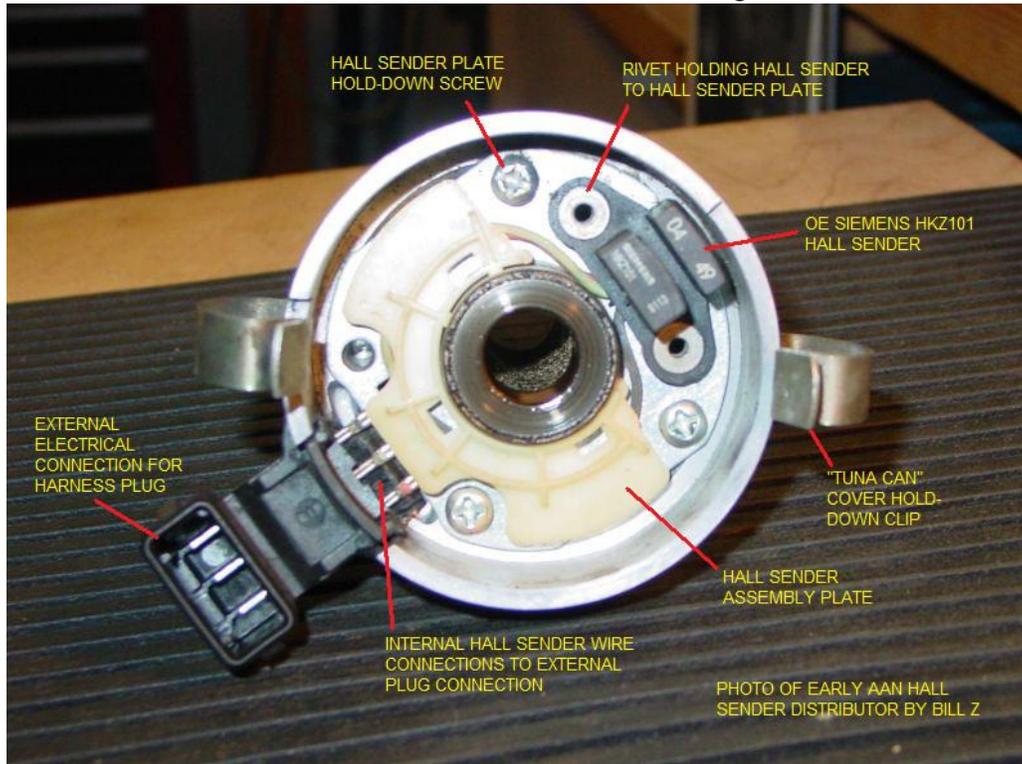
Now we can get down to business. First thing is to slide the center shaft up and out of the distributor/hall sender. You should be looking at this:

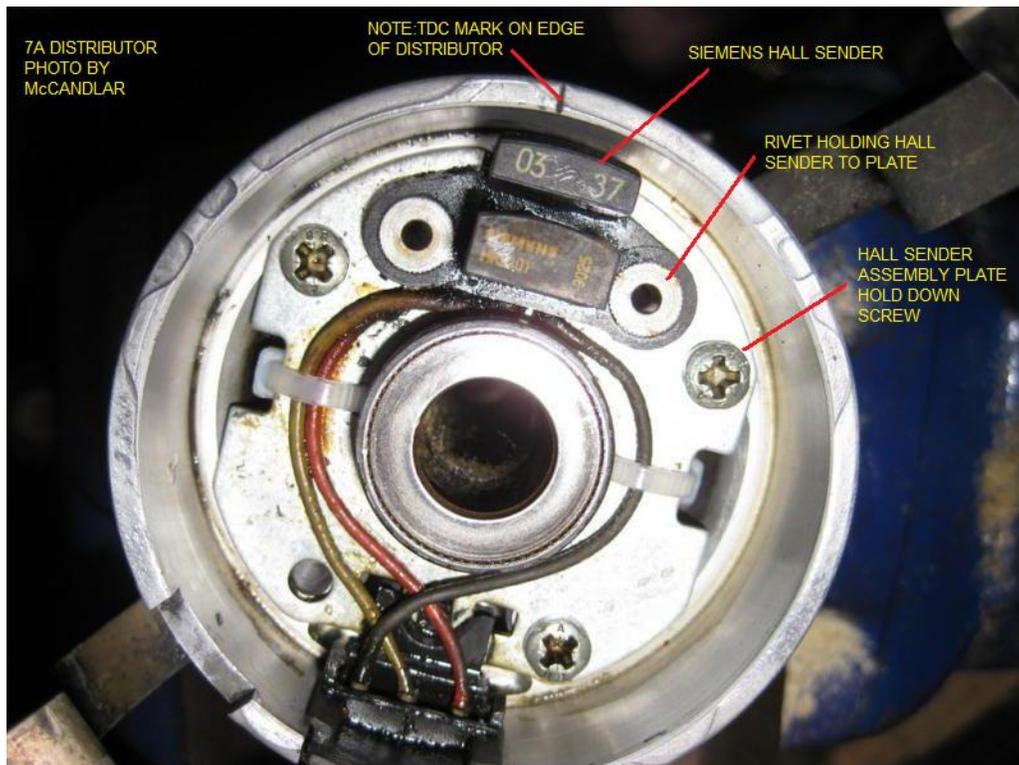
Or this, for a 7A distributor (note: this one is missing its plastic wire cover):

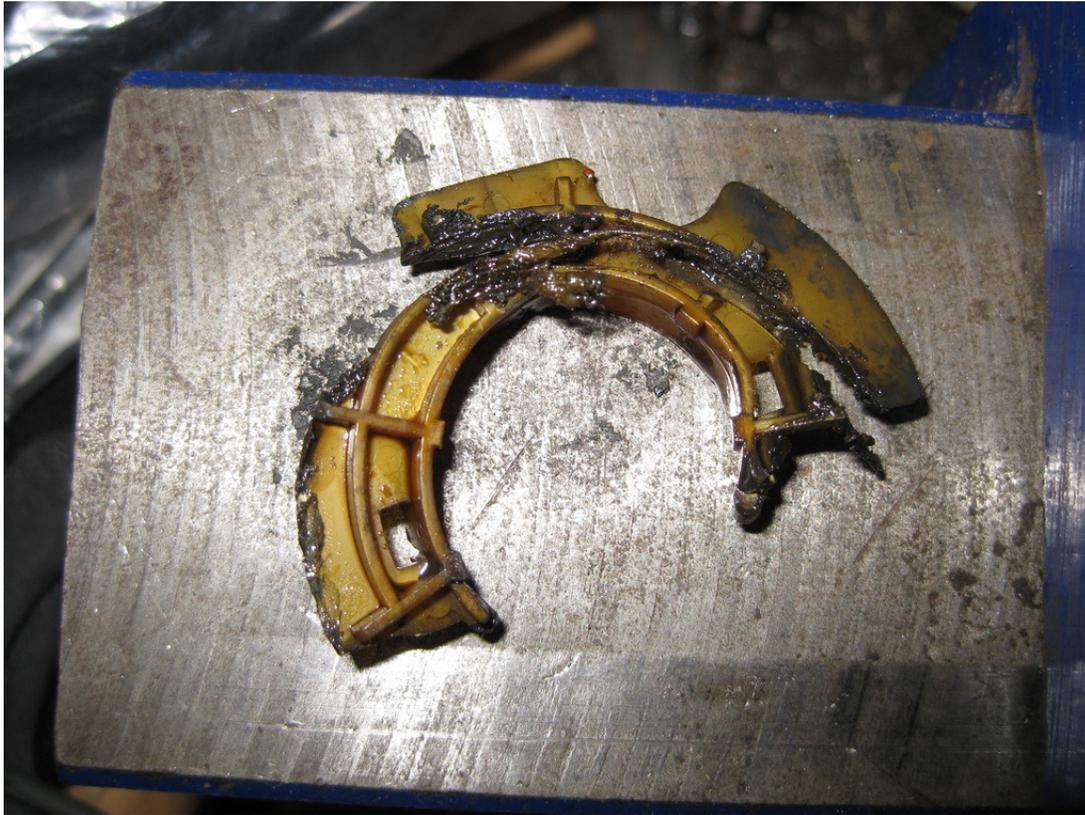
The reason that the 7A Distributor above has no plastic cover is because it might have been damaged like this one:

You can see why the owner of the 7A distributor would have removed the broken wire cover. The 7A owner did the correct thing by tie-wrapping the wires to the distributor housing so they would not contact the Hall sender shutter disc and get cut. If you find yourself with a broken plastic wire cover, either fix the cover or discard and use the tie-wrap trick during reassembly.

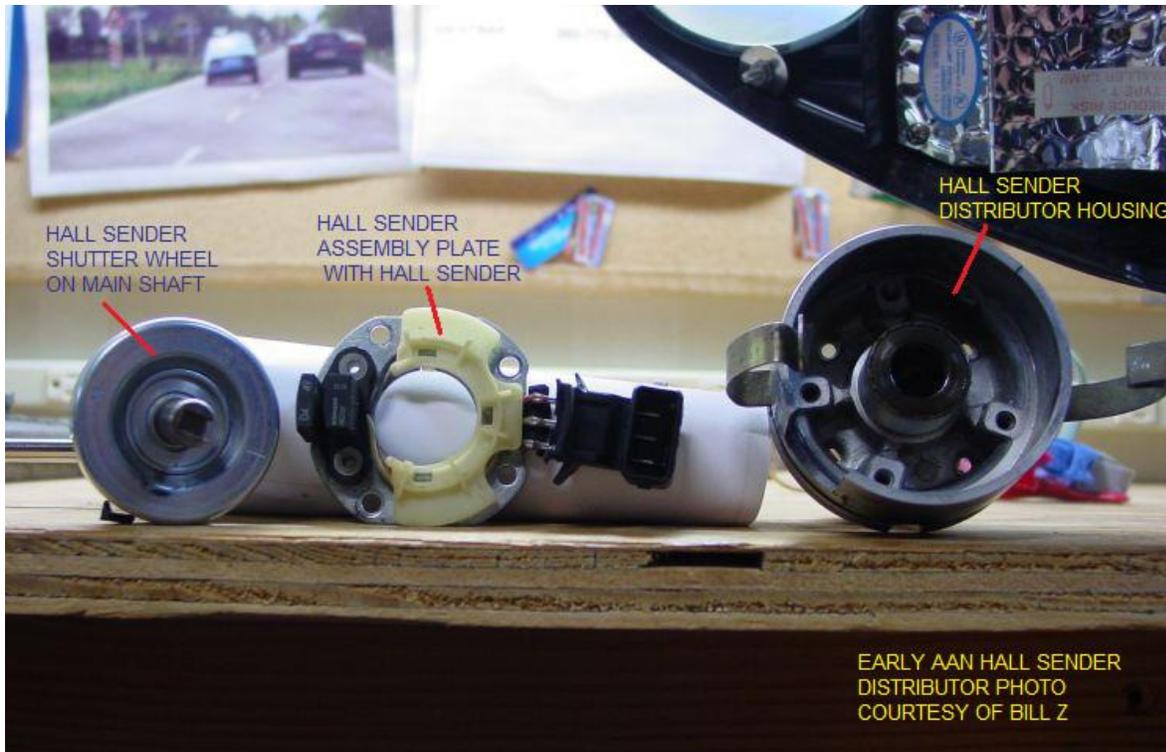
Now remove those Hall Sender Assembly plate hold down (Phillips) screws and gently remove the assembly plate and the integral black electrical connection. The result should look like this:

Now you need to either replace the entire Hall sender assembly plate with the factory part (e.g. 034 998 065 for the 7A) and reverse the disassembly process or replace the Hall sender with an aftermarket or known to be good Hall sender with the same specifications as the factory sender. If you decide to go aftermarket, one source of replacement Hall effects senders that many Audi AAN/ABY/ADU people have used is from BB AutoMacao: <http://www.bbautomacao.com/products.asp?cat=14>. Their BBHME301 is a straight replacement for HKZ101, HKZ101S, HKZ121, and CYHME301 Hall effects senders. Here is what they look like:

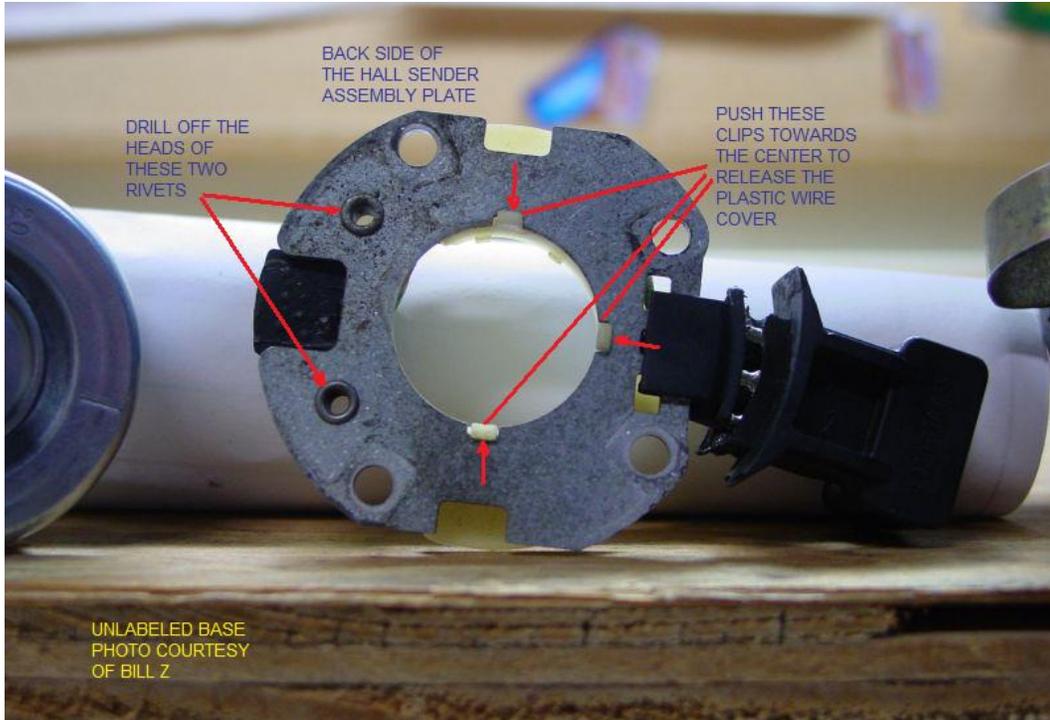
To start the 7A,3B or Early AAN Hall sender replacement, you need to first remove the plastic cover (or clip away any tie-wraps to expose and free the wiring) by pushing on the clips on the back side of the assembly plate. Then you need to drill out the back of the rivets that hold the OE Hall sender to the assembly plate:

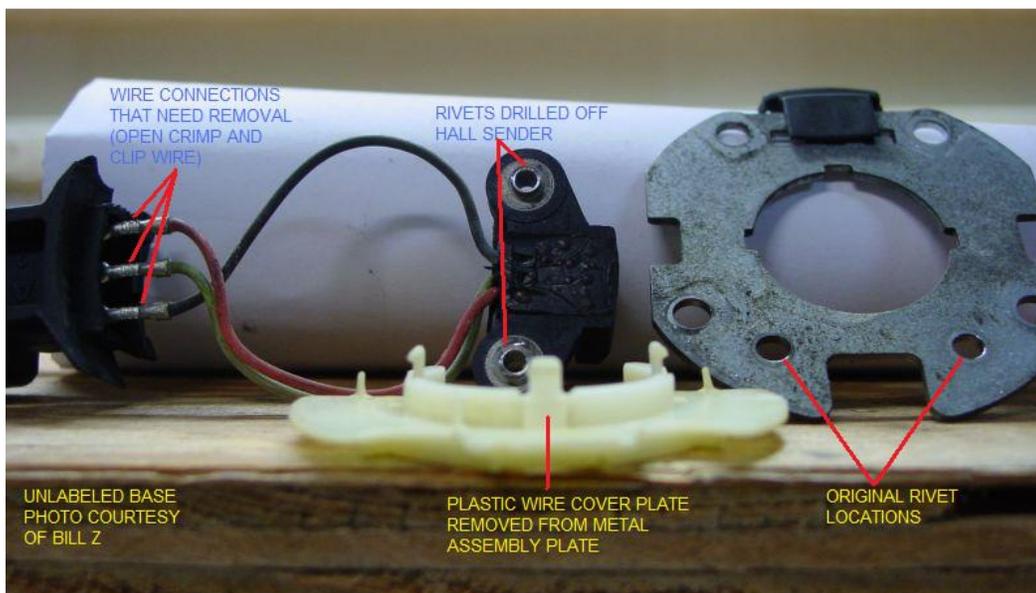
Once you have the rivet heads drilled off, the Hall sender will still be attached to the assembly plate at the electrical connections to the external plug. Depending on how you want to work with the wires at the black external connector, you can either leave the black connector on the assembly plate or remove it, as shown in the next photo:

To remove the Hall sender, open up the first crimp on the connection pin and clip carefully clip away the wires, as suggested in the photos above.

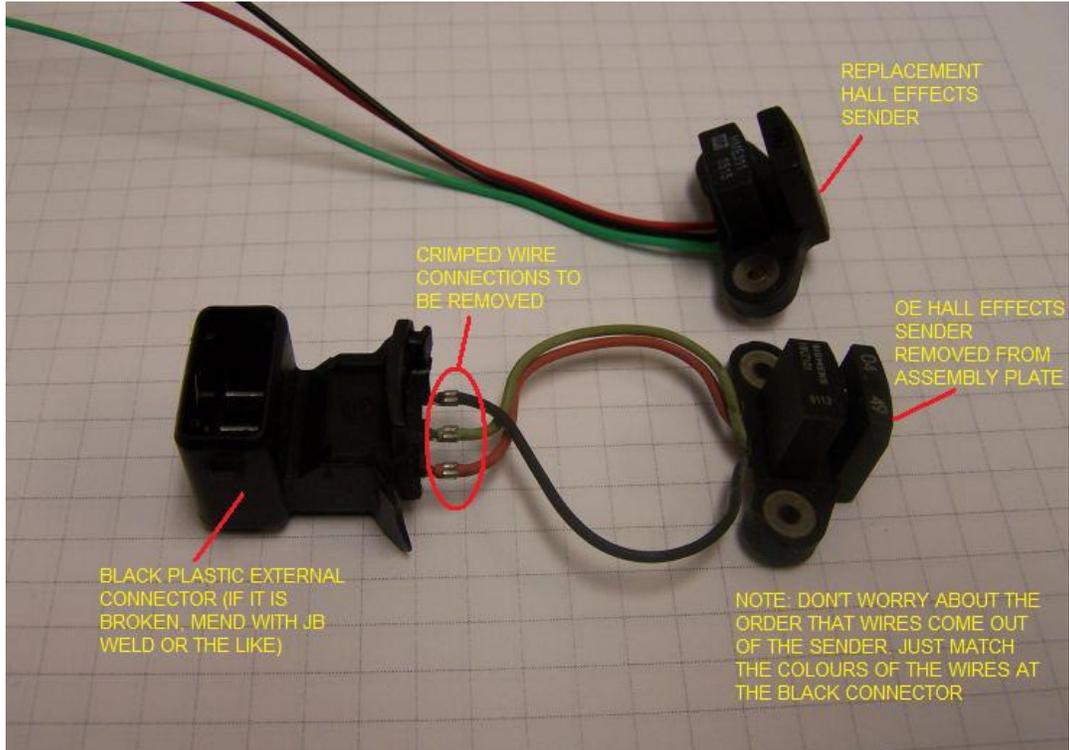
Here is the OE Hall Sender compared to a replacement sender:

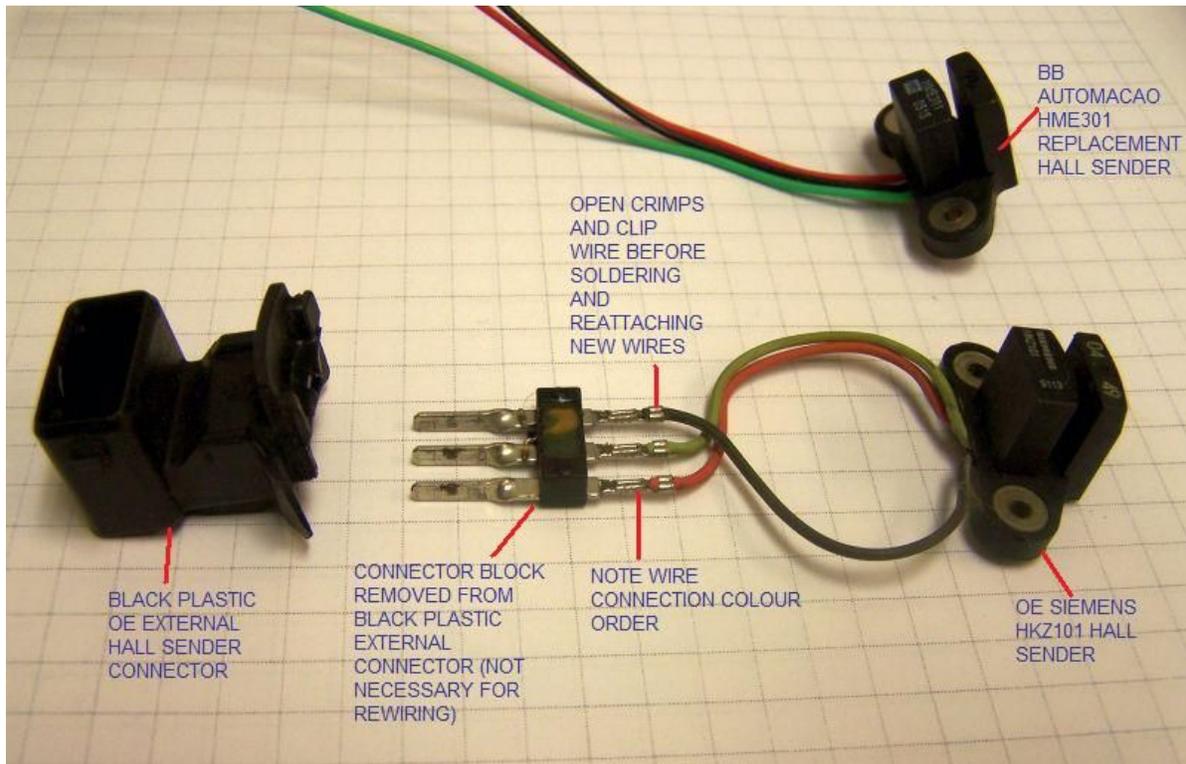
You can also remove the connector plug from the black external Hall sender connector, as shown here:

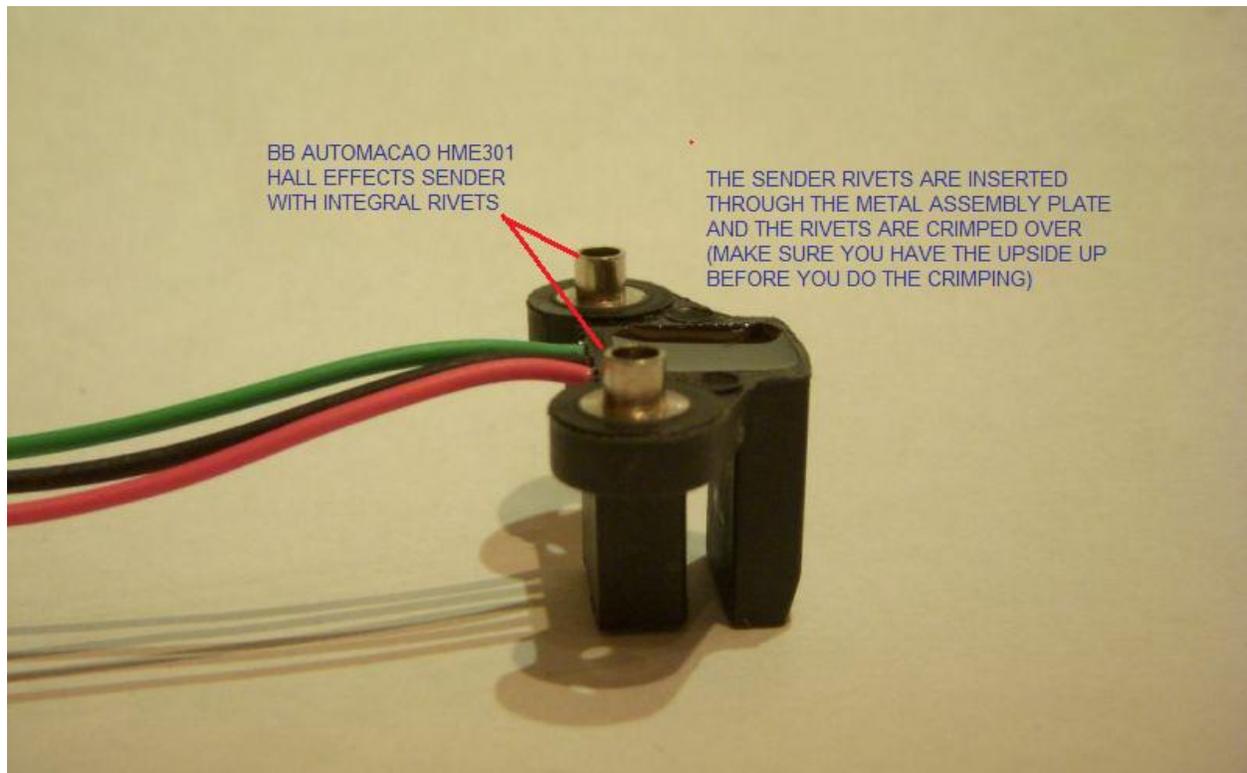
The replacement Hall effects sender comes with integral rivets, as shown here:

To rivet the replacement Hall effects sender to the assembly plate, get the orientation of the sender correct (i.e. on the correct side of the metal plate), insert the sender rivets through the plate and flip the assembly and sender over. Place on firm surface, e.g. work bench and crimp the rivet heads. One simple way to do this is to use a Phillips No.2 screw driver and push the tip down onto the uncrimped rivet head. Push hard and you will distort the rivet head and make a big “+”. Now rotate the tip of the screw driver 45 degrees and push down again. The rivet should be firmly attached to the assembly plate. Repeat for the second rivet.

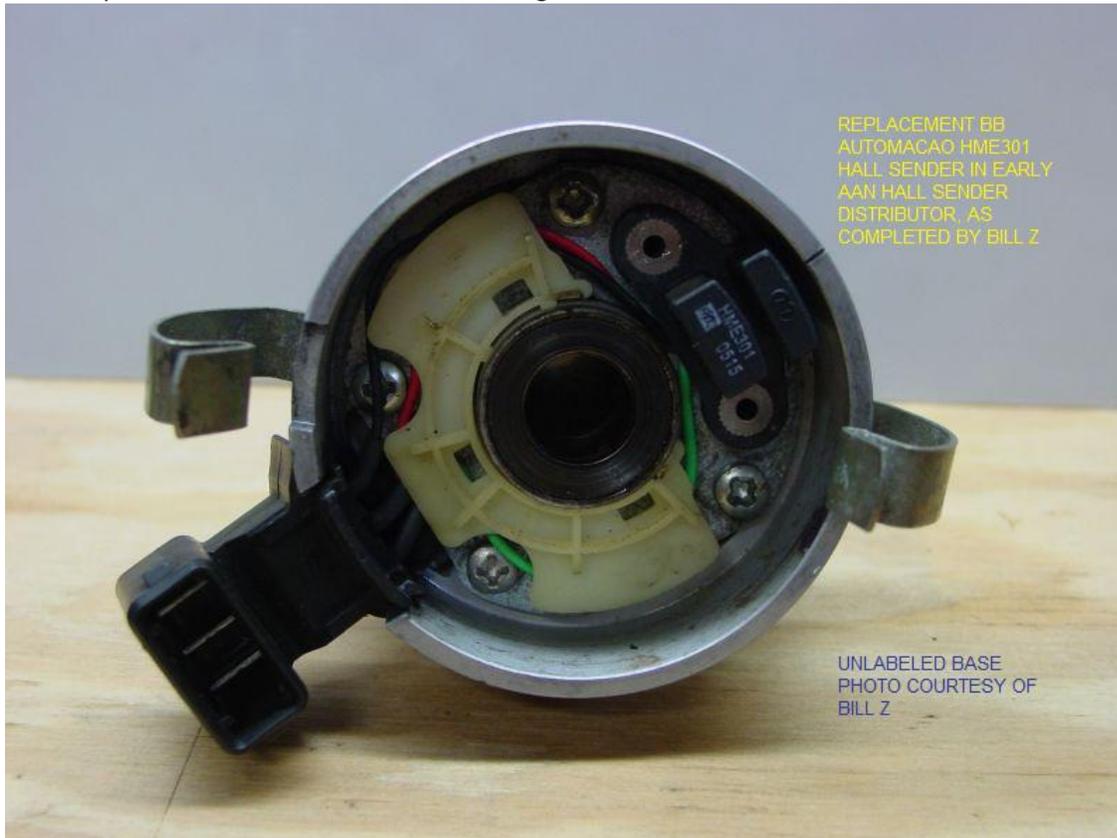
The end product should look and function as good as OE. Good luck.

You are now ready for reassembly, i.e. replacement of the plastic wire cover (AAN), placing the assembly plate back into the distributor housing, screwing the assembly plate to the housing with the screws that you removed at the beginning (and didn't lose), replacement of the main shaft and Hall sender shutter unit (check to see that the shutter sits in the Hall sender nicely), replace the drive gear and replace the OE rivet with the correct diameter and length spring pin.
