## Audi UrS Fuel Line Maintenance

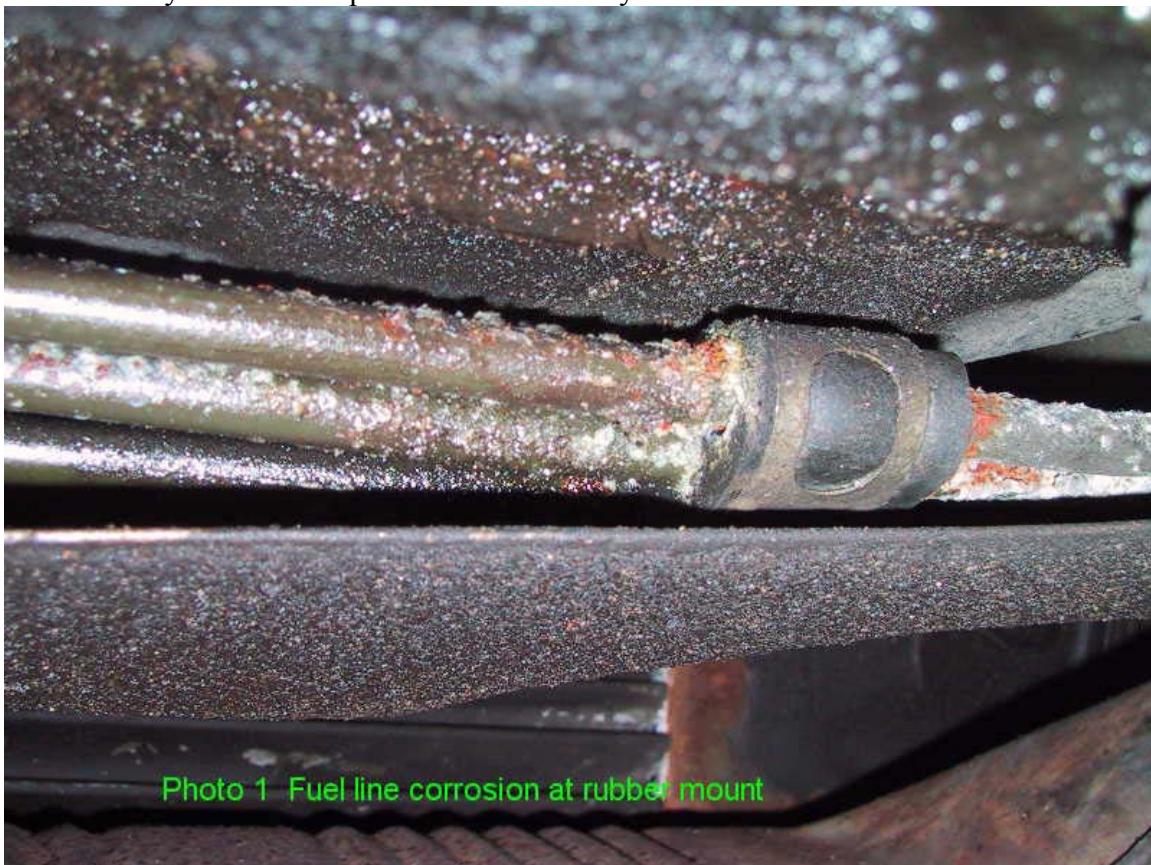
1. Photo 1 shows what a corroding line looks like. This was the most corroded area on my car and the spot the line eventually failed.

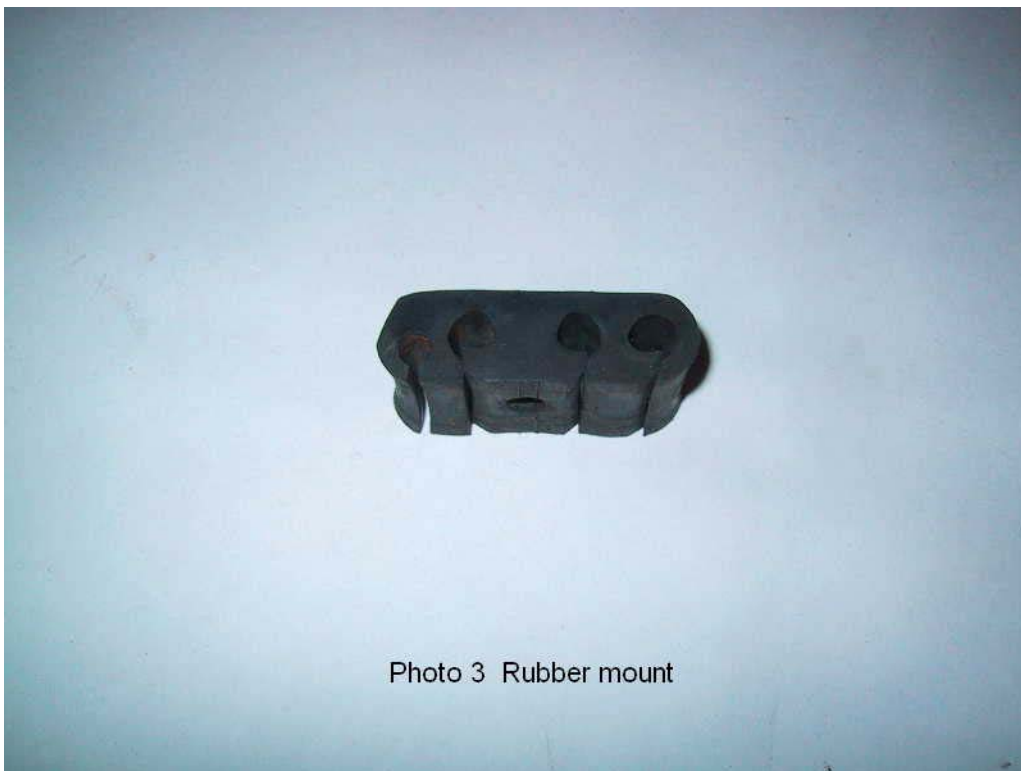
3. The rubber mounts are split at the top (see Photo 3). Remove them from the line.

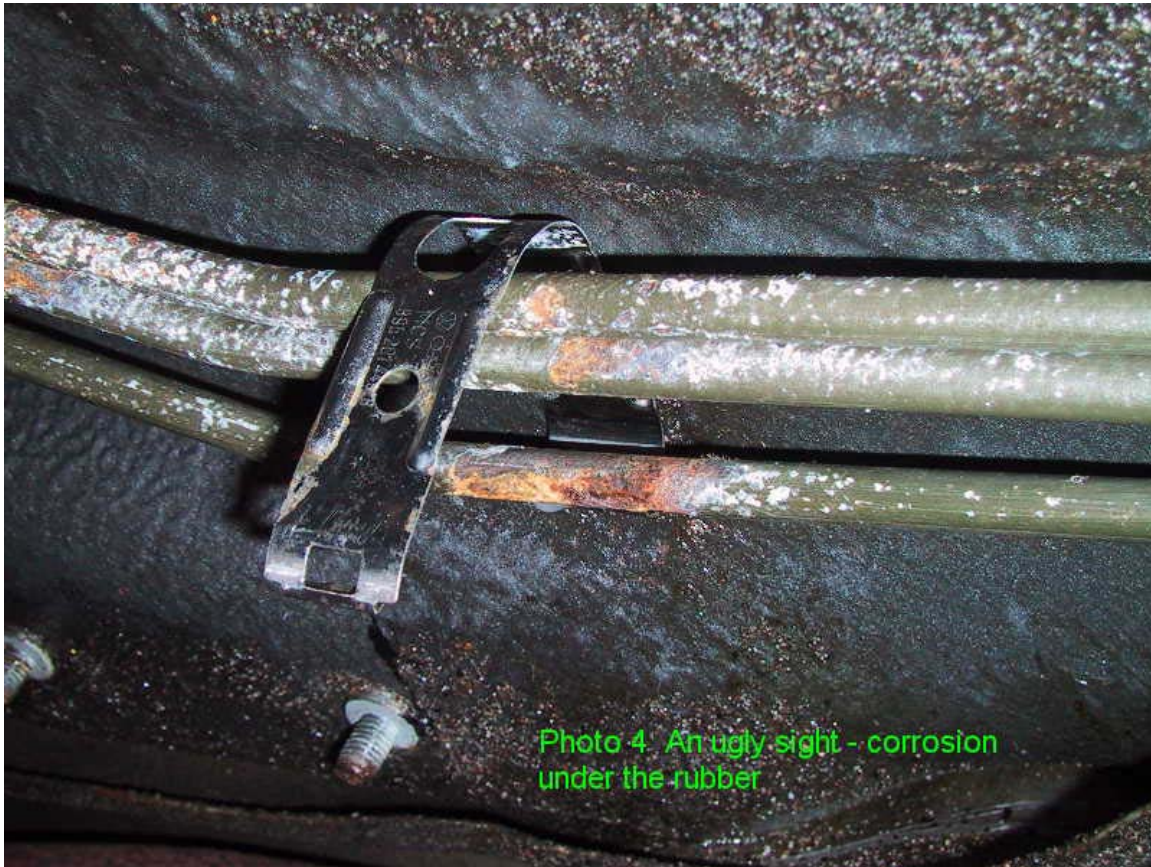
4. Photo 4 shows the corrosion that was occurring under the rubber – the worst spot in this photo was the area of failure in the return line.

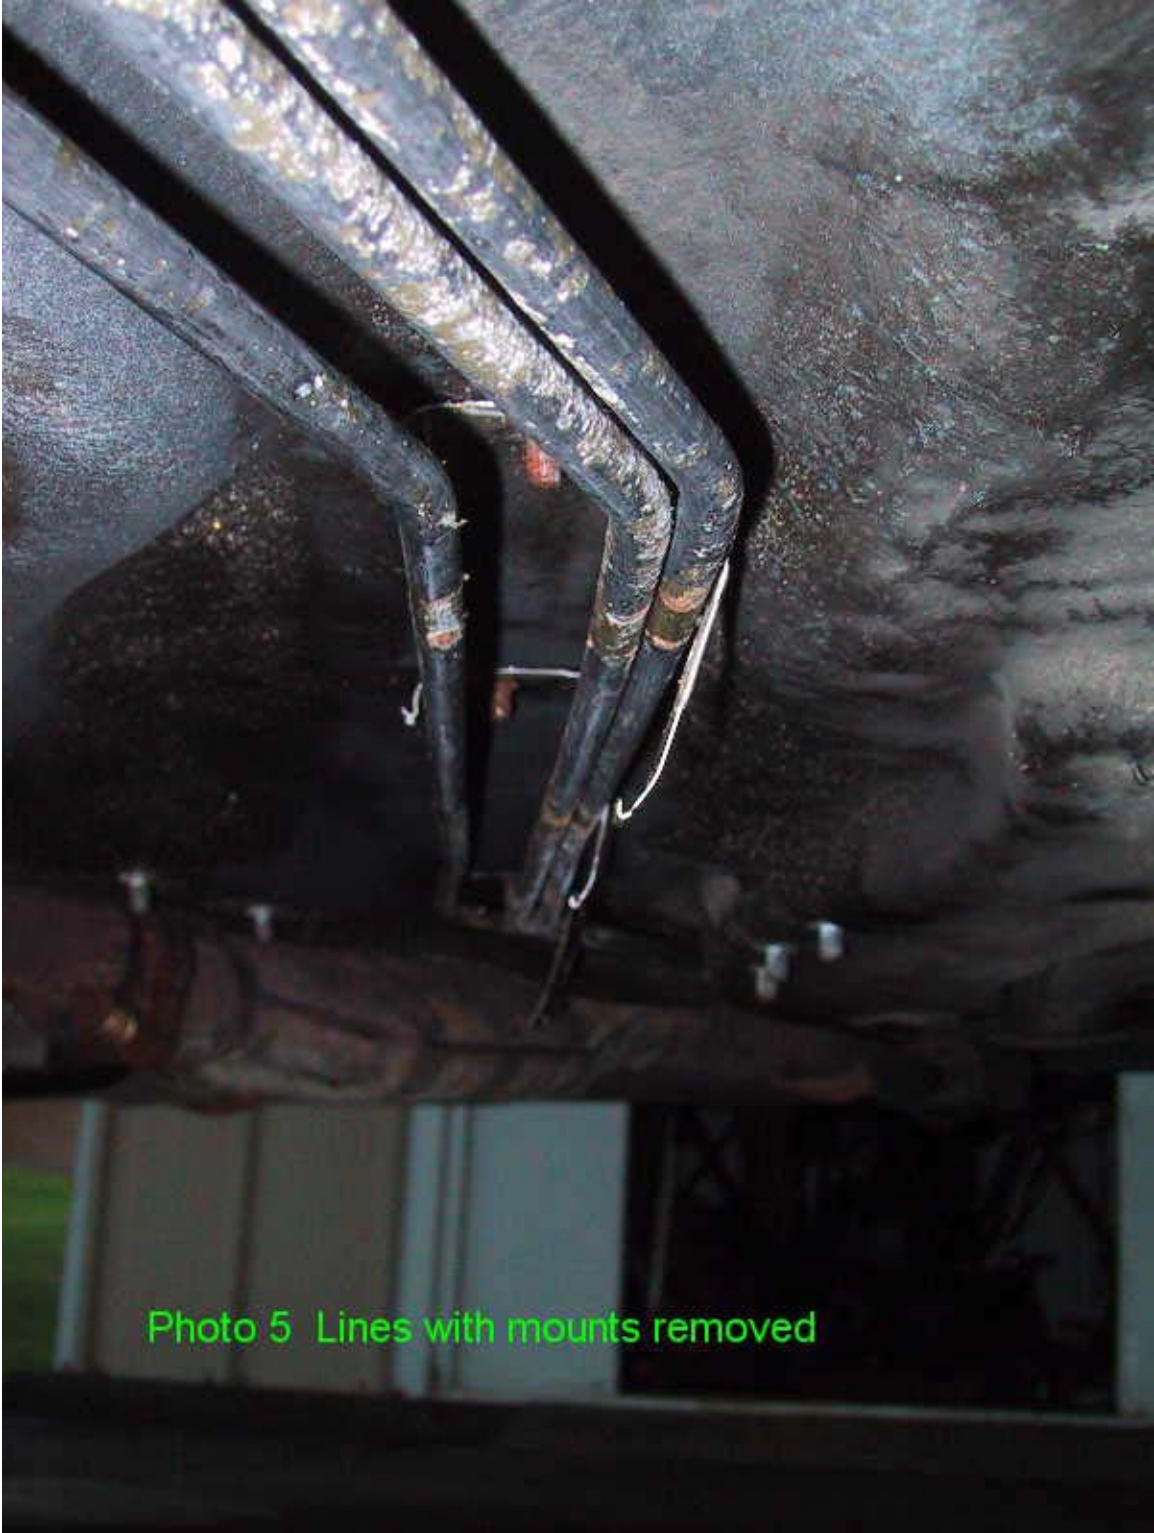
Photo 5 Lines with mounts removed

5. Photo 5 shows the lines with all mounts removed except the ones at each end. These were left on to hold the lines in position while the centre length of the line was cleaned and painted. Note the corrosion under all the rubber mount areas. The front clip and mount cannot be removed without removing the driveshaft shield. This involves removing the exhaust straight pipes from the cats to the centre muffler.

6. Clean up the lines with steel wool (or reasonable facsimile) and wash with a good water-rinse degreaser (I used Simple Green).
7. I painted the lines with two coats of POR-15 over the residual rust that was left after I cleaned the lines up.

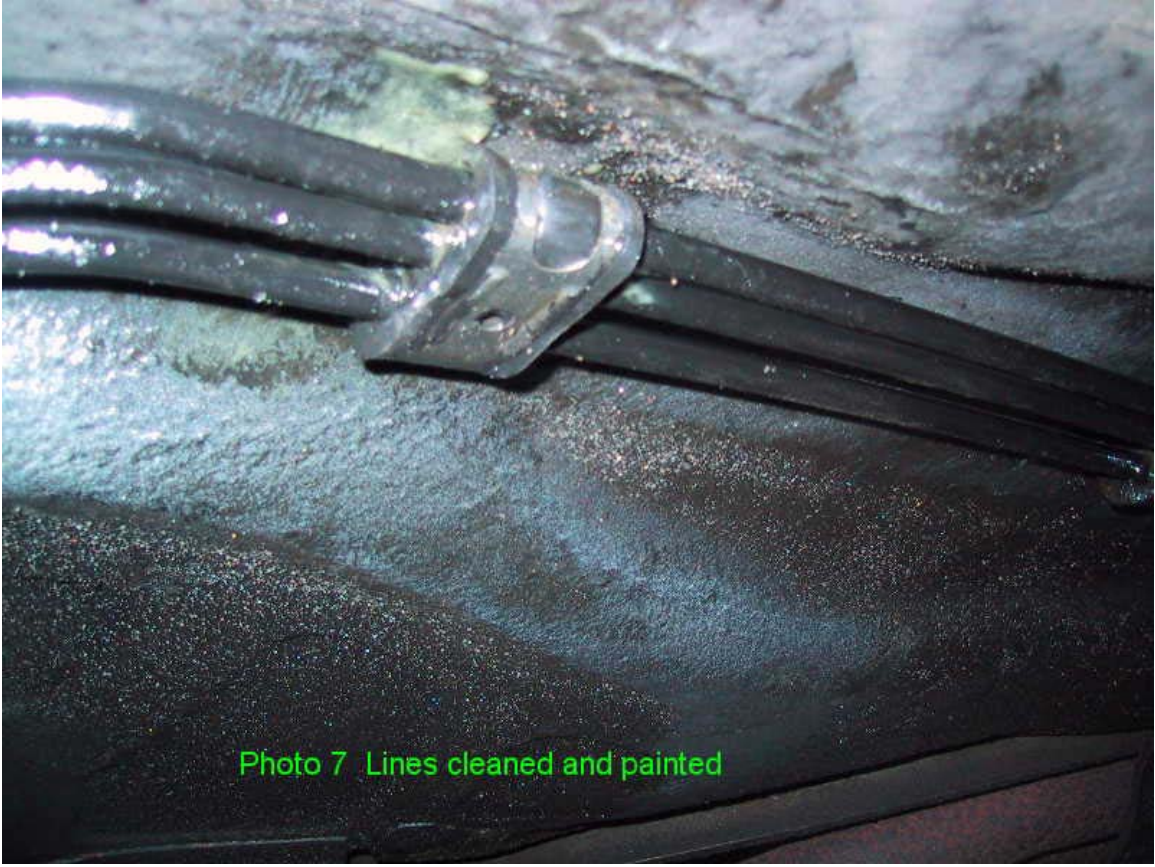
Photo 7 Lines cleaned and painted

10. Photo 7 shows a section of the repaired line. Looks a lot better than Photo 1, doesn't it? Too bad I didn't do it sooner!
