Rebuilding my 1995.5 S6 – Ed Keegan 9/12 – 5/13

Background and Plan of Attack:

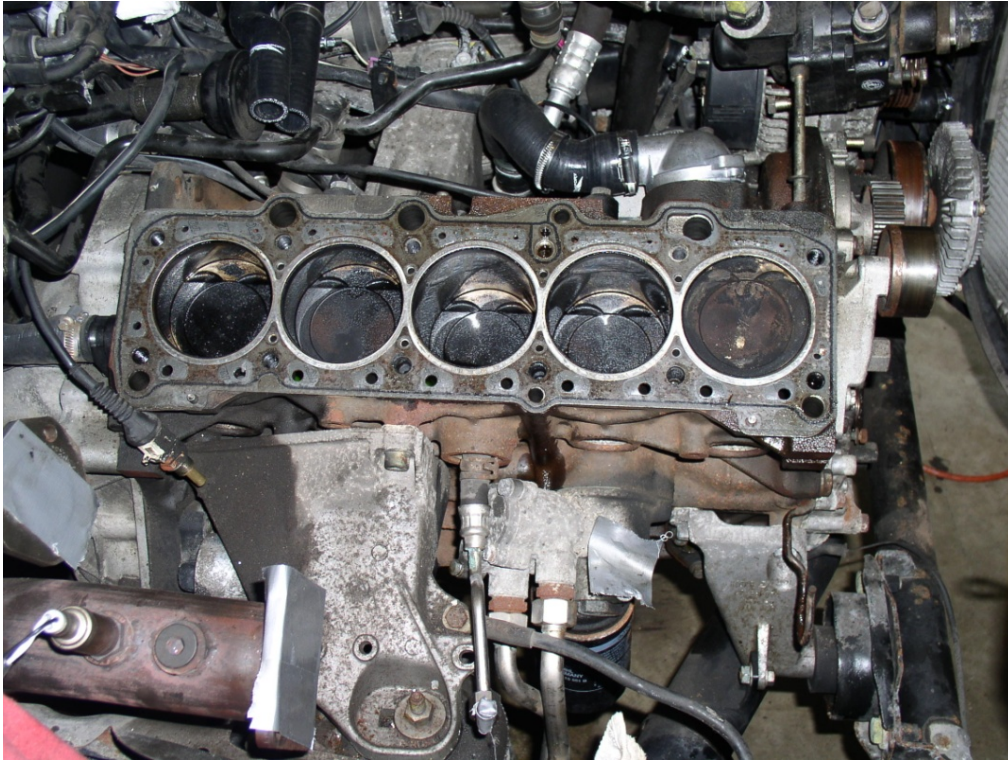
However when I pulled the head, the gasket was pristine:

This meant only a few other possibilities: Cracked Block, cracked turbo or cracked head. When I took the head for machining, several cracks were found around the spark plug threads going all the way through the head and exceeding the recommended repair specs.

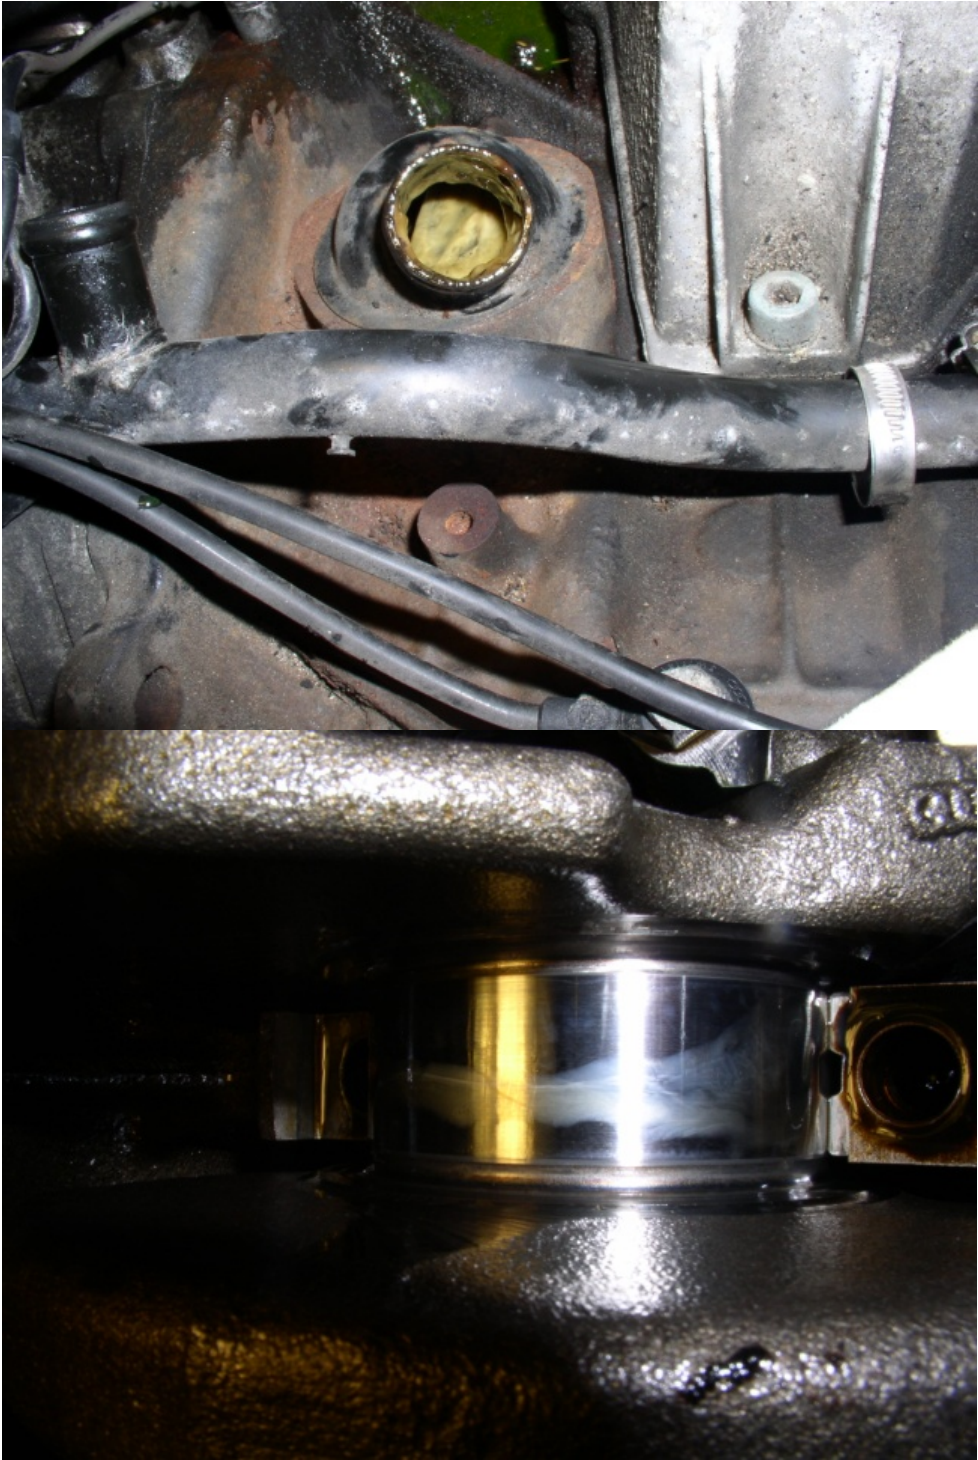
Goo & Bearings:

One additional surprise I had was no visible damage to the bearings, yet there was this yellow goo in the engine:

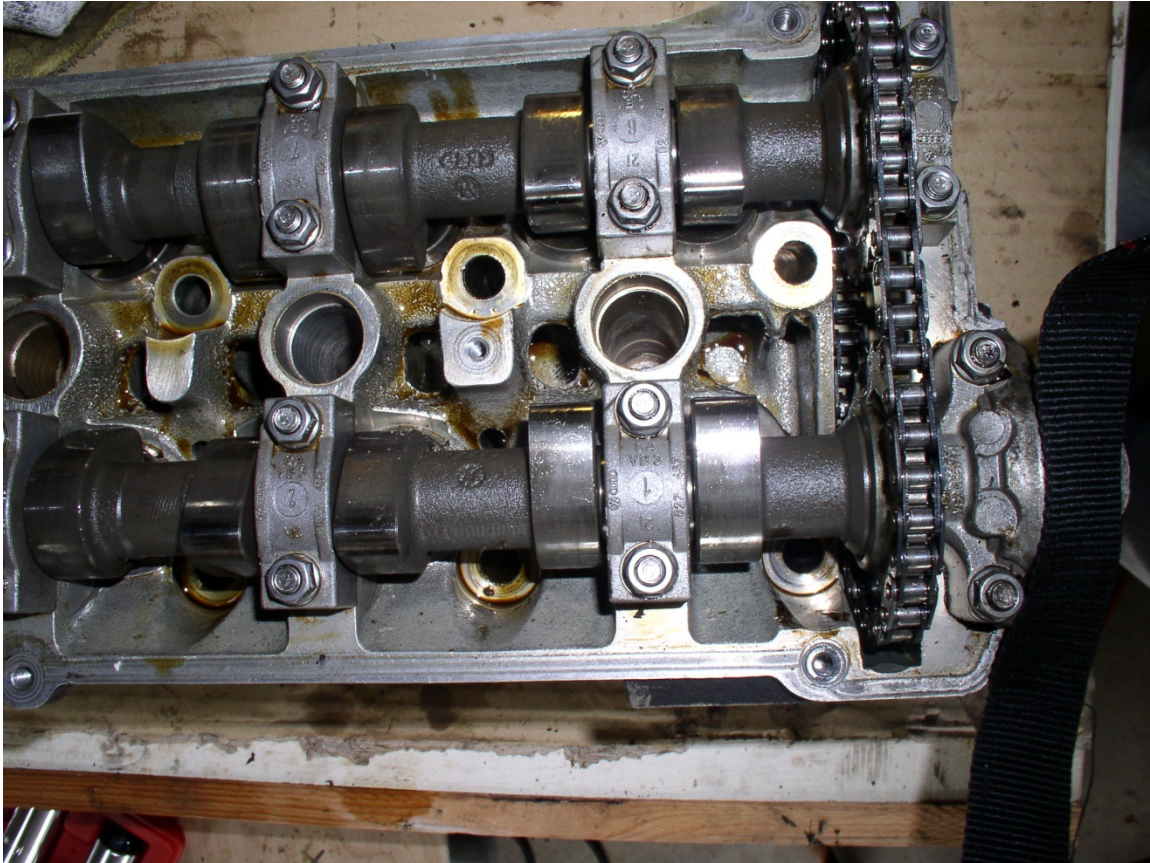
Original Valve Train (pretty good looking for 190K):

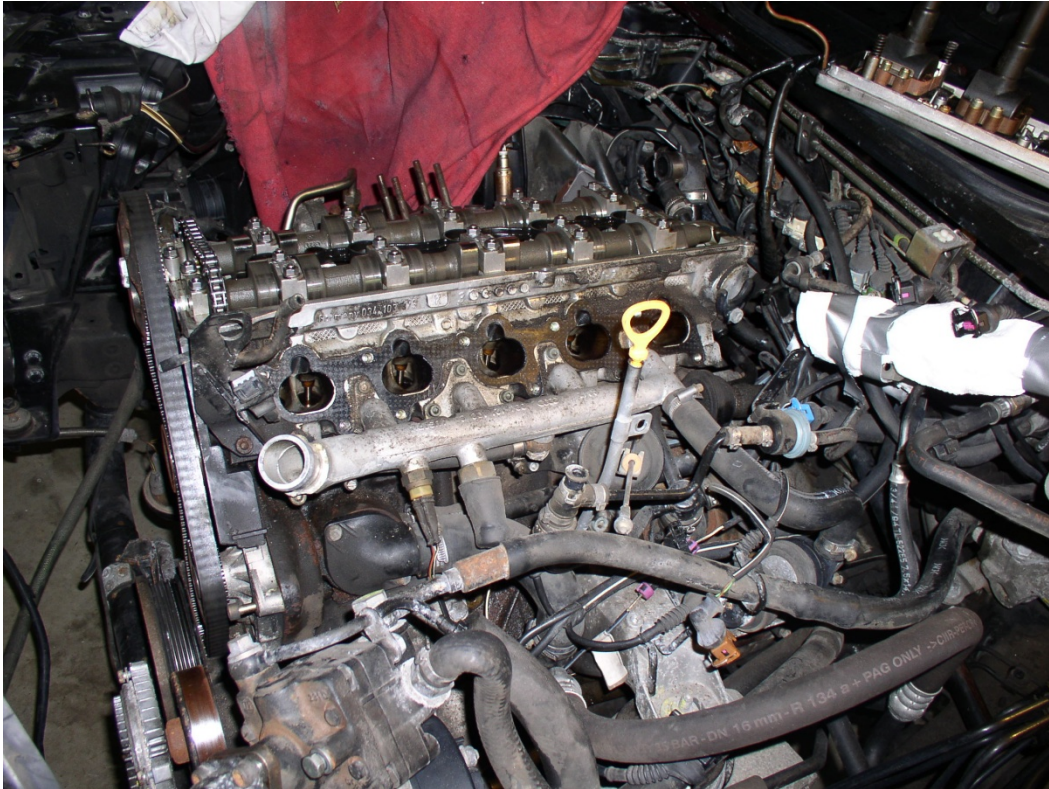
1. Valve cover/ intake Manifold off:

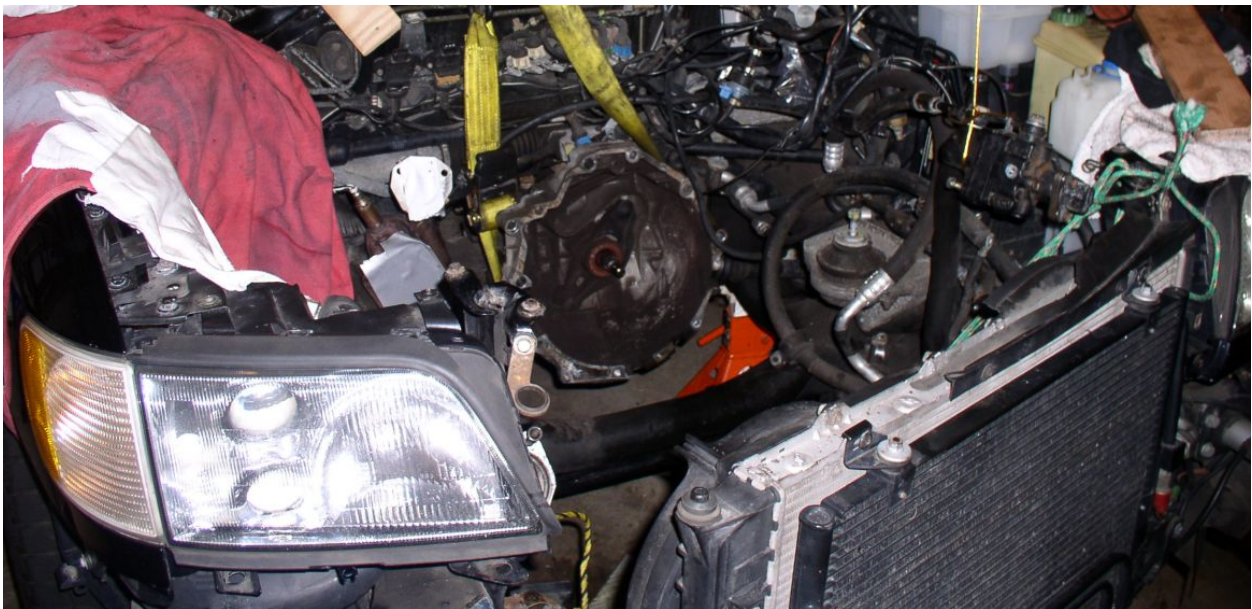
2. Engine Out:

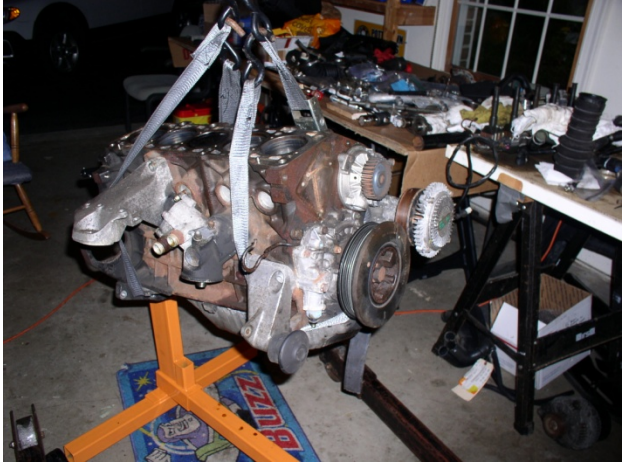
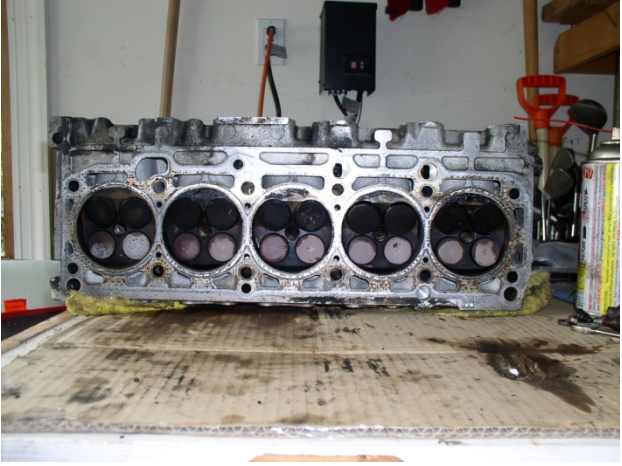
3. Head & Block Apart:

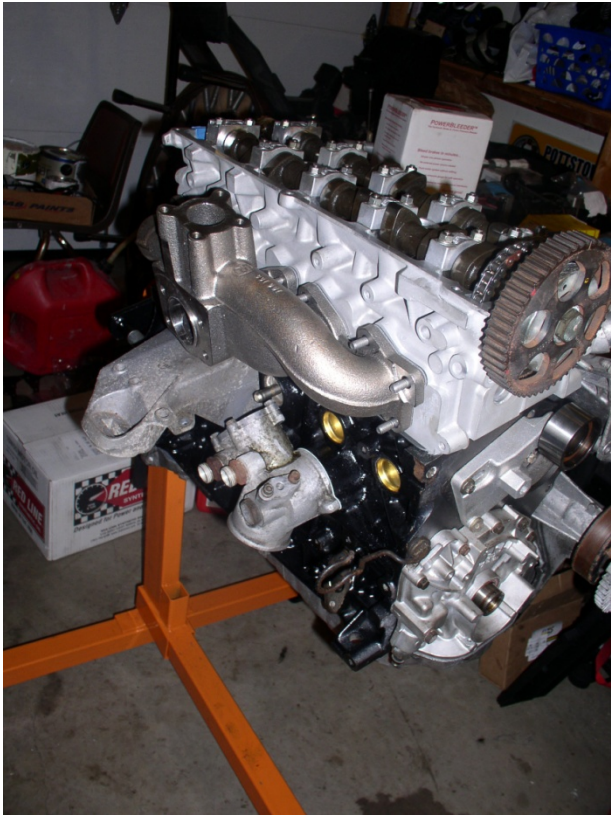
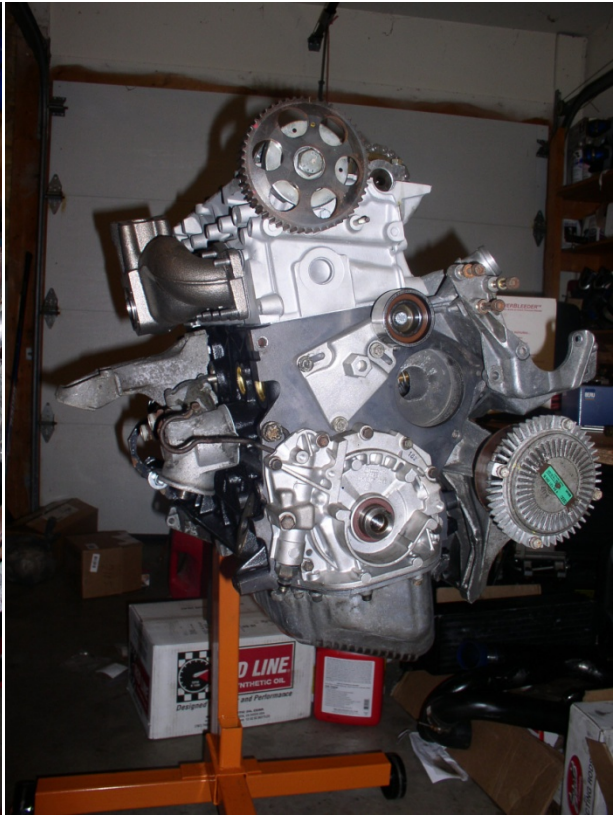
4. Head & Block back from machine shop, on stand with some new stuff added:

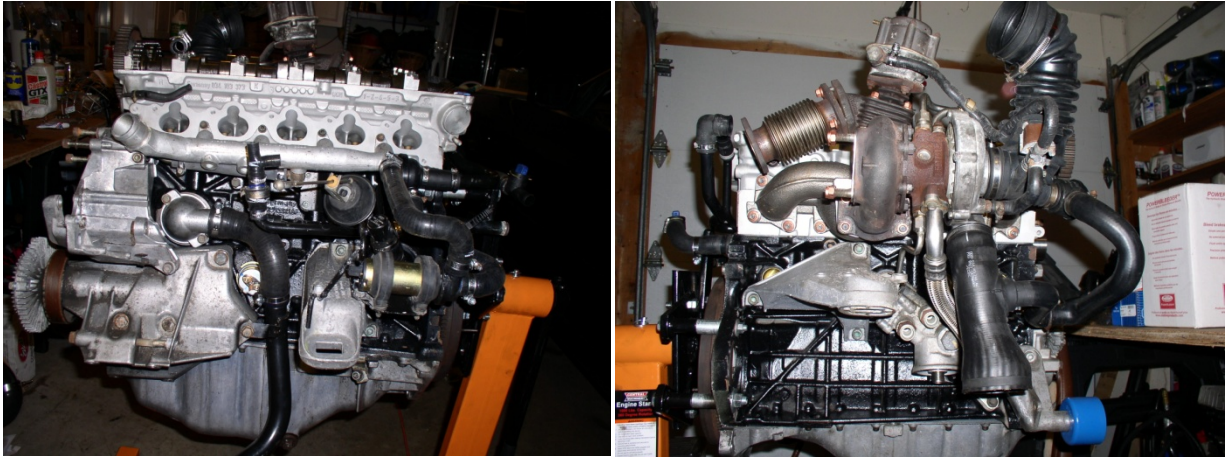
5. A look at both engine sides, partially reassembled:

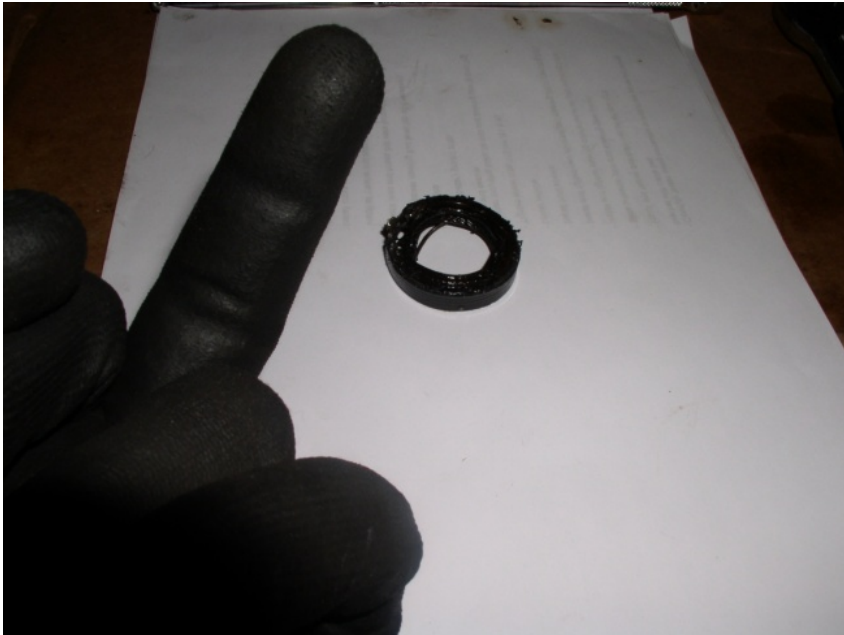
6. The trans main seal (was a pain in the ass to get out and I messed up the first one I put back in (bad improvised tool). Luckily I had purchased 2 of them, so pulled and inserted another correctly:

The Trans Main Shaft seal was a pain and required 2 new ones to finally get right.

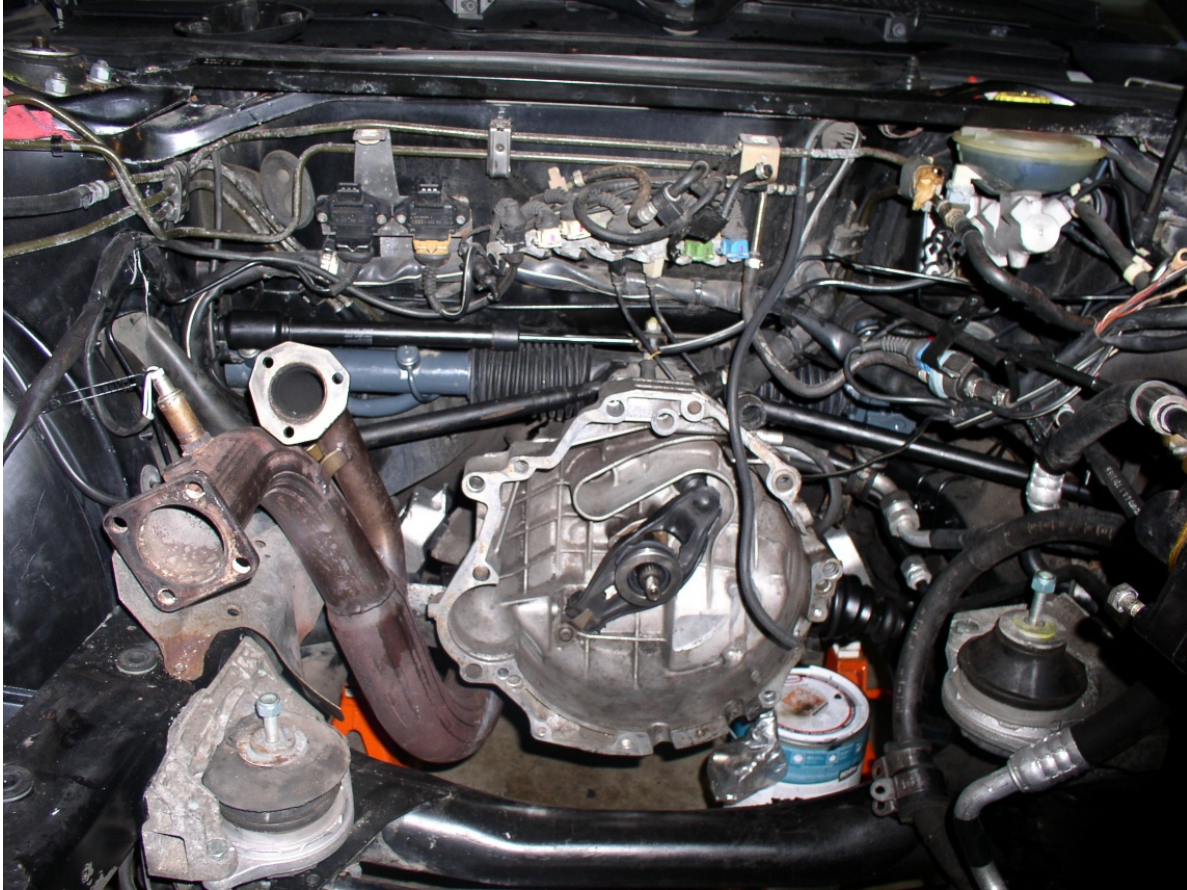
7. PS Rack re-installed, new bushings/ mounts in, just about ready to slip the engine back in:

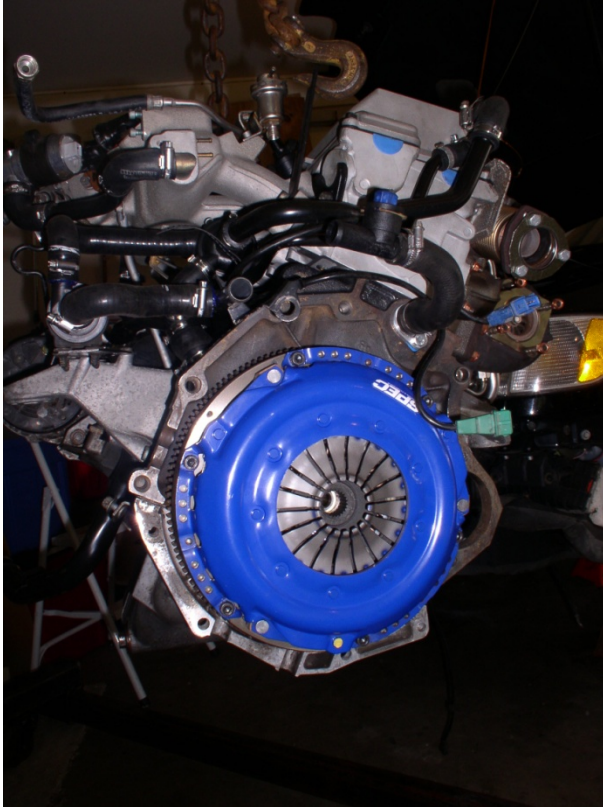
9. Clutch on engine, engine on hoist:

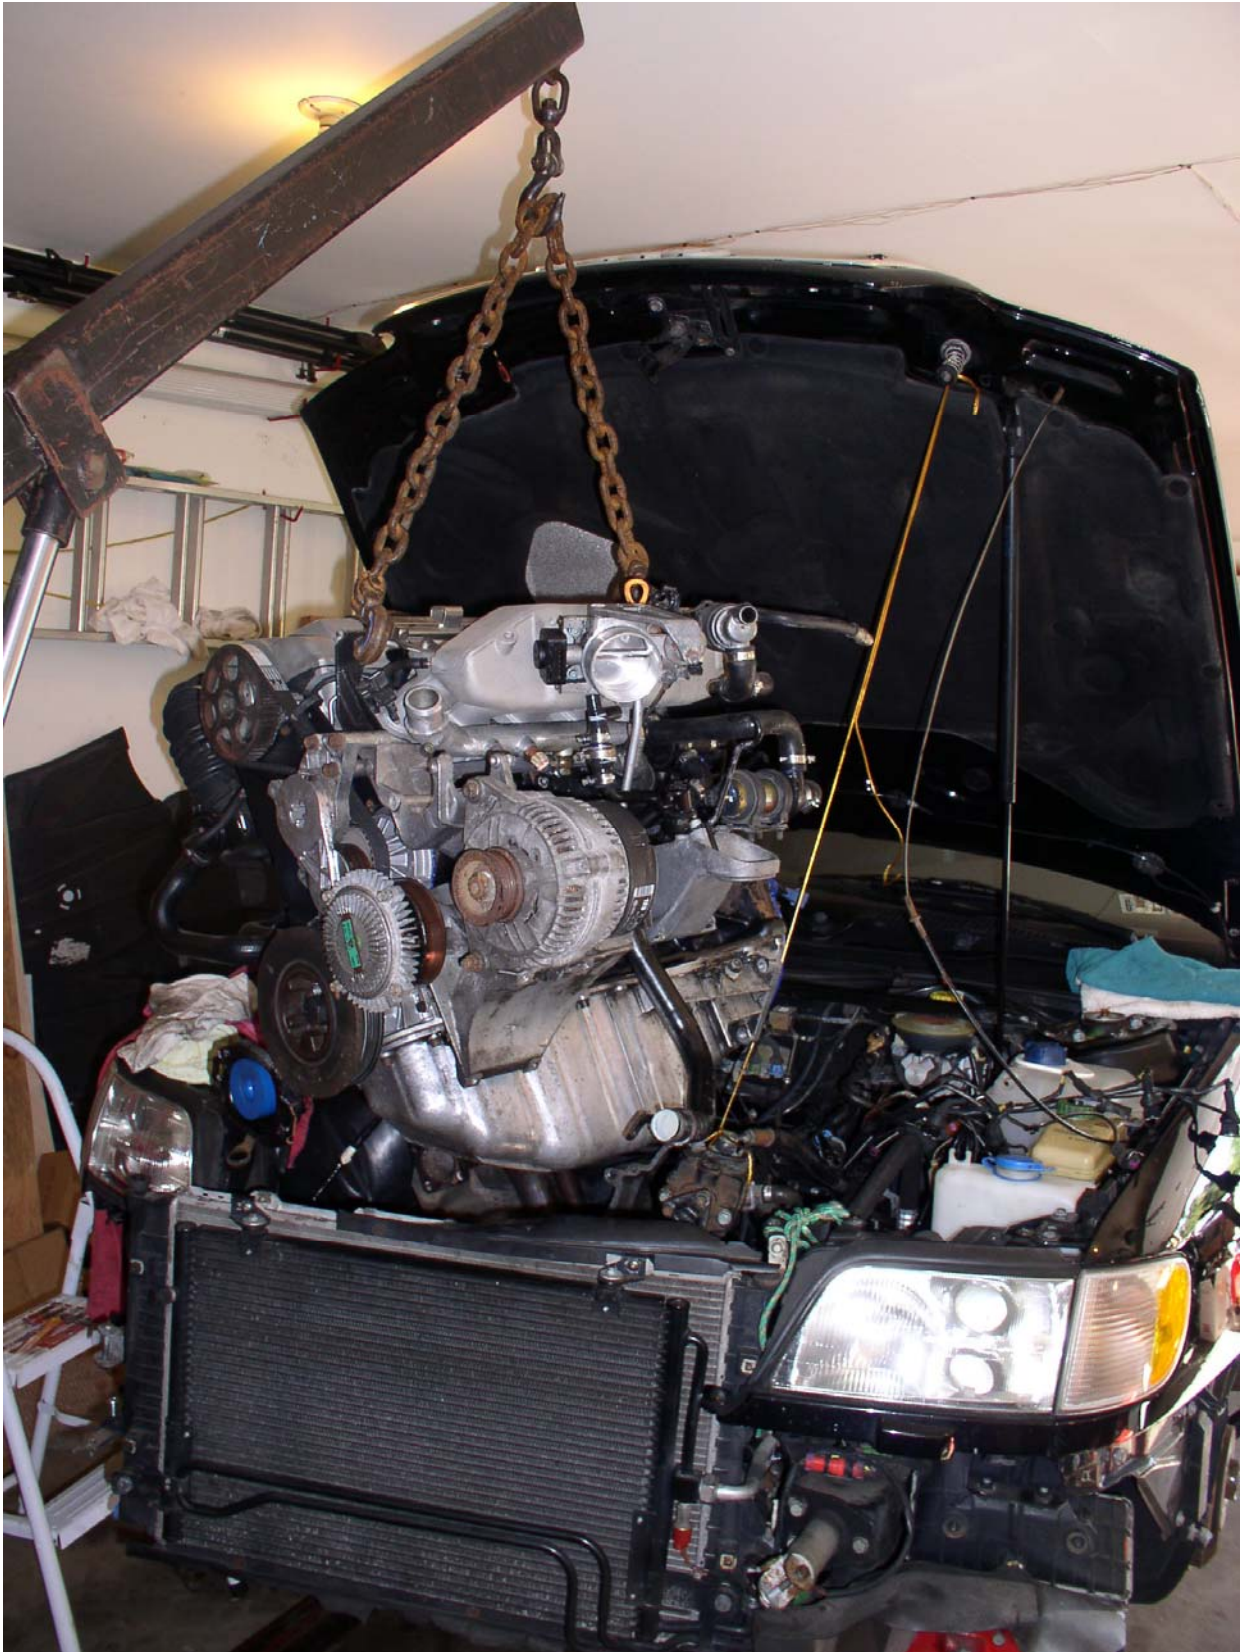
10. Engine on hoist (before shortening chain):

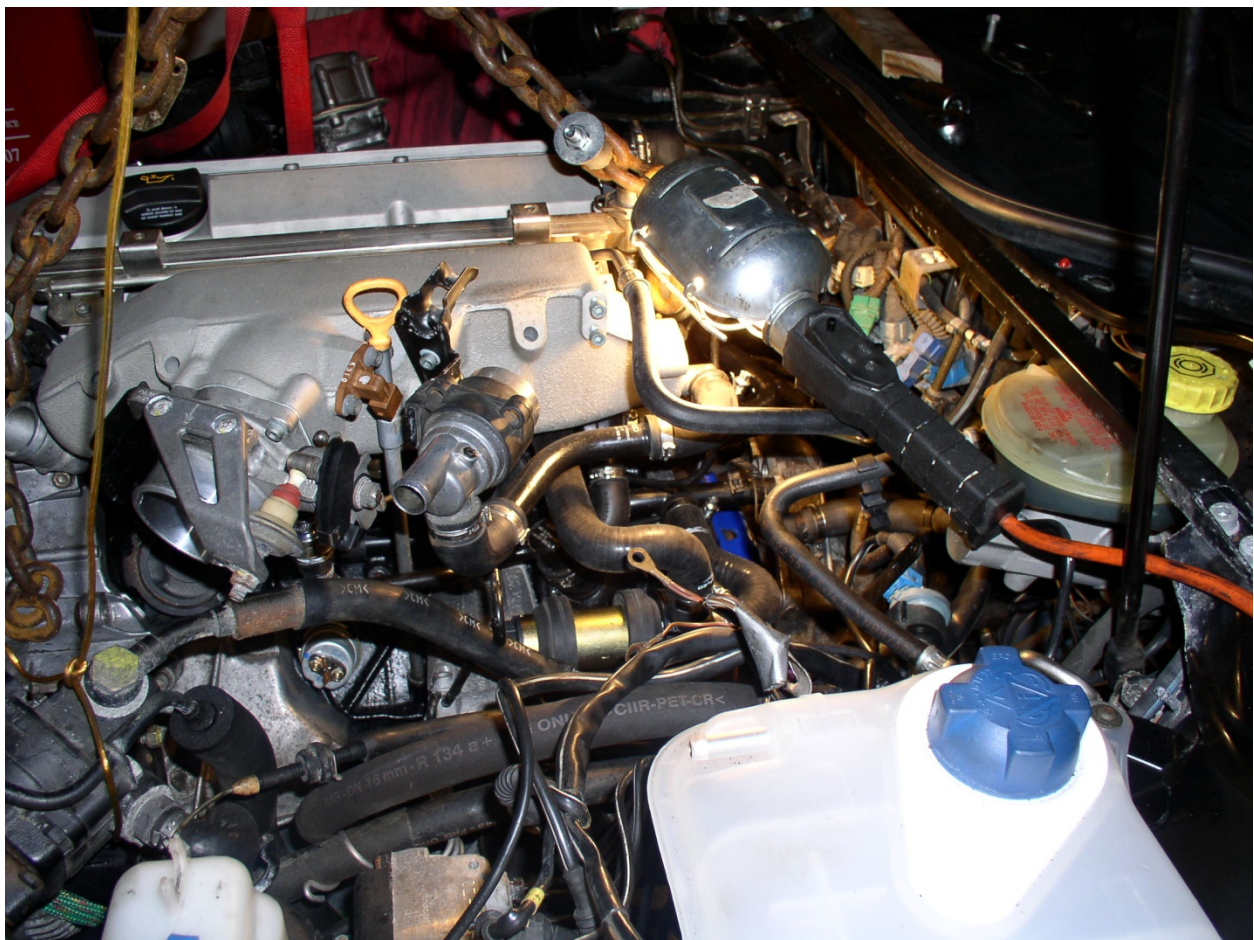
11. Engine just about aligned to transmission (you can see the blue of the clutch):

The last bit of maneuvering for mating the engine to the transmission was more art than science. I used a couple of straps to pull the engine into a better alignment with the transmission after getting the engine down into the bay (still on the hoist). I started with about a 1 ½" gap where I could "feel" the main shaft clinking around the tines of the clutch pressure plate. Based on some suggestions from QW, I used some transmission bolts to align the engine (I did NOT use them to draw the engine onto the bell housing). Once I had the two aligned pretty well I made some last minute adjustments and then moved to the front of the engine and pushed and wiggled while I turned the crank pulley slowly until I heard a click/clunk noise. Since I had the wheels off the car, I engaged the gear and spun the engine by the crank and watched the axle turn. The last thing to do was to get the trans bolts in around the sides and a couple from the bottom, then work back and forth turning them, making sure they were not binding or hard to tighten. The block slowly drew itself the last ½" and then I installed the last few small bolts and torqued everything down.

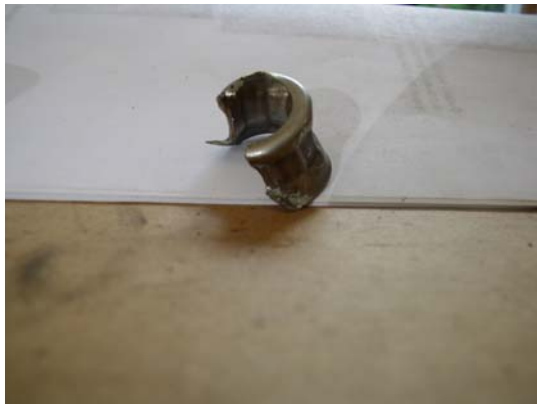
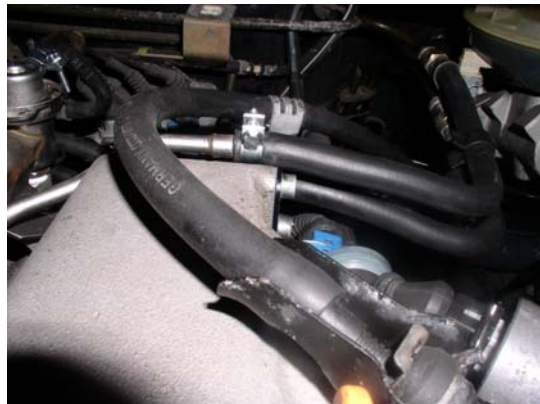
1. Fuel was leaking from the pressure line to the fuel rail
2. The idle was reving high & low well above normal (1100 – 1800)
3. The PS pump was making a noise after running for 30 seconds

I shut her down, removed the fuel line and started scratching my head for a solution. The replacement part was \$500 and would need to be welded to the fuel rail. I decided to cut off the old crimped connection and reattach with a new clamp. Worked perfectly!

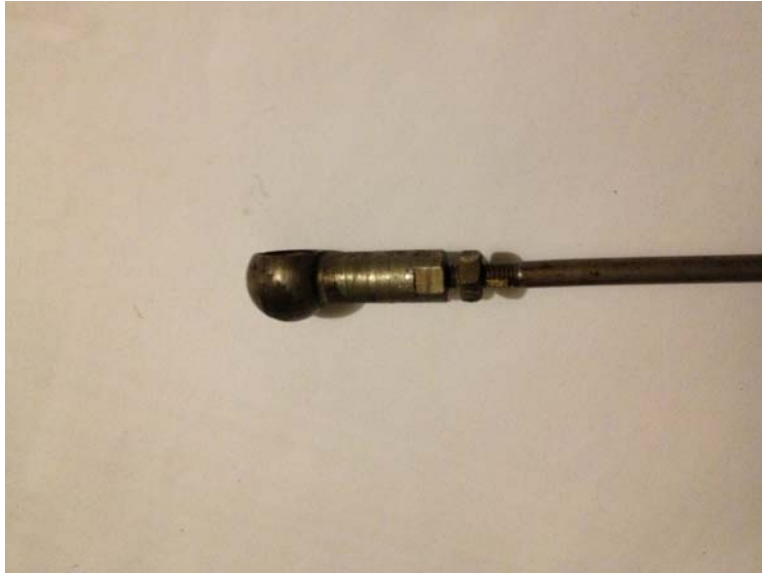
Cruise Control Rod:

The idle was also pretty straightforward, but took some time for the solution to sink in. I found the cause pretty quickly: The cruise control rod was pulling the throttle up off of idle, disconnecting it allowed the car to idle correctly. Originally I thought I had bent the bracket, but after I pulled the module I noticed that the attachment knob had a lock nut and could be adjusted. After realizing that it came to me why I had this issue; I had used a Phenolithic spacer! That pushed the IM further away from the head and was the reason I had to adjust the throttle cable and the cruise control rod.

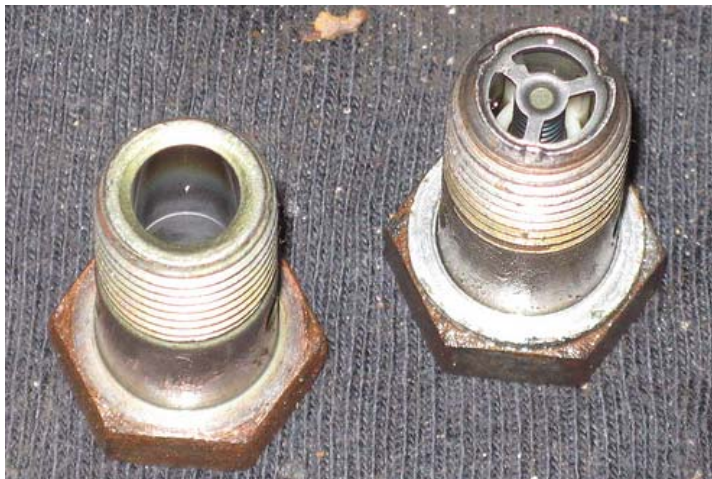
The last issue was the most confounding one since I felt I had kept the parts taken off well documented and sorted. After removing the rack thinking something was wrong (this was after checking flow from the pump to the rack – OK and from the rack back – NOT OK) and sending to Jorgen who found nothing wrong and then re-installing it (all with the engine back in the car – ugh!) I noticed I had a banjo with a check valve in it. And while I thought I had kept them with the hoses they came from, somehow they got switched, creating a situation where the check valve prevented flow going back to the reservoir.

PS hose Banjos (high pressure bolt on the right – only on later S6's):
