Replacement of the Hall Sender on a 7A, 3B, early AAN and some VW product distributors

By Dave Forgie with contributions from Jorge R (Pulga1952) and Bill Z.

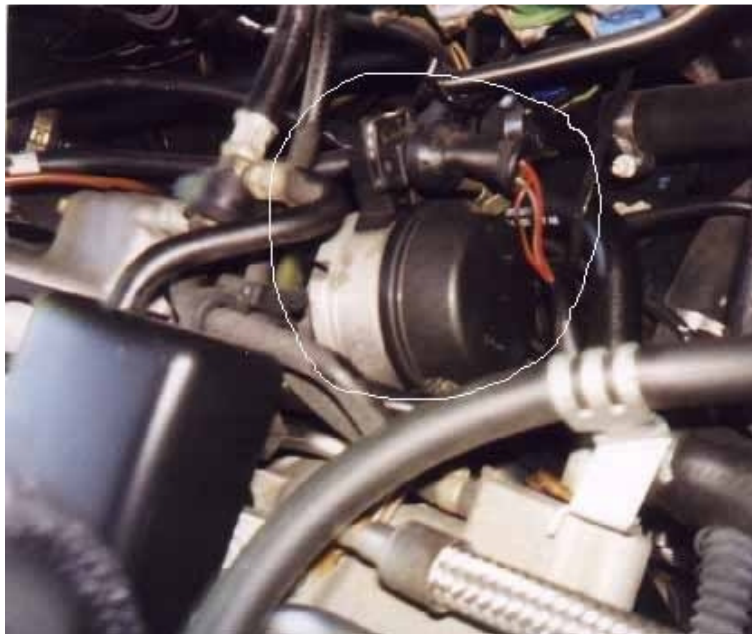
In the case of the five cylinder 20 valve turbo engines, only the early AAN engines, i.e. those engines built before January 31st, 1992 in cars assembled prior to about mid-February, 1992 (to VIN NN100000), had their Hall effects sender in a vestigial distributor (aka "the tuna can") distributor, as discussed here: <http://forums.quattroworld.com/s4s6/messages/22580.phtml> and shown here at the back of the intake side of the AAN head (the "distributor" has a gear that is driven off a gear on the back end of the intake cam):

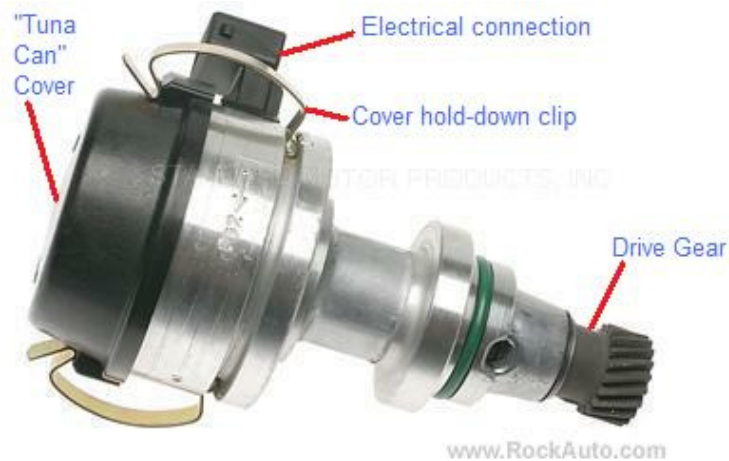
The first thing to do is to remove the “Distributor” (“tuna can”) from the engine by removing the electrical connector(a), removing the cover on the distributor/Hall sender noting the position of the rotor or slotted-wheel inside (mark with felt pen), and then removing the hold-down bolt and sliding the unit out of the head. It should look like this (but maybe without the cover, note the cover hold-down clips):

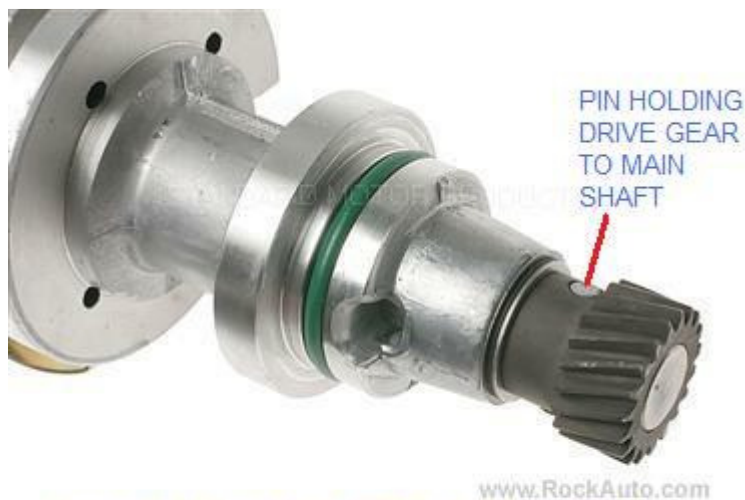
The first task is to remove the drive gear at the end of the distributor unit. It is held to the main shaft by rivet or spring pin, as shown here:

Bill Z said “I had to drill the rivet head off and then tap it through. It had a solid pin in it which I replaced the rivet with the spring pin. I drilled off the pin and used a punch and a small ball peen hammer to tap it out. I measured the OD of the shaft and cut the spring pin to size.”

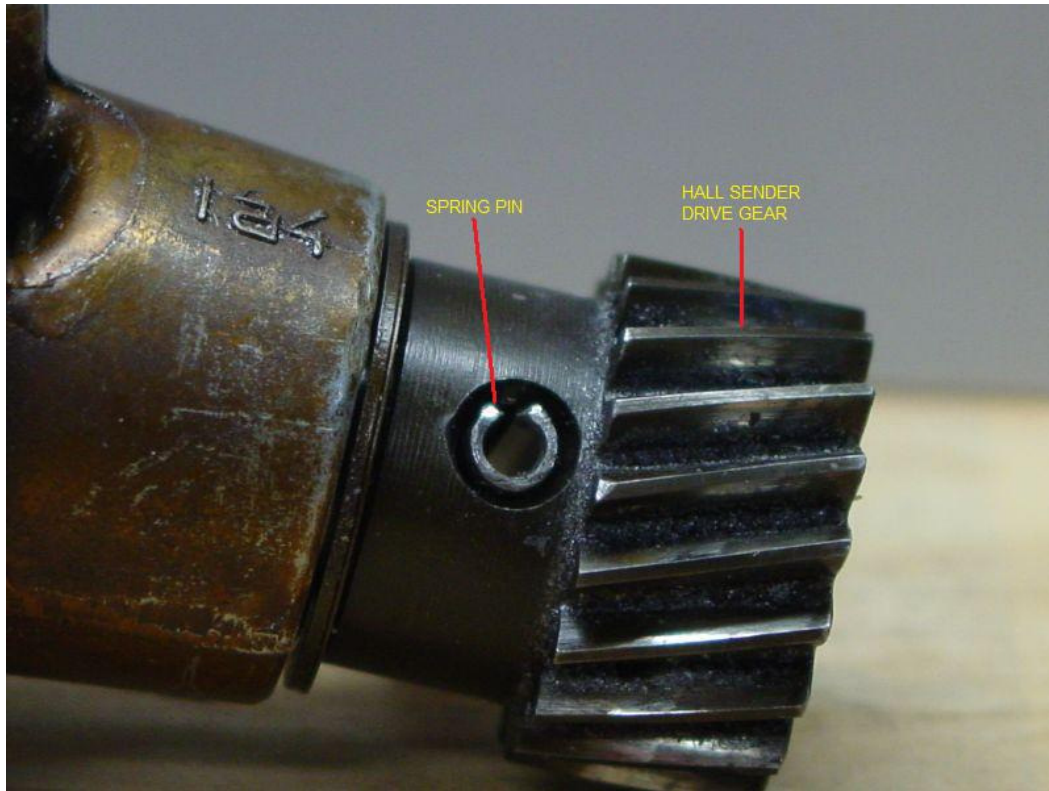
If you have a spring pin holding the drive gear to the shaft, it will look like this one on an AAN Hall sender, photo taken by Bill Z :

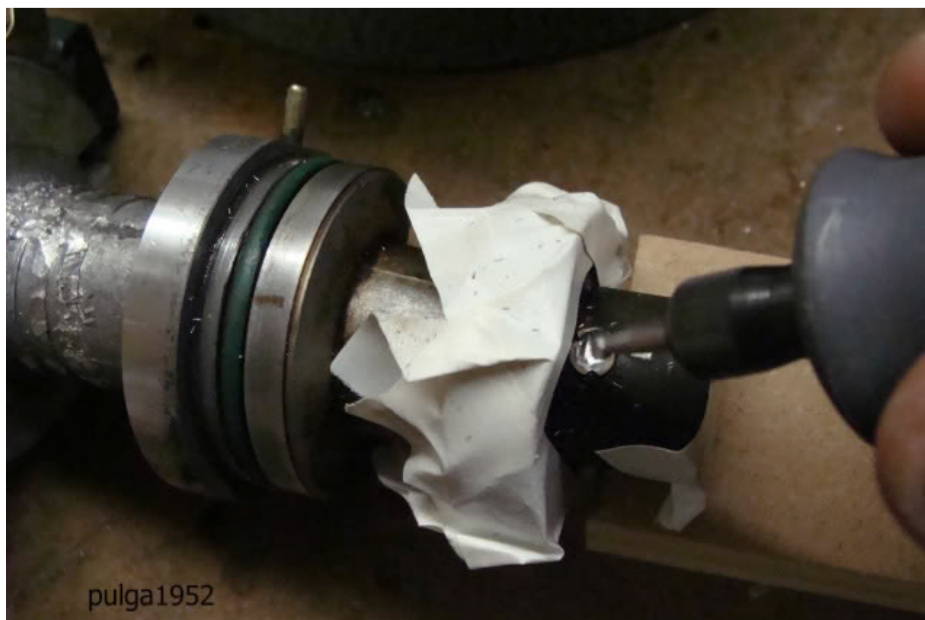
If are looking at a rivet and not the end of a spring pin, you will need to Dremel off the end of the rivet, as shown here in Jorge R's photo of a VW ABA distributor:

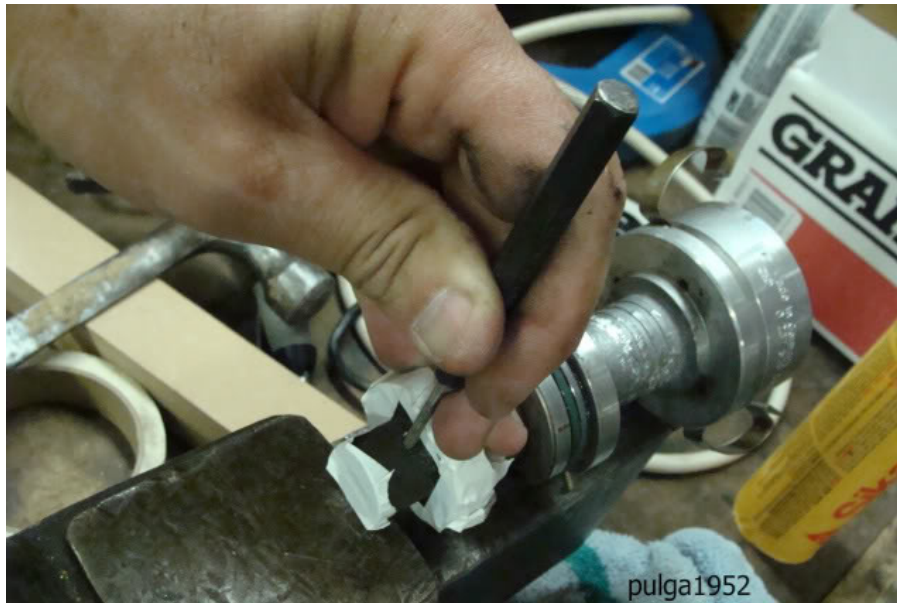
Cradle the distributor/Hall sender unit in vice or firm location and use a pin punch to remove the spring pin, as shown here in Jorge R's ABA distributor photo:

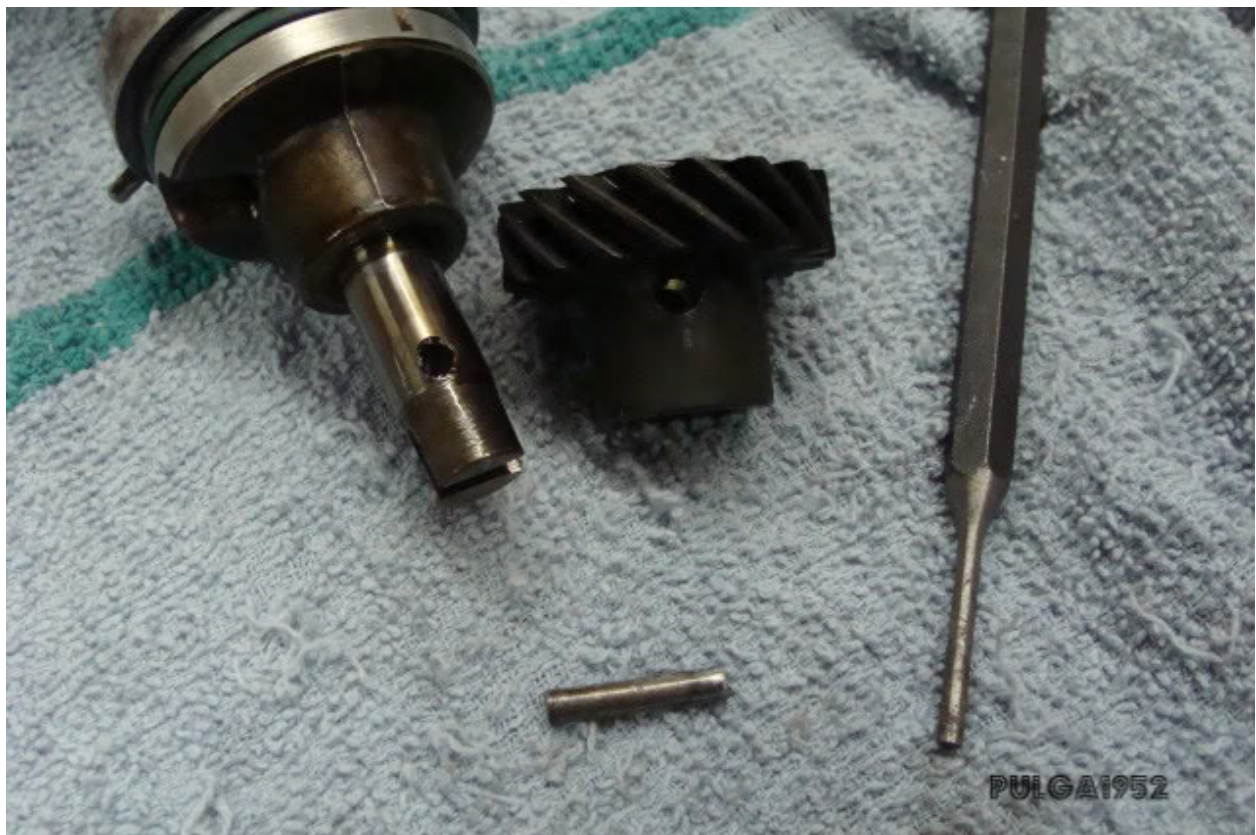
This should leave you with the drive gear off and the ability to pull the drive shaft completely out of the top of the distributor/Hall sender unit, as shown here in Jorge R's photo:

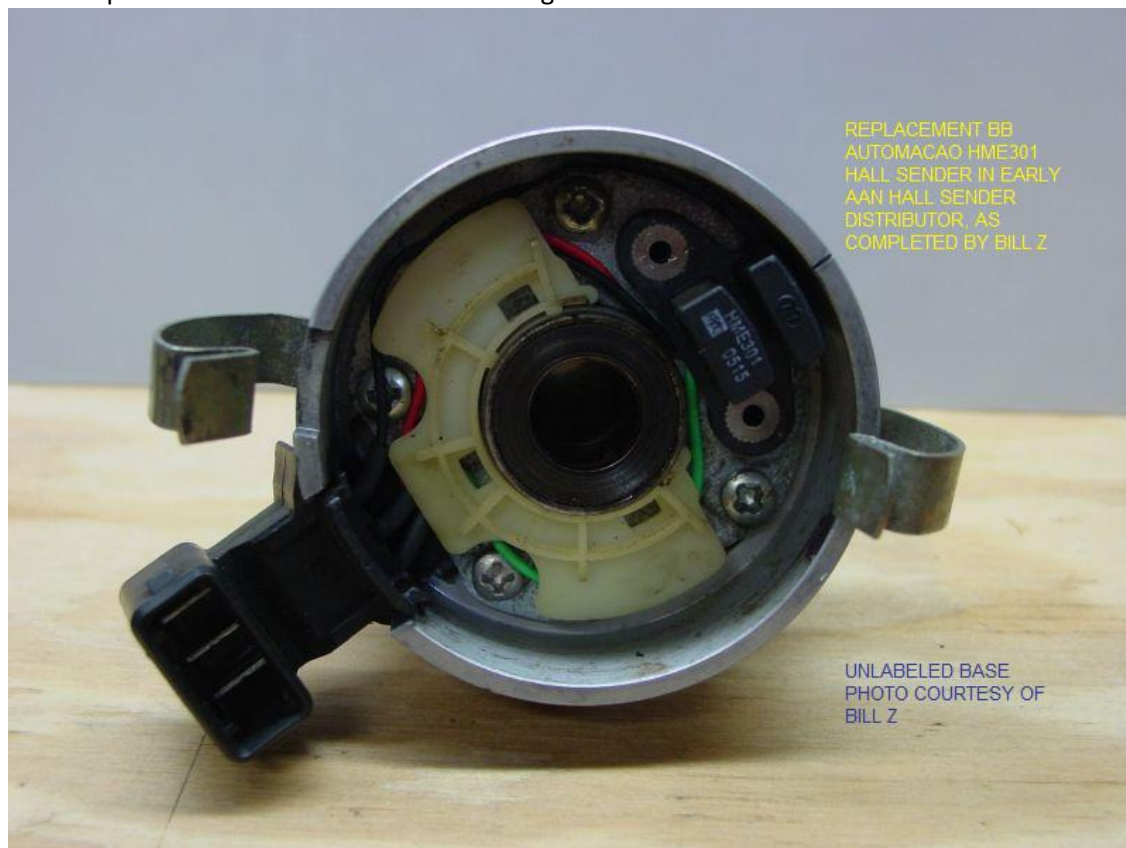
The end product should look and function as good as OE. Good luck.

You are now ready for reassembly, i.e. replacement of the plastic wire cover (AAN), placing the assembly plate back into the distributor housing, screwing the assembly plate to the housing with the screws that you removed at the beginning (and didn't lose), replacement of the main shaft and Hall sender shutter unit (check to see that the shutter sits in the Hall sender nicely), replace the drive gear and replace the OE rivet with the correct diameter and length spring pin.
