This write-up explains the procedure for replacing the after-run pump (ARP) on Audi S4s and S6s with the AAN engine. The ARP is an auxiliary water pump that assists in circulating coolant through the engine. My ARP began leaking at around 105k miles. Although the ARP continued to work, the plastic tube that sends coolant into the impeller broke, causing a leak between the coolant line and the ARP (see picture).

- Zane Smith, under the guidance of Les Woods
1994 Audi S4

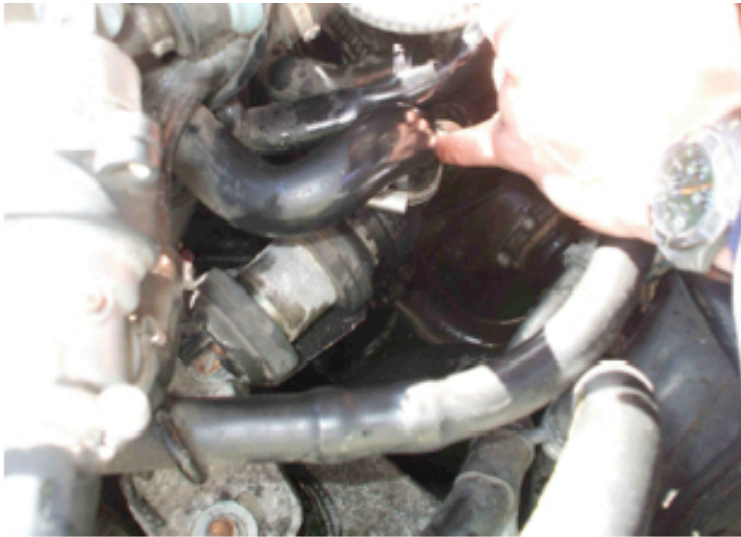
Old ARP with pinky in coolant hose.
Electrical plug is disconnected.

- 5.) This is where things get tricky. As I mentioned at the beginning, my ARP failed because the plastic piece that goes straight into the impeller broke. The plastic piece that broke was stuck in the coolant hose and had disintegrated, making it difficult to remove (see picture). I had to use pliers to pull the pieces of plastic out. If your car has the same problem, it's important to get all the plastic bits out so that they don't get stuck in the cooling system. I was able to remove bits that were lodged in the hose by tipping the hose down and flushing them out with coolant and sticking my pinky through the hose to make sure the coast was clear. It's for this reason that I advise taking off the top coolant line first.

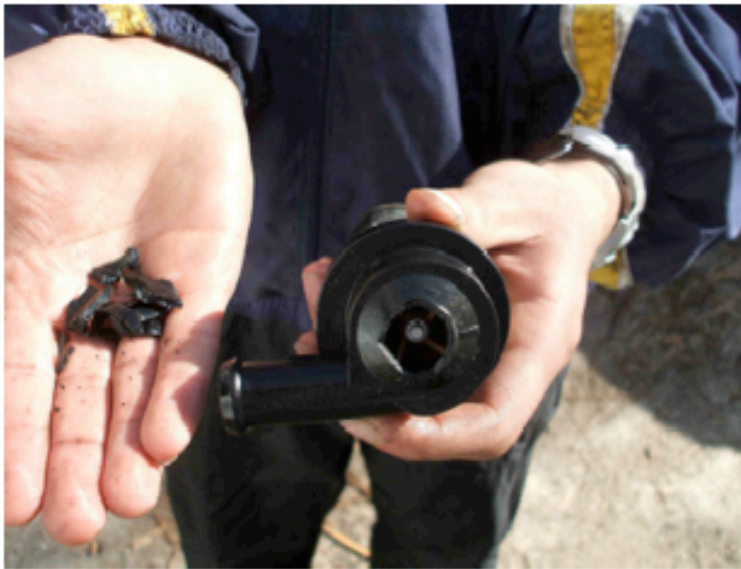
Old ARP with plastic bits that
broke. Check out that impeller.

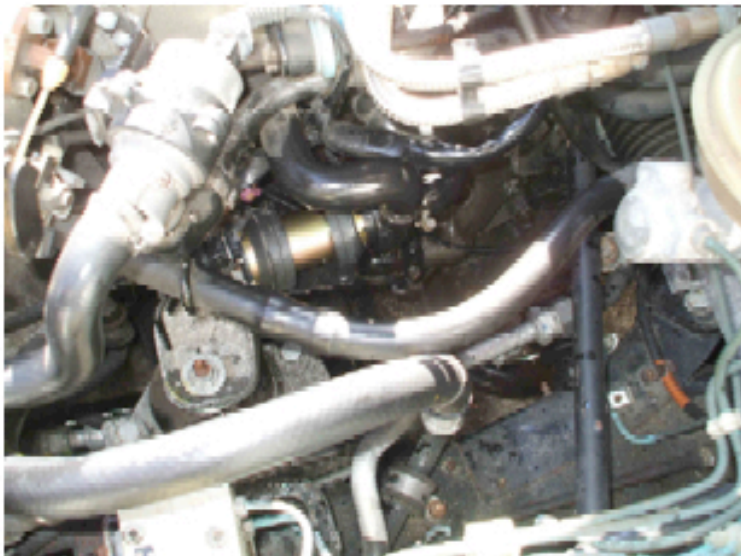
New ARP with everything
connected and installed.

- 8.) Slide your new ARP into its new home, snug up your clamps, and reconnect the electrical plug.
- 9.) Fill your coolant expansion tank, start the car, and blast your heater to circulate coolant. Leave the cap off the tank so coolant can bleed through the system. Add coolant as needed, as you would when performing a coolant flush and fill.
