Basic Install Instructions

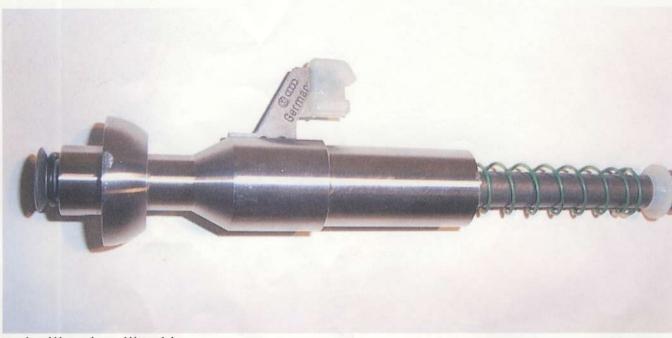
11. Assemble your new shaft assembly in this order, from bottom to top: O-ring, shifter body, green spring, plastic bushing, snap ring. Be sure to put some grease on the shaft. The skinny spring will sit in the recessed portion on the very top, and the assembly looks like this (exploded view):

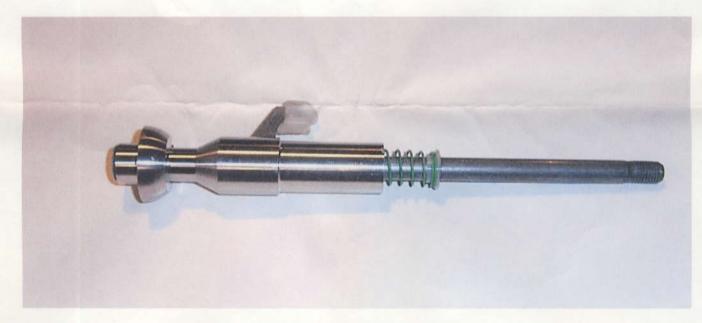
and will end up like this:

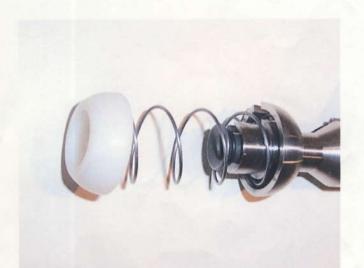
12.Use short, wide spring and new plastic half-ball like so:

then hold tight by hand and press into your freshly renewed shifter ball socket. Use grease liberally here.
